Mississippi Riverbank Erosion Inventory: Coon Rapids to Fridley

November 2021

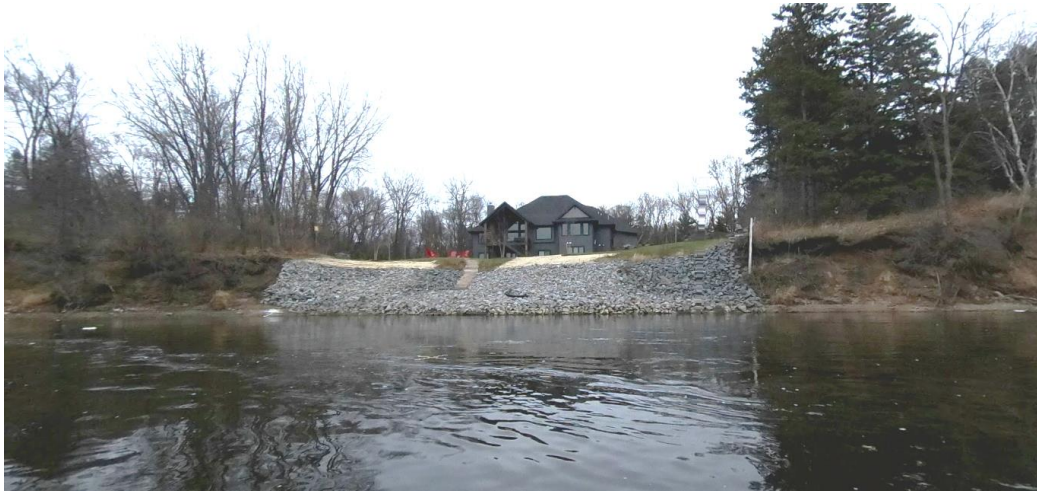
Figure 3. Riverbank stabilized with riprap bordered on both sides by severely failing vertical slopes.

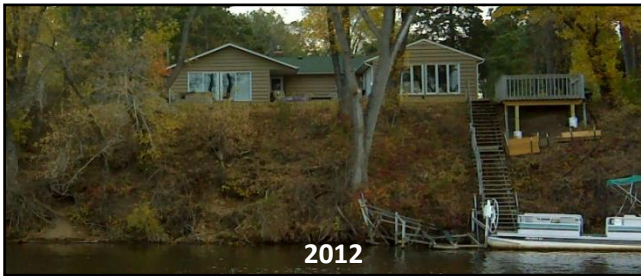
Description: Short but severe cliff that caused the collapse of a staircase leading to the river. Bank upstream of the cliff still contains vegetation but is equally steep and exhibits an eroded toe

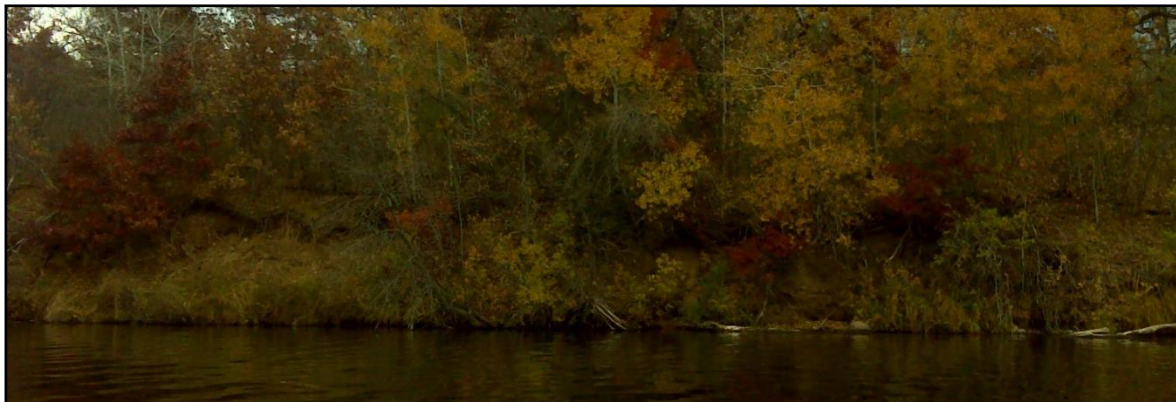
Description: Erosion has caused slumping, exposing soils and creating vegetative overhang. Located at Coon Rapids Dam park.

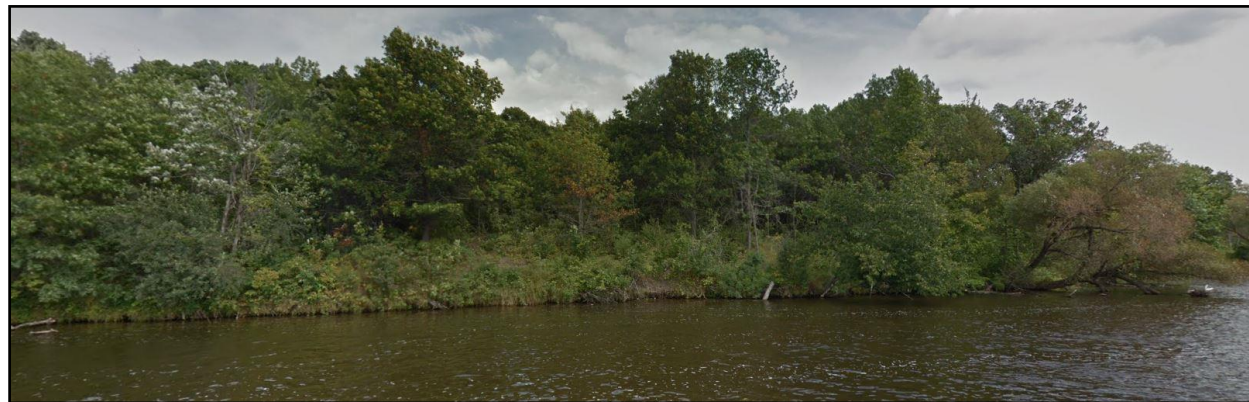
Description: Moderate toe erosion has exposed some roots and caused minor slumping/ leaning trees.

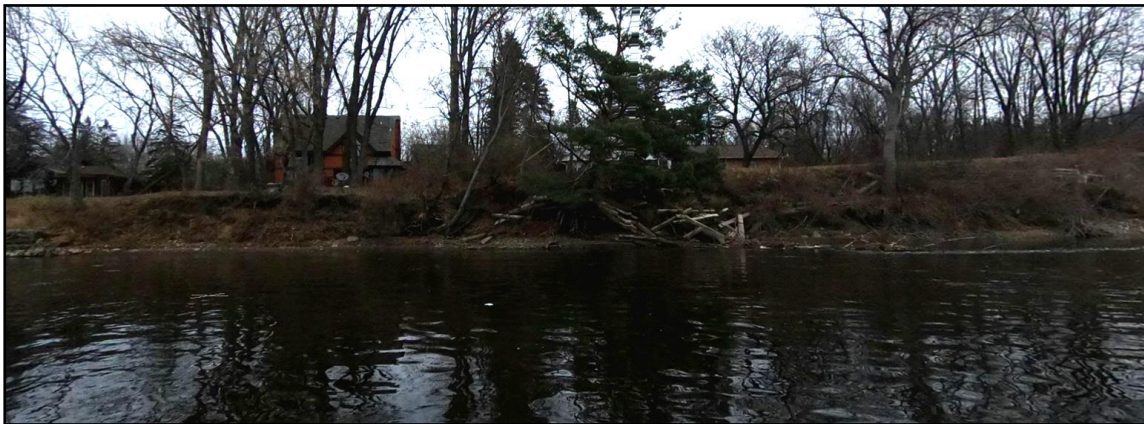
Description: Erosion has caused a slump on the upstream part of this shoreline and an undercut toe on the downstream portion. This transitions into severe erosion on the next stretch of shoreline.

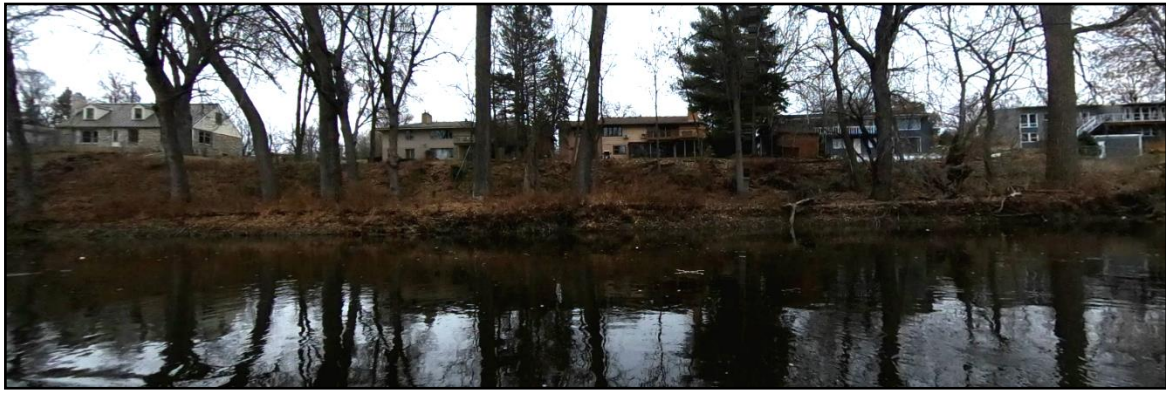
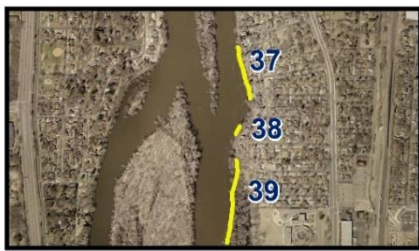
Description: Erosion has caused the toe to recede and the bank to become vertical with some exposed root systems. The most visible erosion is occurring only on the bottom section of the shoreline.

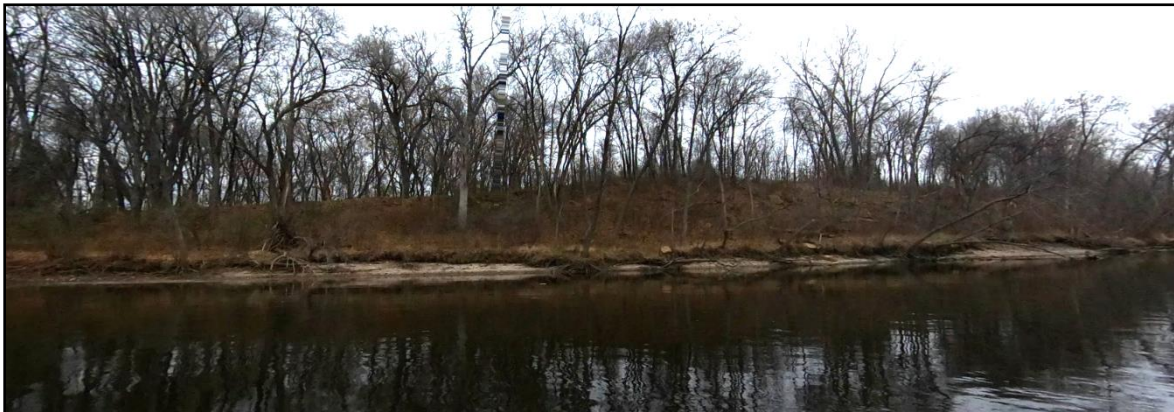
Description: Relatively short erosion height on a larger slope, but it has caused an undercut, exposed roots/leaning trees, and some moderate slumps.
