# Coon Rapids Dam Pool Shoreline Inventory

*The Minnesota Department of Natural Resources*

December 2012

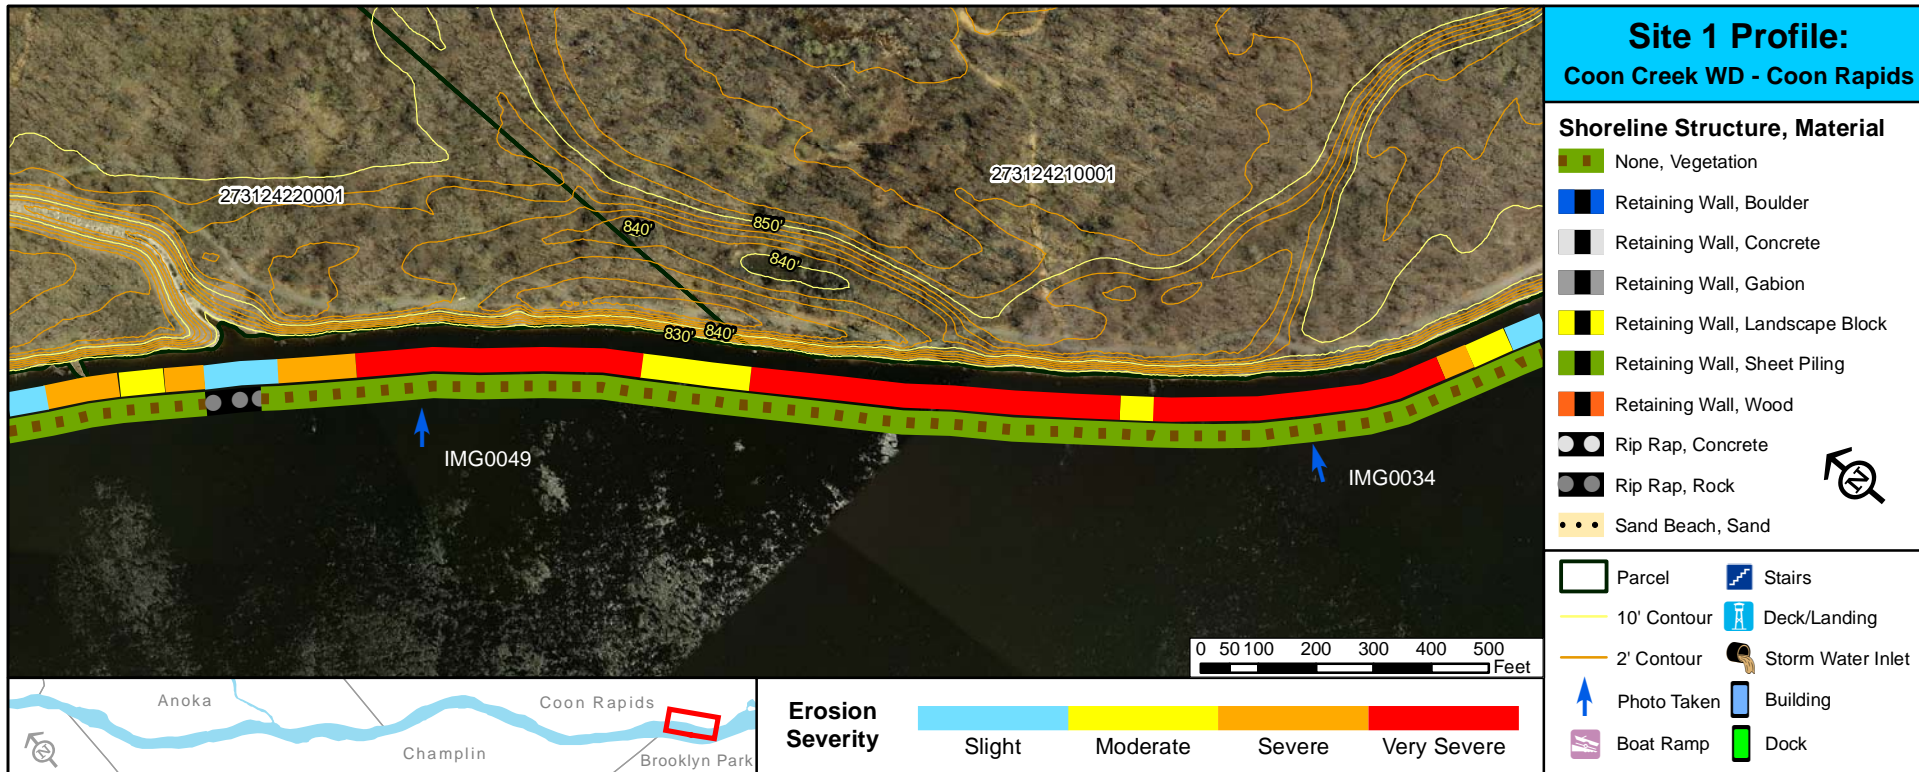
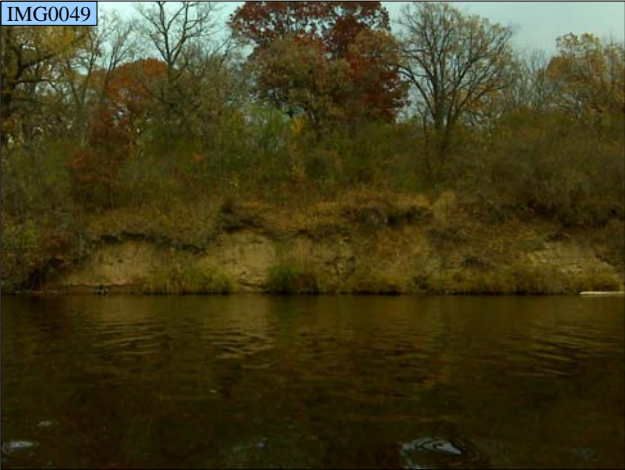
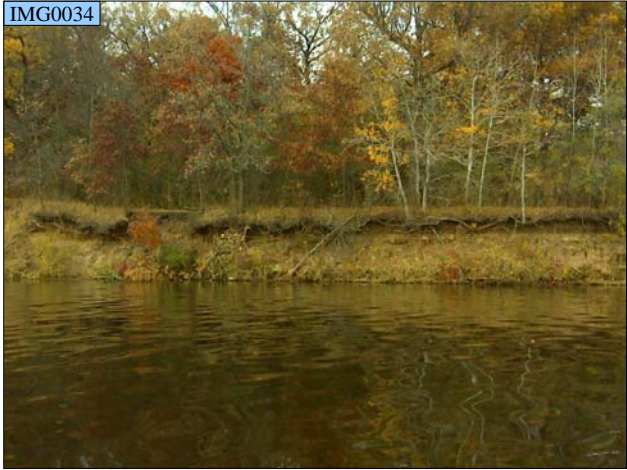
**Additional Info:** This site is located on the outside of a curve in the river, called a cut-bank. This makes it likely to be hit by large ice sheets and moving water during the spring melt. Many fallen trees and vegetative overhangs of several feet show the fast pace of erosion here. The bank varies in height between 12 and 20 feet. A paved bike trail runs along the top of the bank, often 5 feet or less from the edge of the bank. Within a few years the bank could threaten the stability of the trail.

Site Information	Estimated Annual Soil Loss	Severe Erosion Length	Typical Slope	Property Ownership	Atlas Page #	Photo #
	1871 tons	2051 feet	1.5-2.0 to 1	Anoka County	6-12	31-60

**Potential Solution:** Protect the toe of this bank from ice damage by arming it with large rip rap or boulders. Use native planting on the slope to hold the soil in place. Turf reinforcement material may be necessary on the steepest slopes.

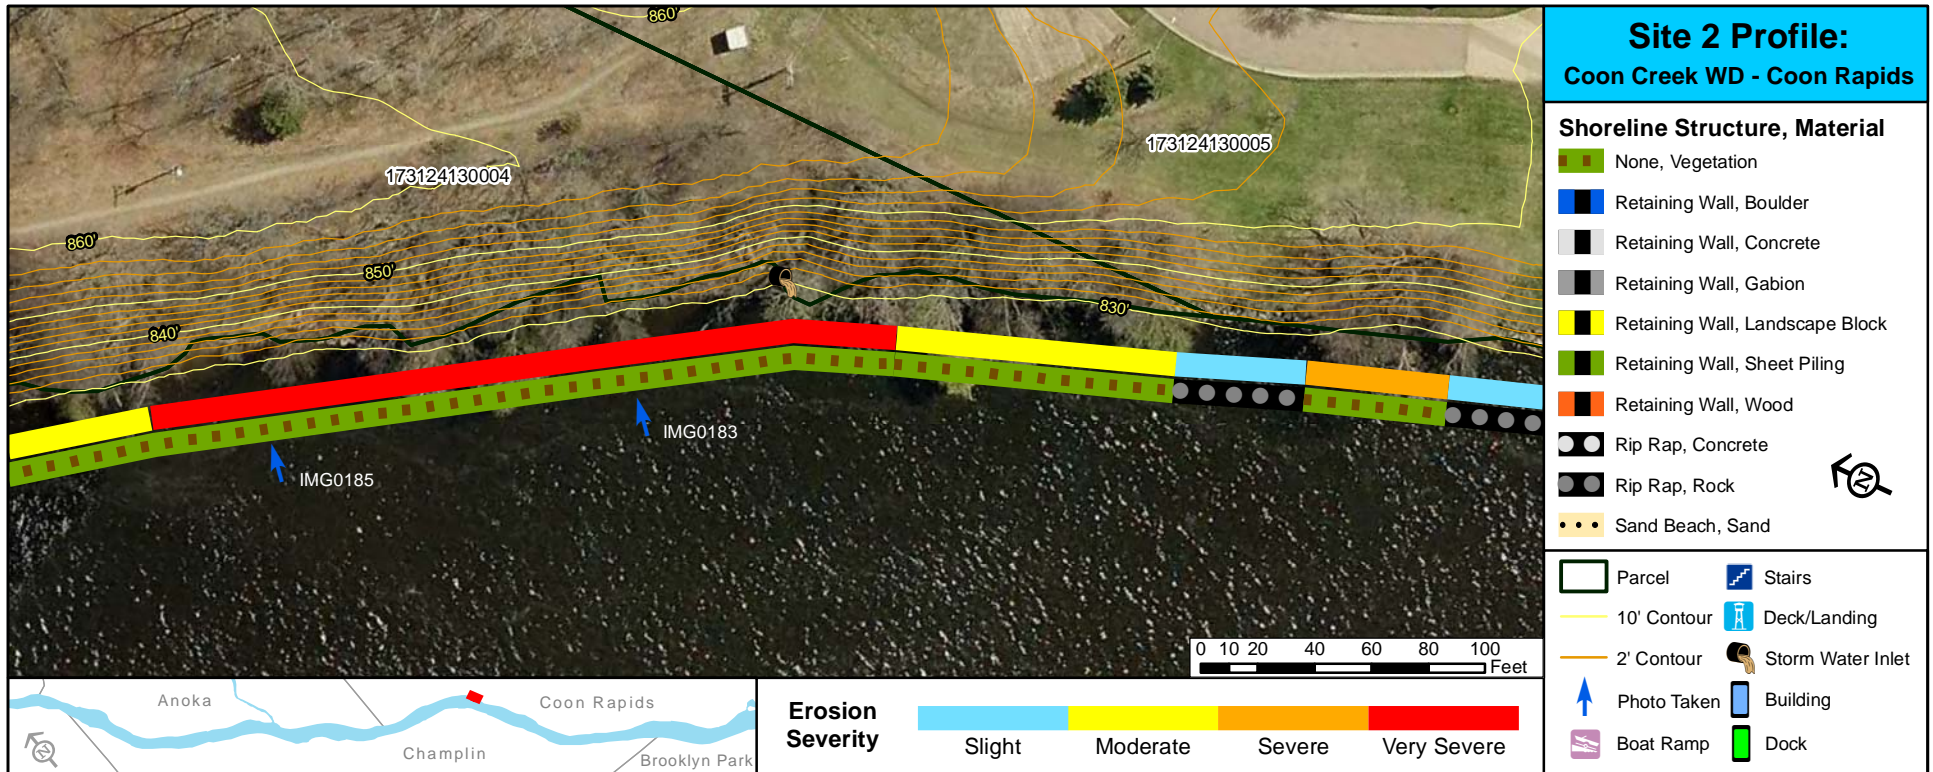
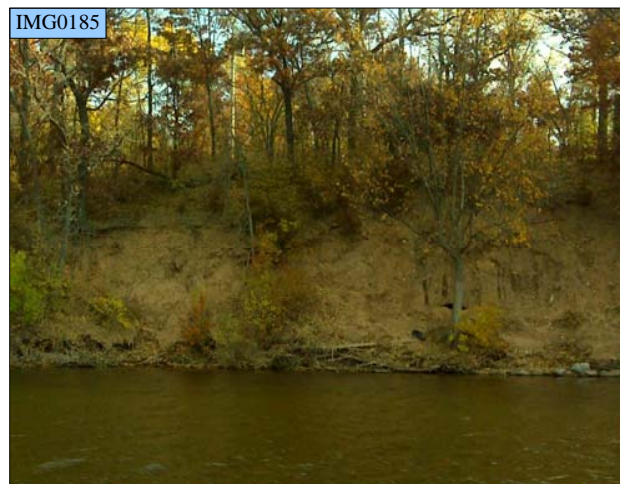
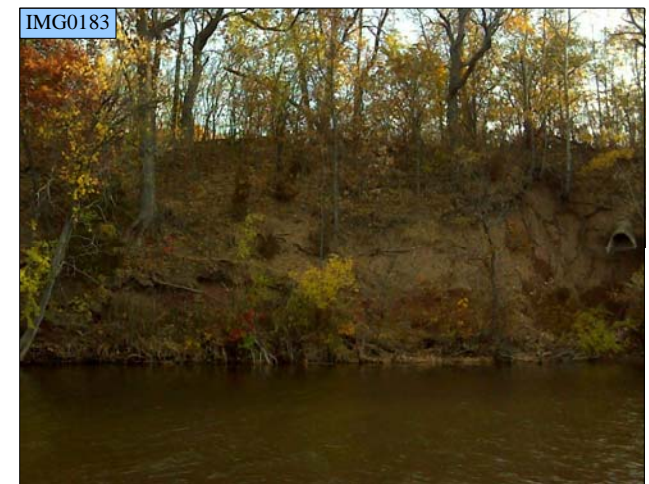
**Additional Info:** This site is located on the outside of a curve in the river, called a cut-bank. It is likely hit by large ice sheets and moving water during the spring melt. As shown in picture 183, a concrete storm water culvert is sticking 5 feet out from the sheer bank. This along with the many slumping trees at the site show the large amount of sediment lost.

Site Information	Estimated Annual Soil Loss	Severe Erosion Length	Typical Slope	Property Ownership	Atlas Page #	Photo #
	510 tons	312 feet	1.4 to 1	Anoka-Ramsey Community College	37-39	178-191

**Potential Solution:** Protect the toe of this bank from ice damage by armoring it with large rip rap or boulders. Use native planting on the slope to hold the soil in place. Turf reinforcement material may be necessary on the steepest slopes. This site has the highest ratio of soil loss per linear foot of any site inventoried, which could potentially make it a more cost-effective project.

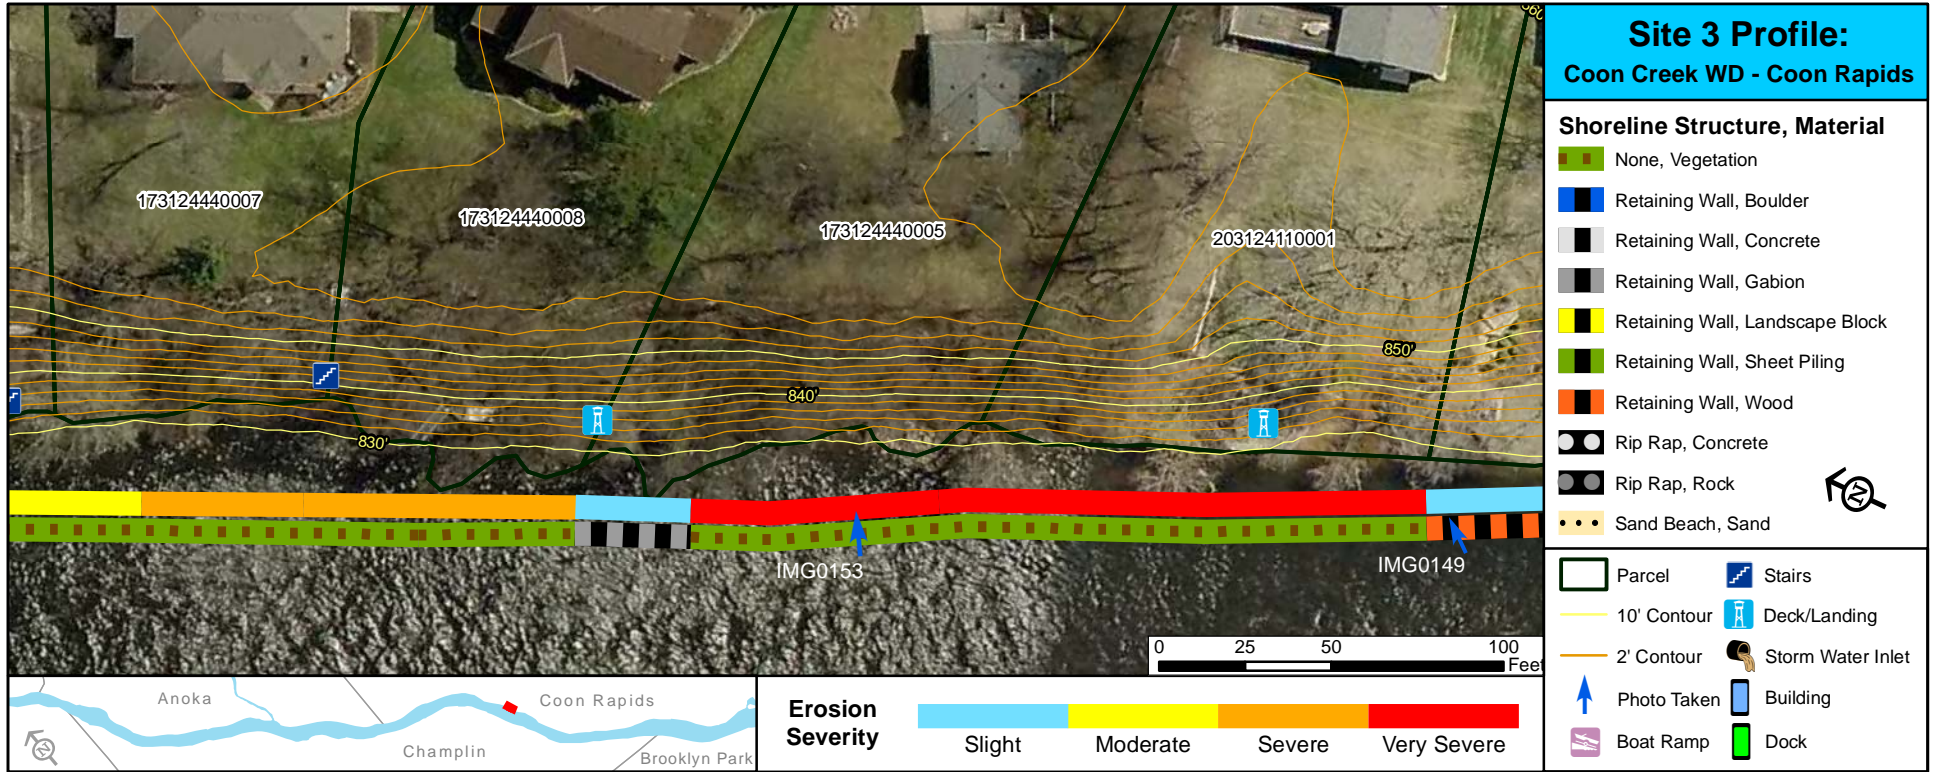
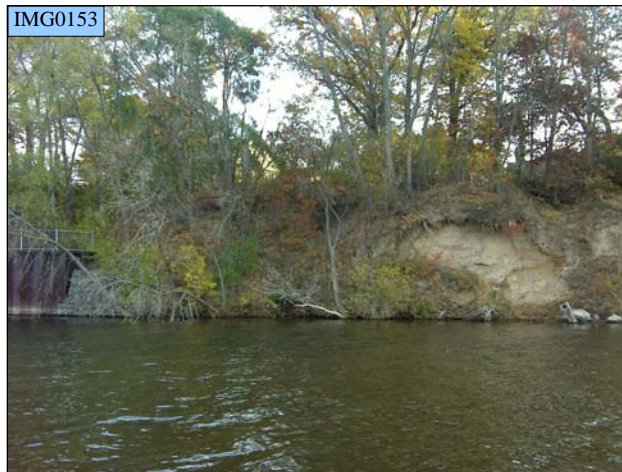
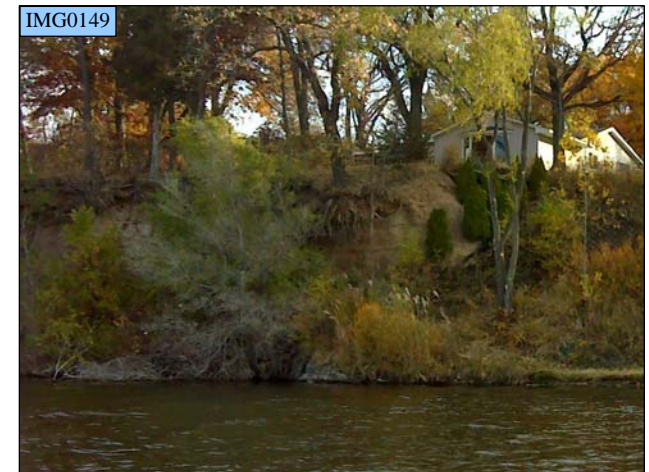
**Additional Info:** At least one large tree has been lost here since the last photo inventory in 2004. Several others are slumping and have their roots exposed. Vegetative overhangs of a few feet are common.

Site Information	Estimated Annual Soil Loss	Severe Erosion Length	Typical Slope	Property Ownership	Atlas Page #	Photo #
	439 tons	341 feet	1.4 to 1	Private	33-34	149-159

**Potential Solution:** Protect the toe of the bank from ice damage using large rip rap or boulders. The bank is so steep here that grading of the slope might be necessary to produce a stable bank. Native planting with a turf control material might also be an option for some of the slope. This site has a high ratio of soil loss per linear foot, which could make it more cost-effective than other potential projects.

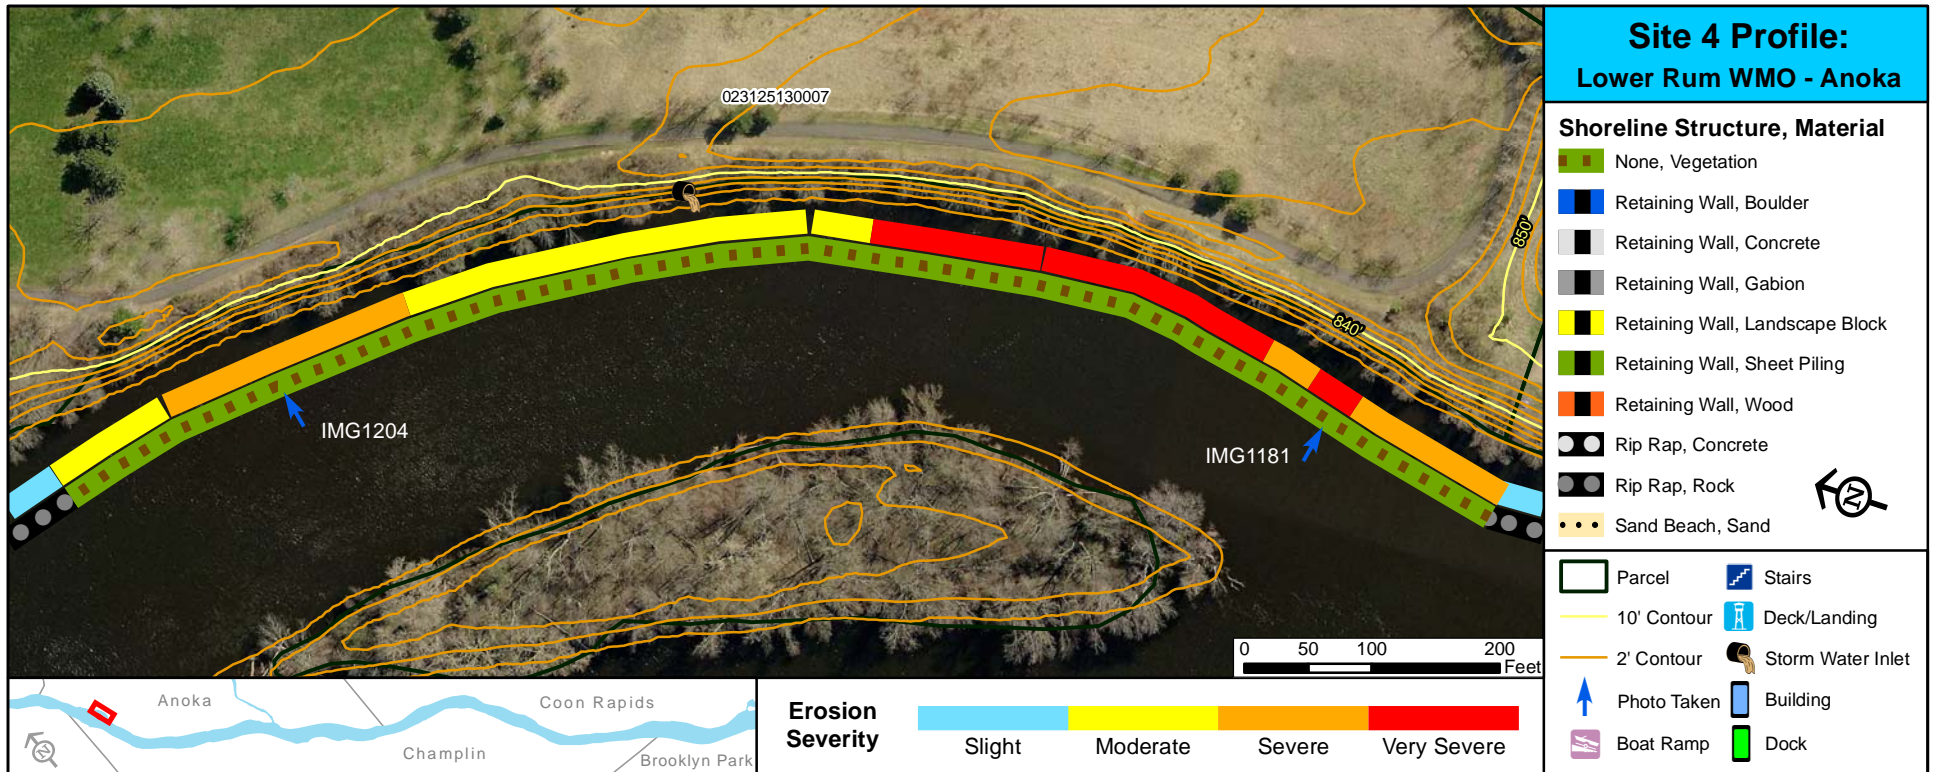
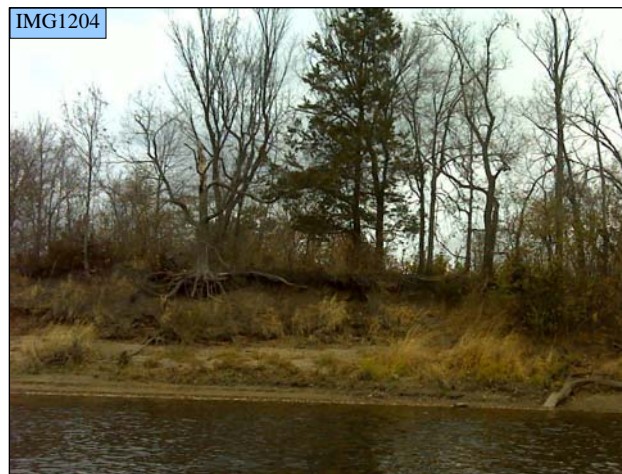
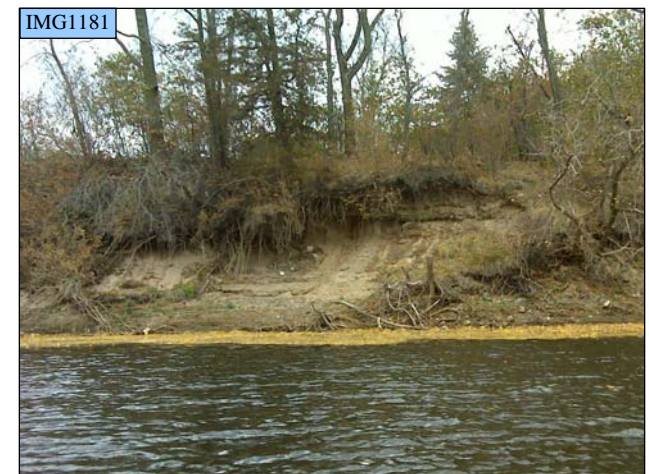
**Additional Info:** Located on a cut-bank, this area is likely to be hit by large sheets of ice in the spring. Many slumping and recently fallen trees show the fast pace of soil loss here. Root overhangs of several feet are widespread in the areas marked severe and very severe. A paved City of Anoka bike trail runs along the top of the bank, between 10 and 15 feet away from the steep bank. Within a few years erosion could threaten the integrity of the trail.

Site Information	Estimated Annual Soil Loss	Severe Erosion Length	Typical Slope	Property Ownership	Atlas Page #	Photo #
	581 tons	738 feet	2.0 -2.5 to 1	City of Anoka	102-105	1179-1209

**Potential Solution:** Protect the toe of this bank from ice damage by armoring it with large rip rap or boulders several feet above the waterline. Use native plants to cover and stabilize the upper slopes. A turf stabilization material may also be needed for the steepest sections of the bank.

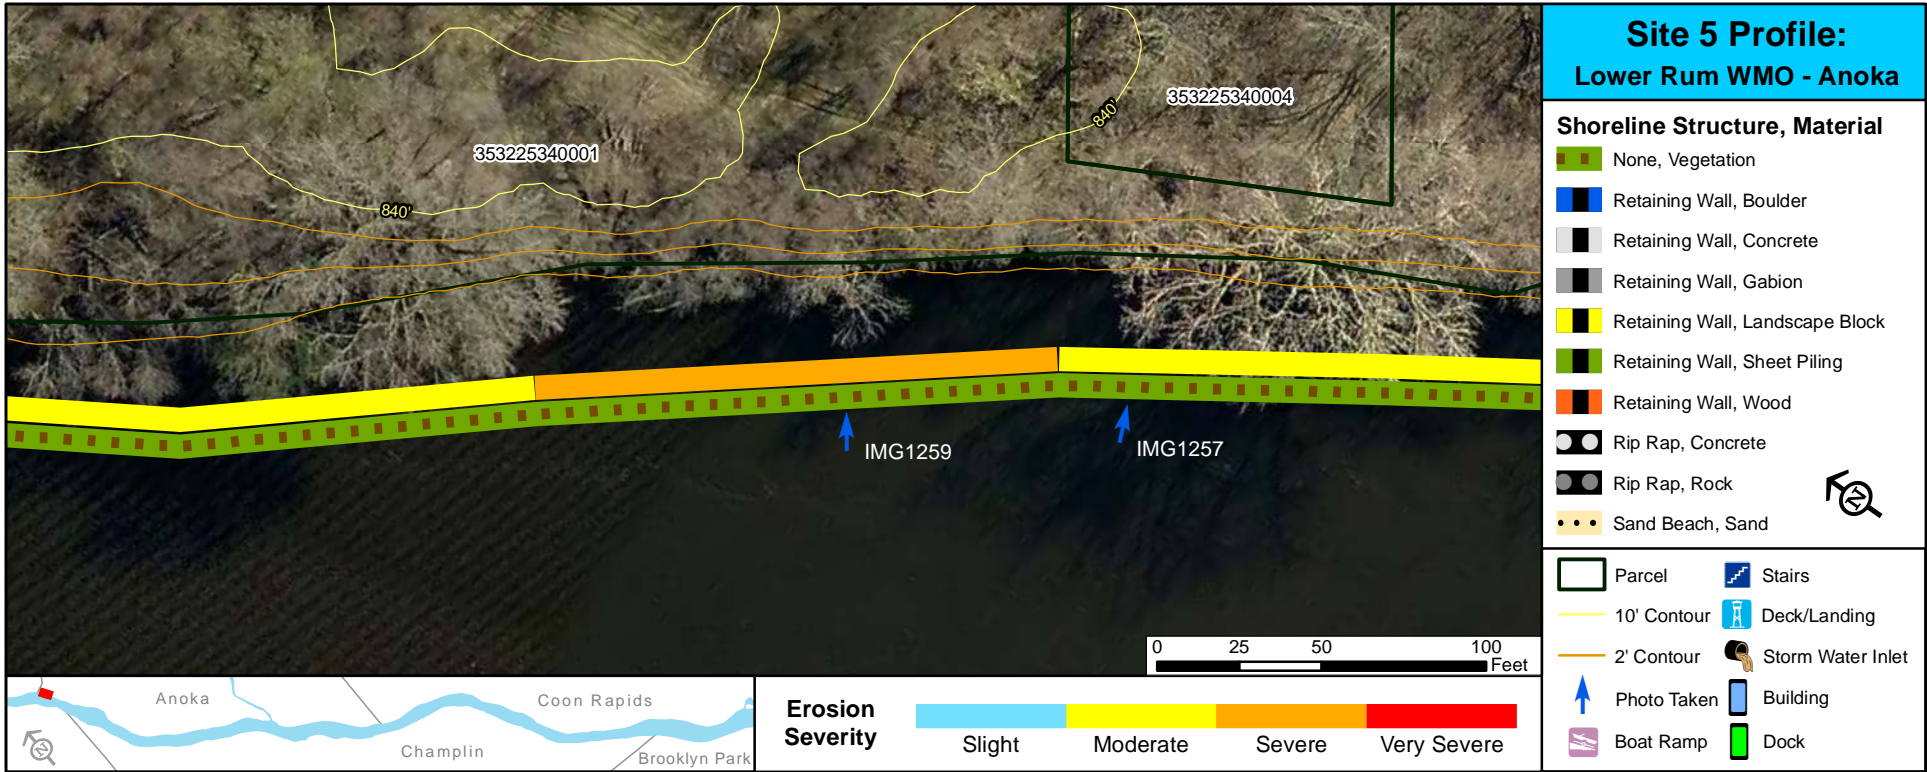
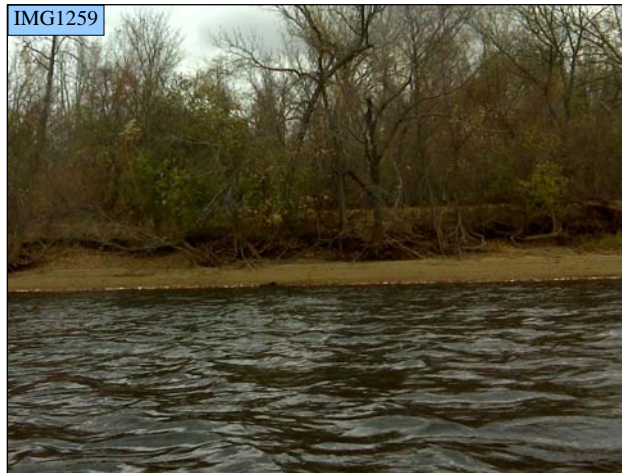
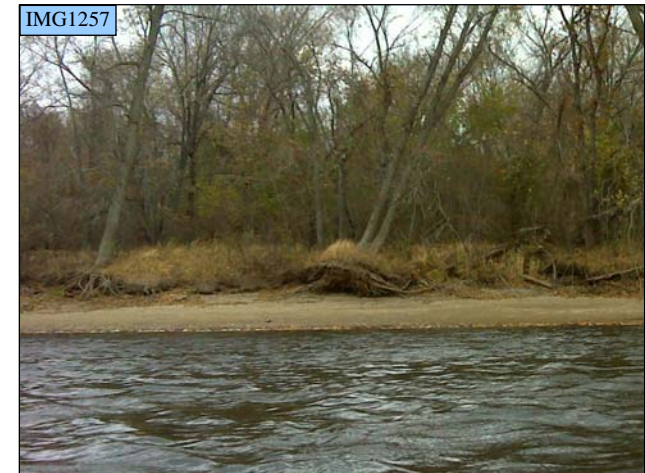
**Additional Info:** This site is located on the northern end of King’s Island in Anoka. It is located on a cut-bank, which likely means it is hit by large ice sheets in the spring. All of the trees along the shoreline have heavily exposed roots and a few are beginning to slump. The bank is only a few feet tall, so the total amount of soil loss here is not as great.

Site Information	Estimated Annual Soil Loss	Severe Erosion Length	Typical Slope	Property Ownership	Atlas Page #	Photo #
	51 tons	159 feet	2.5 to 1	City of Anoka	111-112	1255-1265

**Potential Solution:** Protecting the bank from ice using rip rap or boulders will help the bank rebuild itself over time. Native plants will help hold the soil in place.

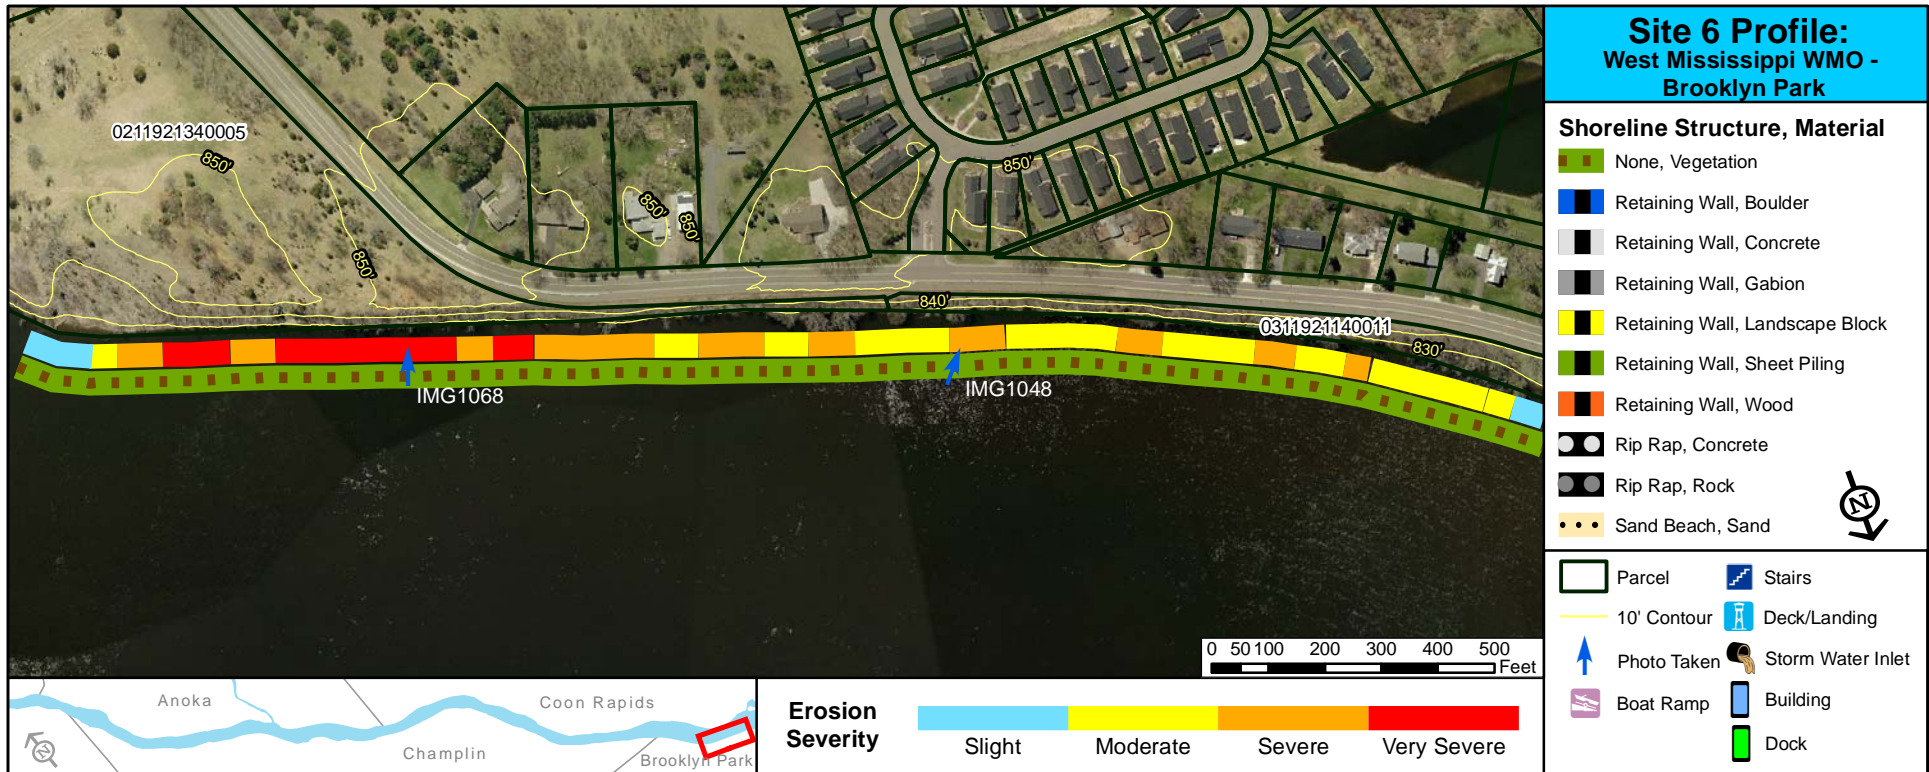
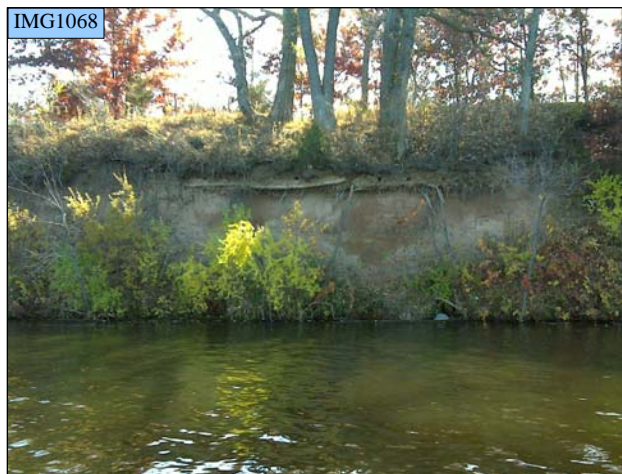
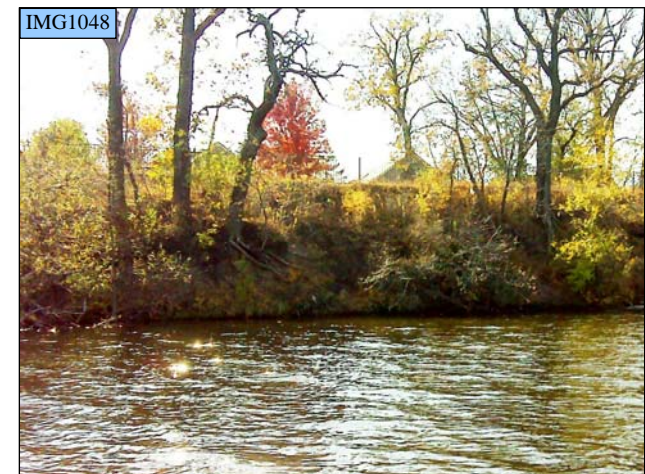
**Additional Info:** Located on a cut-bank, this area is likely hit by large sheets of ice and moving water in the spring. The downstream portion of this site, where erosion is worst, is part of the Coon Rapids Dam Regional Park. Root overhangs of several feet are widespread and the bank is mostly bare. The upstream portion is owned by a local HOA. The erosion is less concentrated here, but a paved bike trail and West River Road are only a few feet from the top of the steep bank.

Site Information	Estimated Annual Soil Loss	Severe Erosion Length	Typical Slope	Property Ownership	Atlas Page #	Photo #
	1142 tons	1446 feet	1.5-2.0 to 1	Three Rivers Park District & Private	201-206	1030-1082

**Potential Solution:** Protect the toe of this bank from ice damage by armoring it with large rip rap or boulders several feet above the waterline. Use native plants to cover and stabilize the upper slopes. The bank is very steep in some areas, so a turf stabilization material may also be needed.

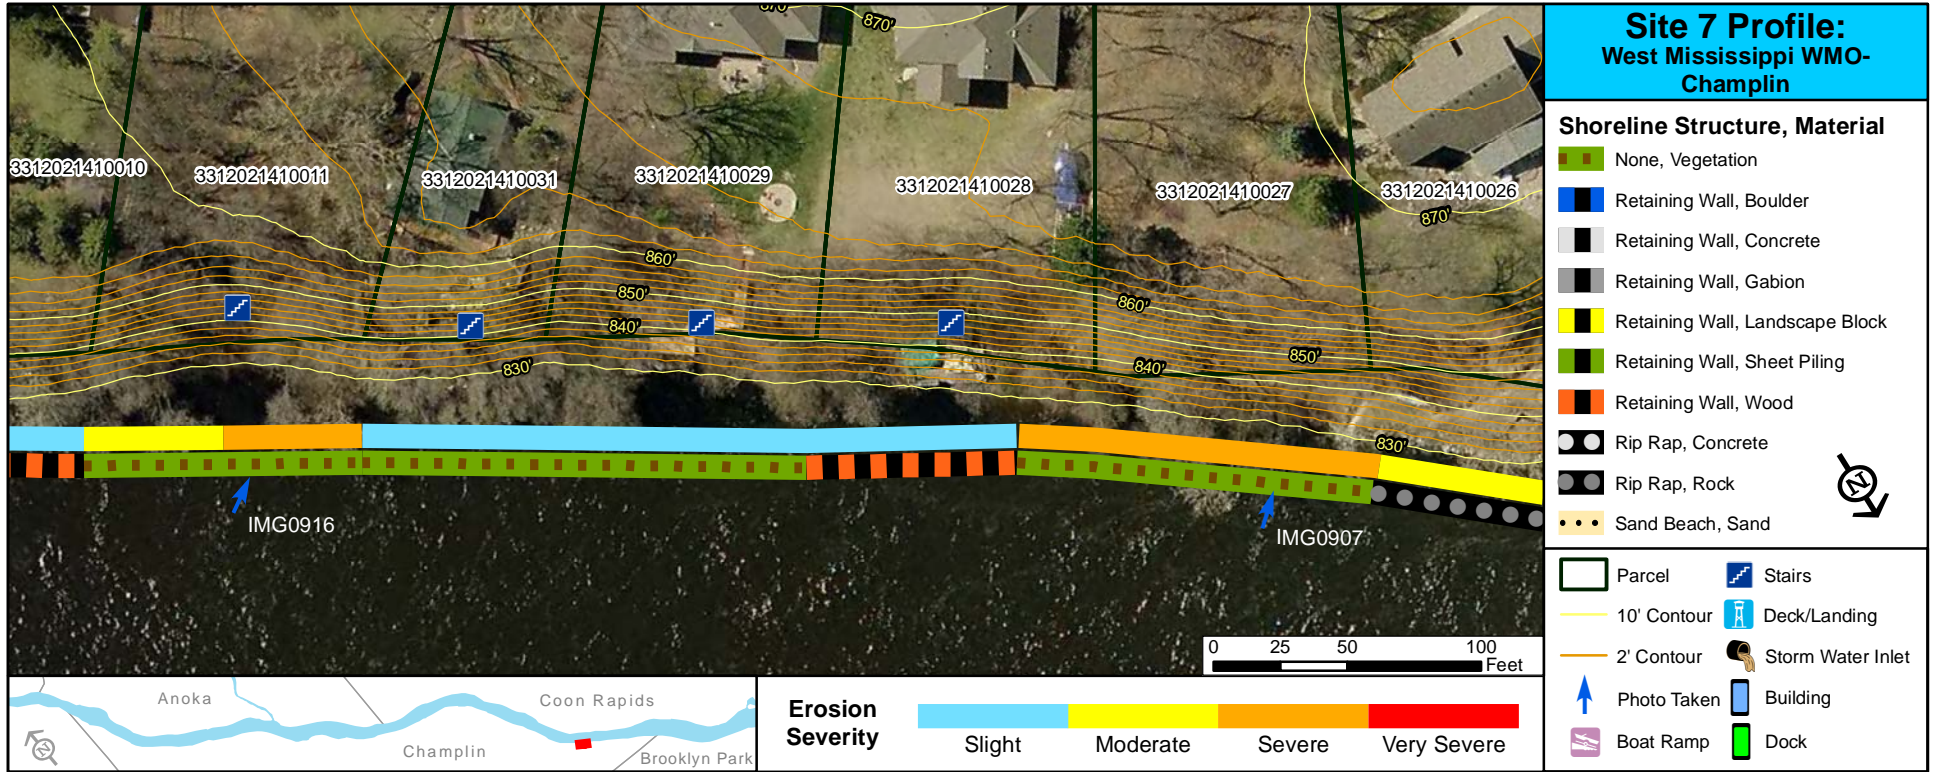
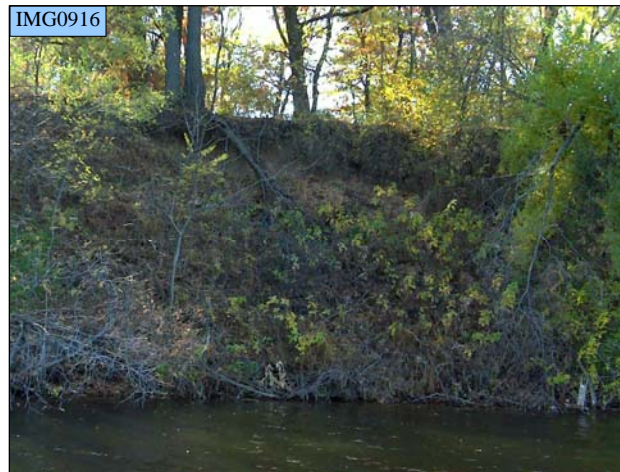
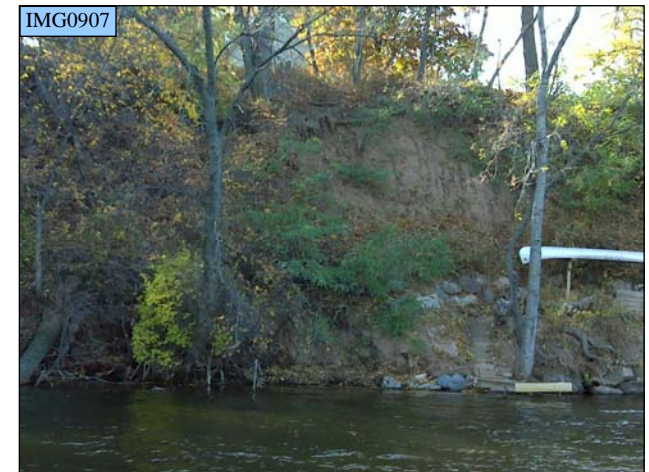
**Additional Info:** Located on a cut-bank, this area is likely to be hit by large sheets of ice and moving water in the spring. Most of the erosion at this site is currently happening above water level. The bank in this location is tall (30+ feet) and very steep. Much of the bank is bare with many exposed tree roots indicating a fast pace of erosion.

Site Information	Estimated Annual Soil Loss	Severe Erosion Length	Typical Slope	Property Ownership	Atlas Page #	Photo #
	209 tons	186 feet	1.4 to 1	Private	184-185	902-918

**Potential Solution:** Protect the toe of this bank from ice damage by armoring it with large rip rap or boulders several feet above the waterline. Use native plants to cover and stabilize the upper slopes. A turf stabilization material may be needed for the steepest sections of the bank. Some thinning of the tree canopy would allow more sunlight to reach the bank and promote plant growth.

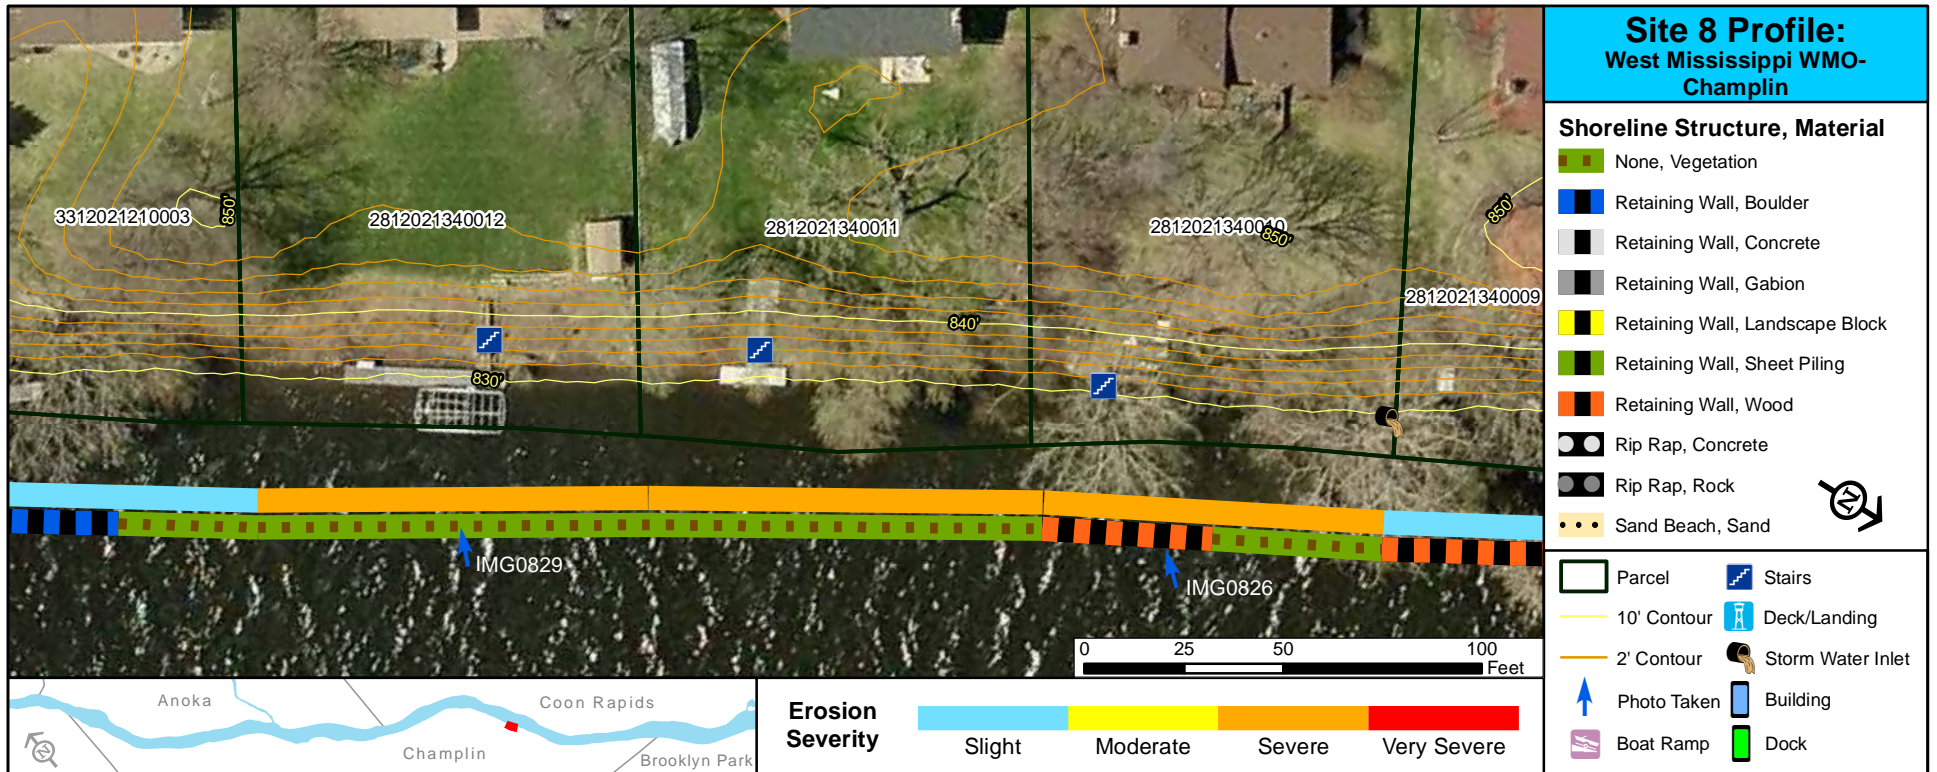
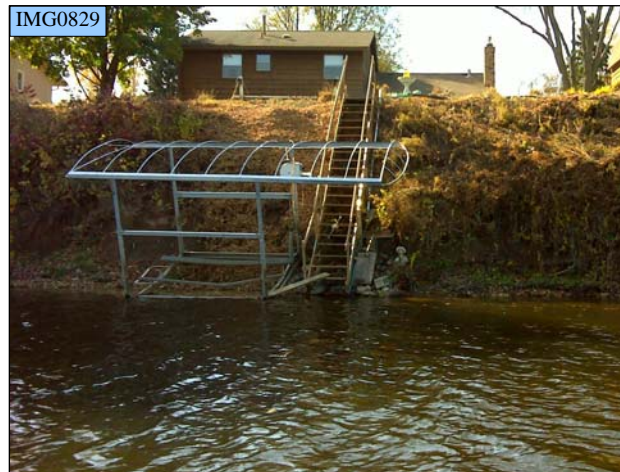
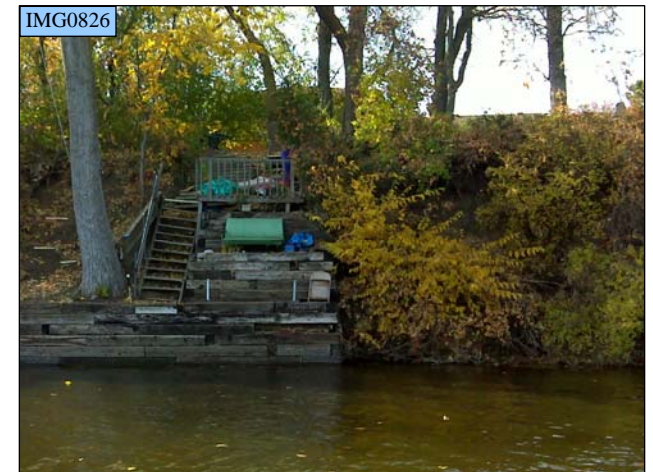
**Additional Info:** The bank here is not particularly high, but it is quite steep. Very few trees are growing on part of the southern end of the bank. This may be the result of or a contributing factor to the erosion. The erosion here seems aggravated by yard waste dumping which smothers vegetation.

Site Information	Estimated Annual Soil Loss	Severe Erosion Length	Typical Slope	Property Ownership	Atlas Page #	Photo #
	168 tons	283 feet	1.5 to 1	Private	174-175	820-833

**Potential Solution:** Promote plant growth here by disposing of yard waste properly and thinning the tree canopy in some places to allow in more sunlight. Some turf stabilization material may also be necessary to stabilize the steepest sections of the bank.

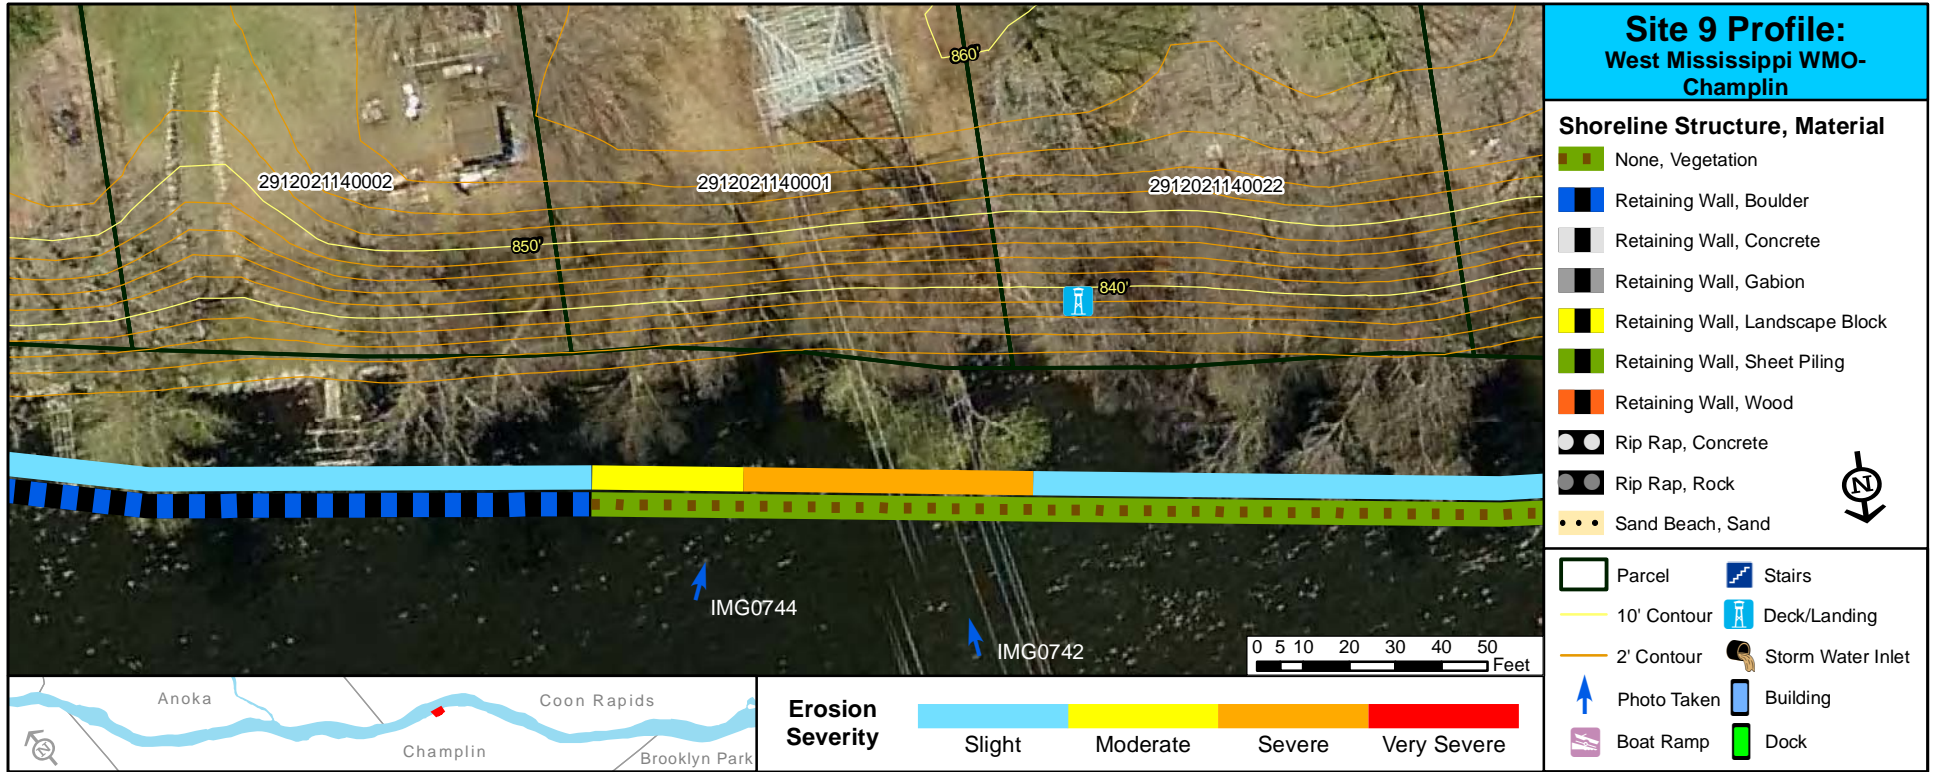
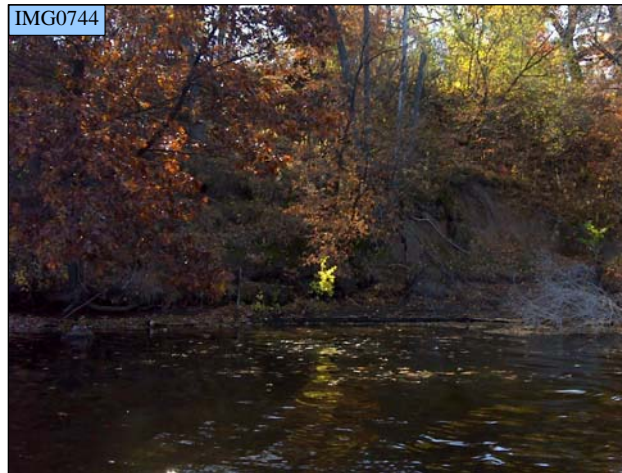
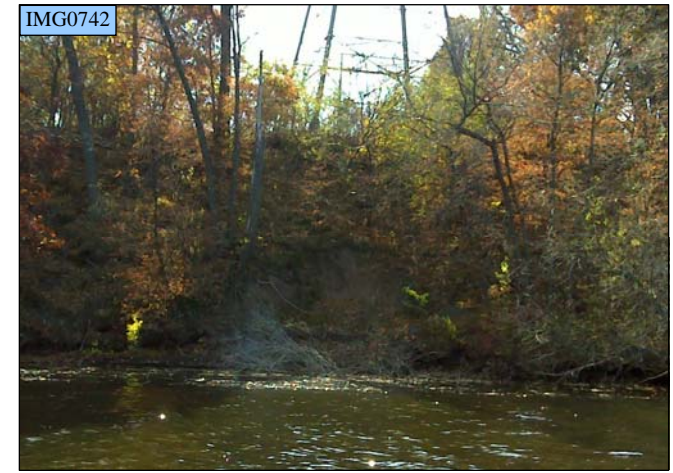
**Additional Info:** The erosion here is located directly below a transmission line. Repeated cutting of trees below the line might be contributing to the erosion here. The base of the tower is approximately 15 feet back from the top of the steep bank.

Site Information	Estimated Annual Soil Loss	Severe Erosion Length	Typical Slope	Property Ownership	Atlas Page #	Photo #
	64 tons	63 feet	1.8 to 1	City of Champlin	165	741-744

**Potential Solution:** Protect this bank by armoring the toe with rip rap or boulders. Consider removing trees and planting grass cover to stop repeated cutting of trees. Some turf stabilization material may also be needed on the steepest part of the slope.
