# Coon Rapids Dam Pool Shoreline Inventory

*The Minnesota Department of Natural Resources*

December 2012

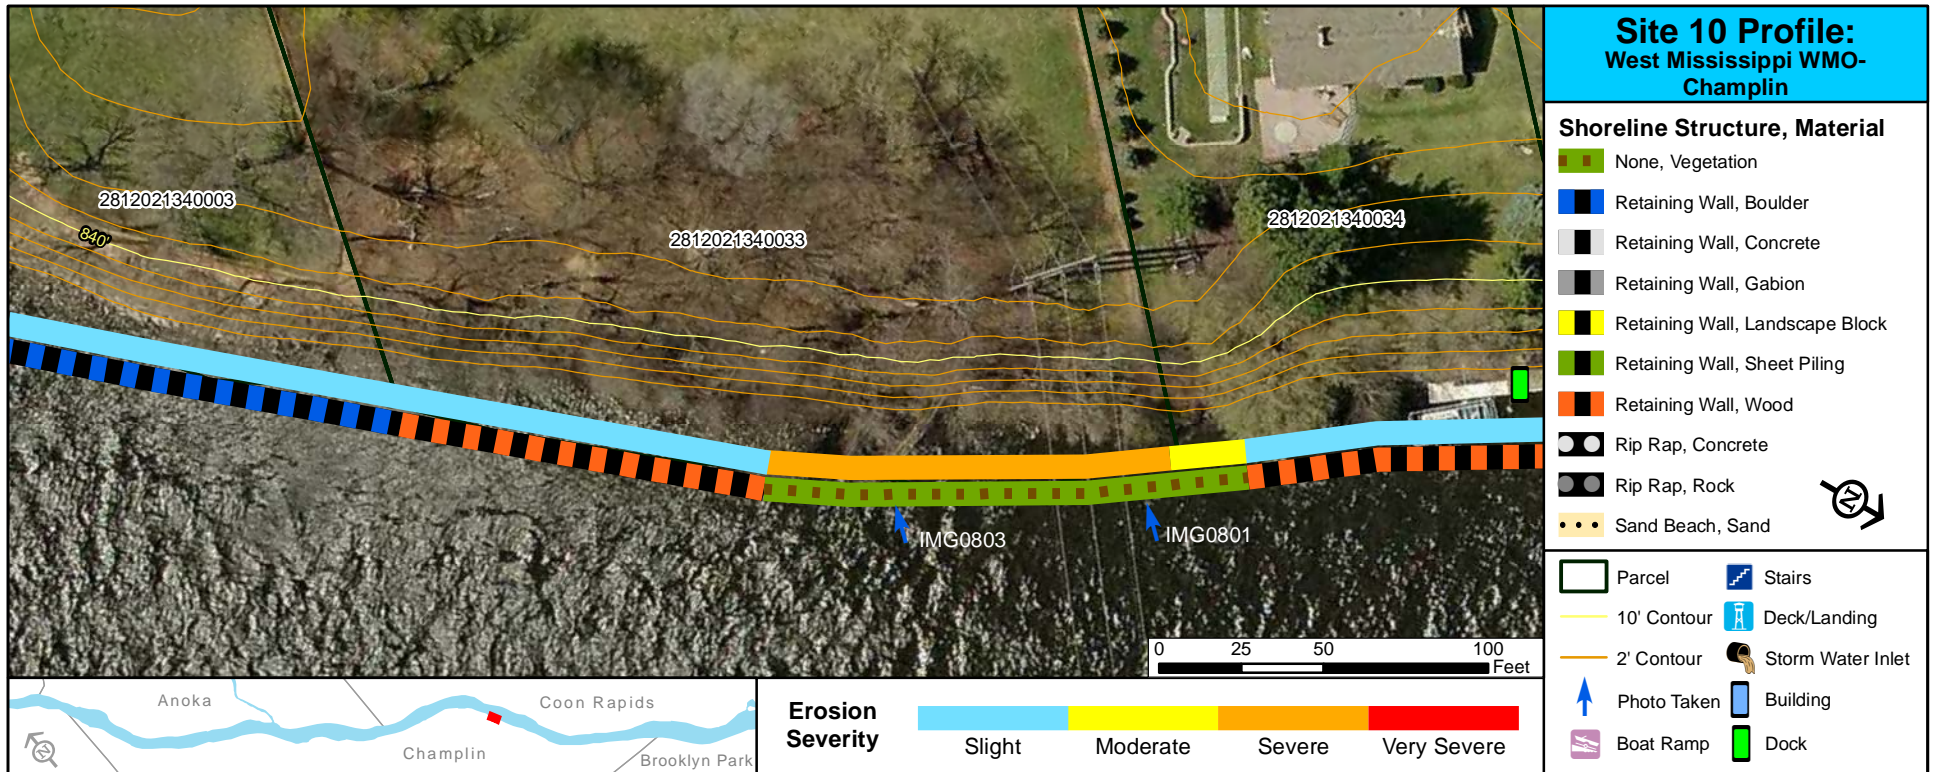
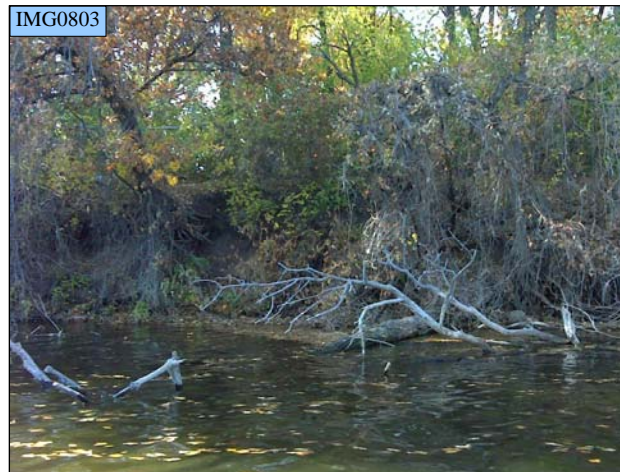
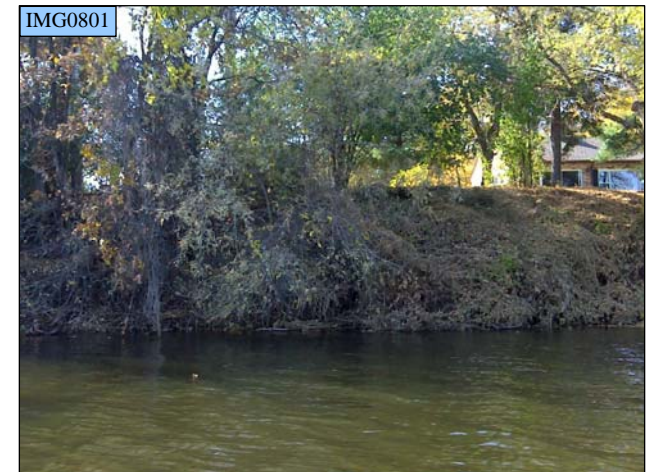
**Additional Info:** The erosion here is located mostly below a power line crossing the river. Repeated cutting of trees away from the line may contribute to the erosion problem here. Yard waste dumping was also apparent here.

Site Information	Estimated Annual Soil Loss	Severe Erosion Length	Typical Slope	Property Ownership	Atlas Page #	Photo #
	55 tons	124 feet	2.0 to 1	Private	172	798-806

**Potential Solution:** Avoid the repeated cutting of trees by replacing them with grass cover. Also, promote more robust vegetation growth by disposing of yard waste properly and potentially thinning the tree canopy to allow more sunlight to reach the plants.

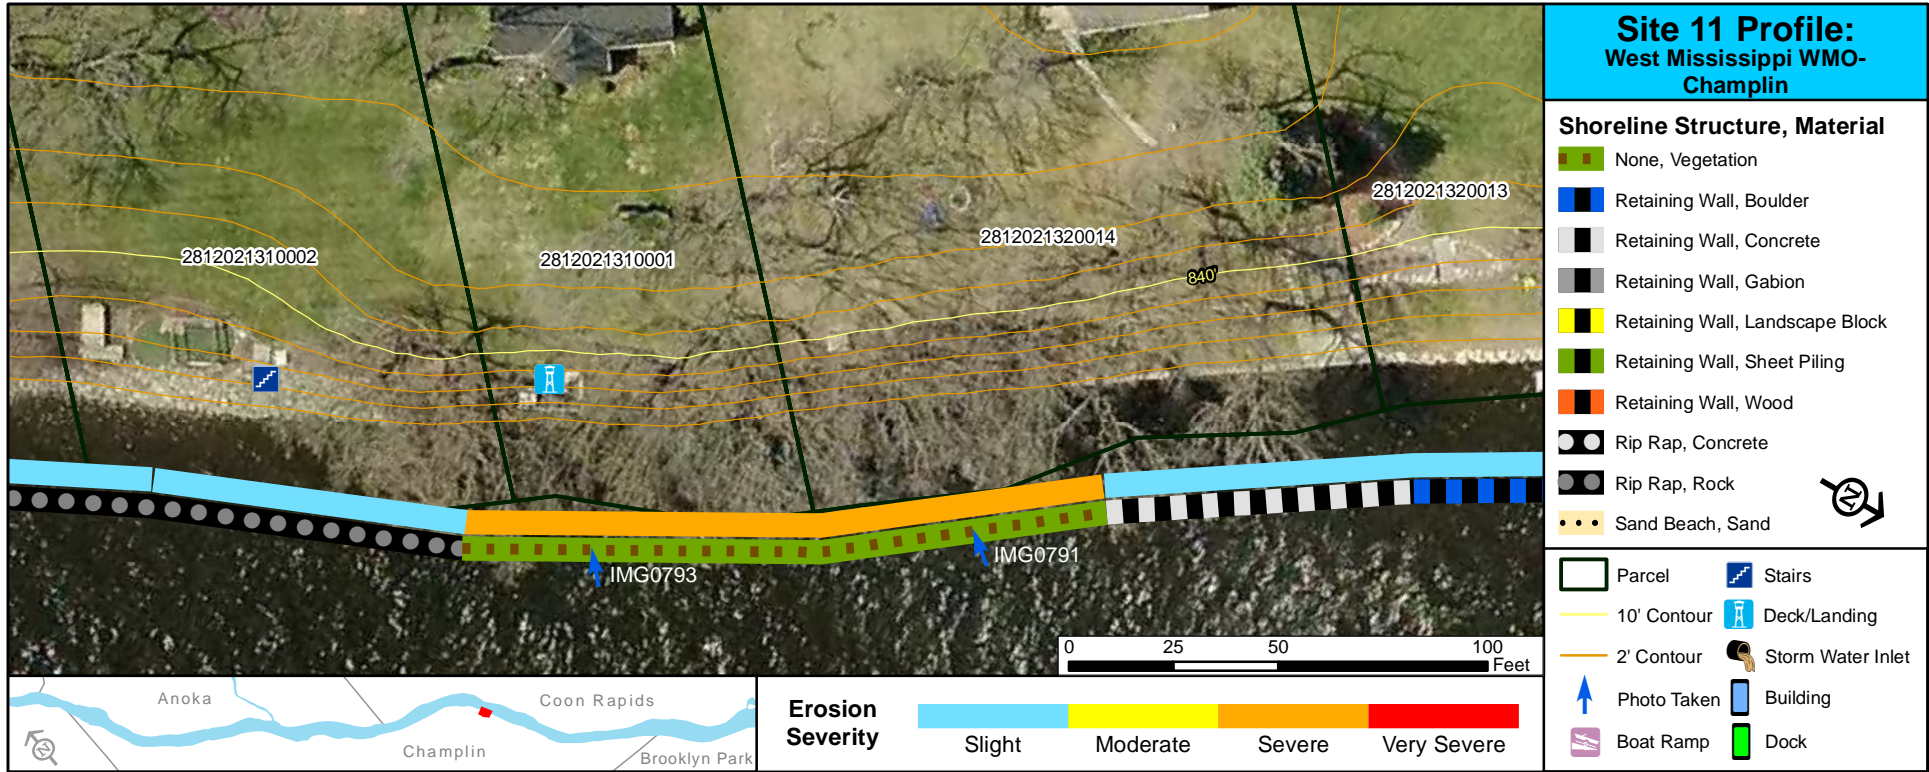
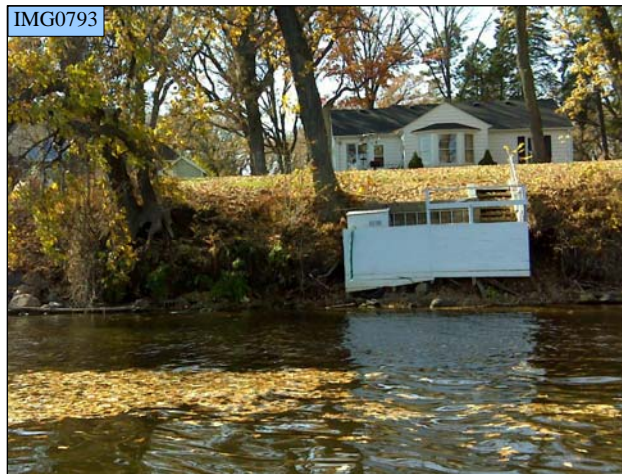
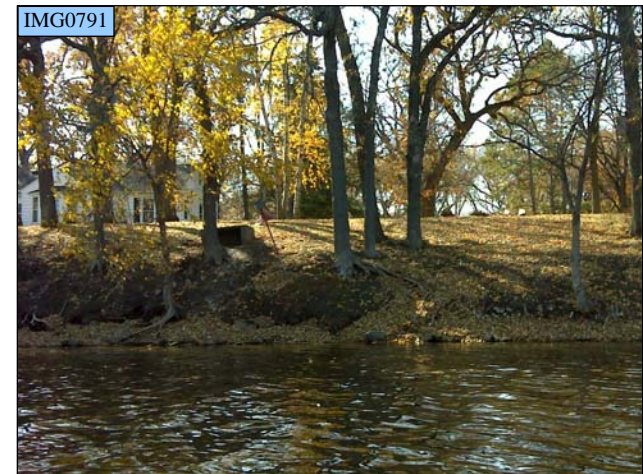
**Additional Info:** Many roots of the large trees along the top of the bank are exposed. These trees could be threatened if the erosion here continues. It appears the grass is mowed all the way to the edge of the bank, which often leads to erosion.

Site Information	Estimated Annual Soil Loss	Severe Erosion Length	Typical Slope	Property Ownership	Atlas Page #	Photo #
	55 tons	154 feet	2.0 to 1	Private	171	788-795

**Potential Solution:** Allow a buffer of un-mowed vegetation to grow along the top of the bank. Some armoring of the toe would also help stabilize the bank.

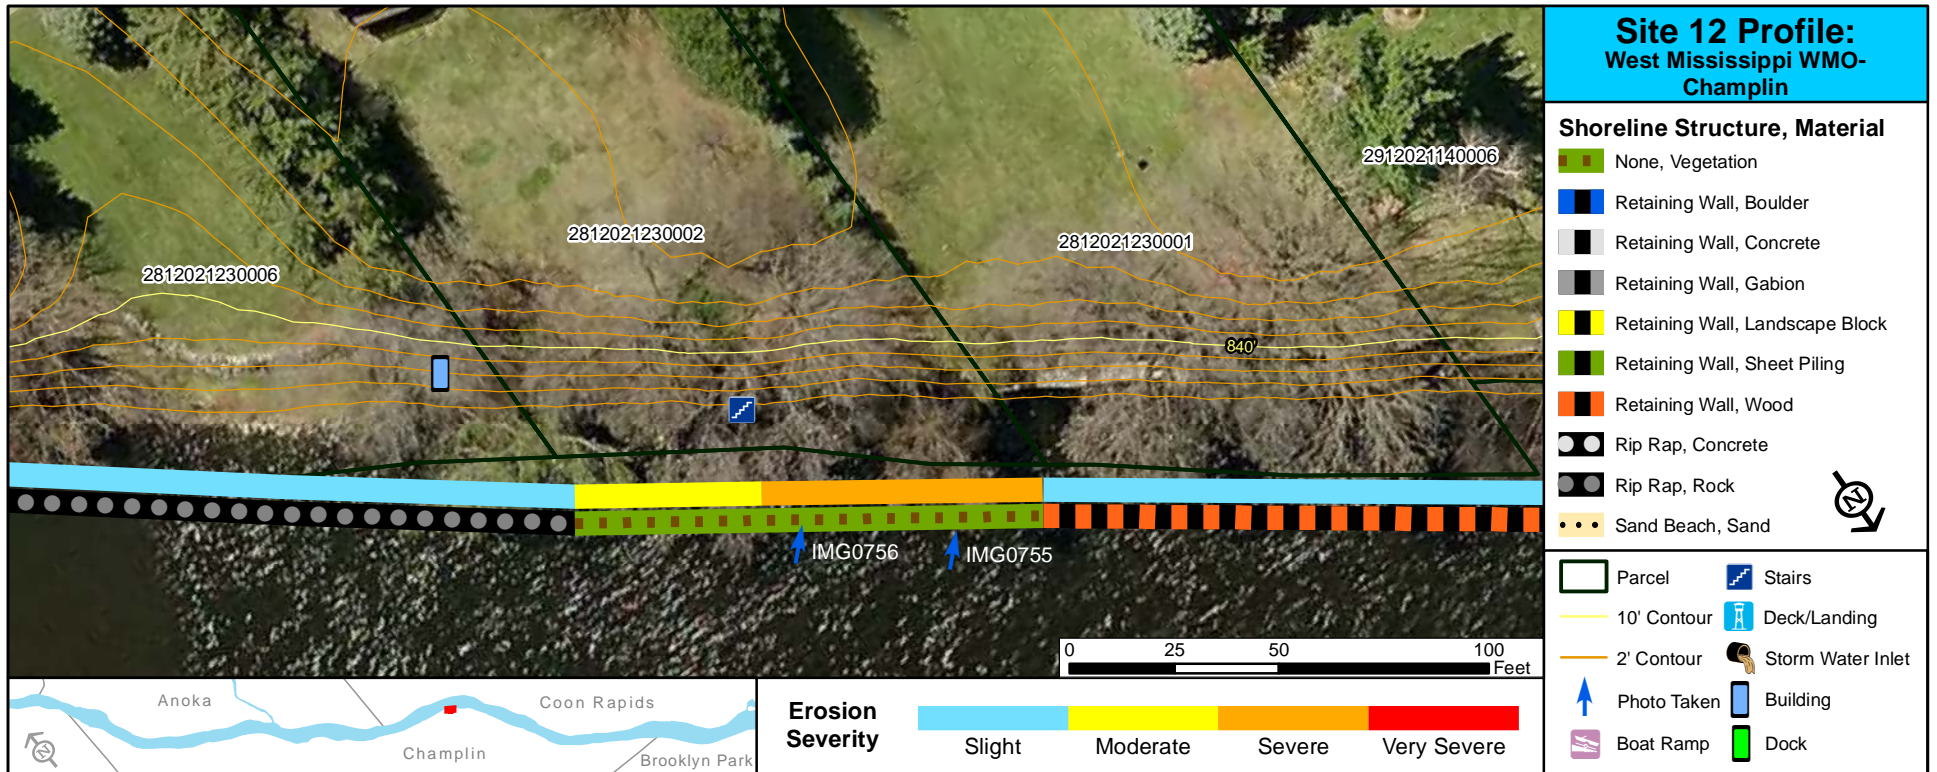
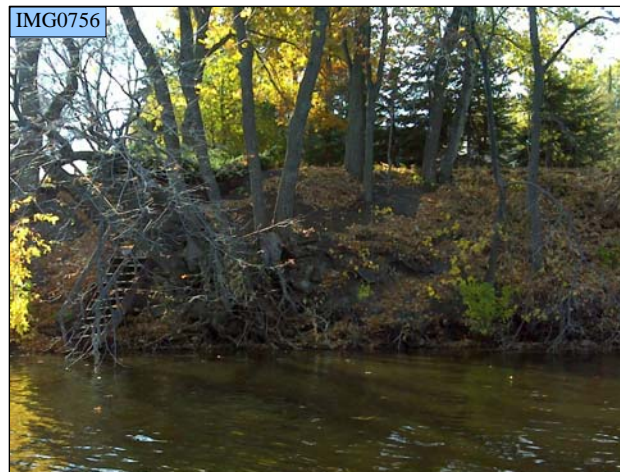
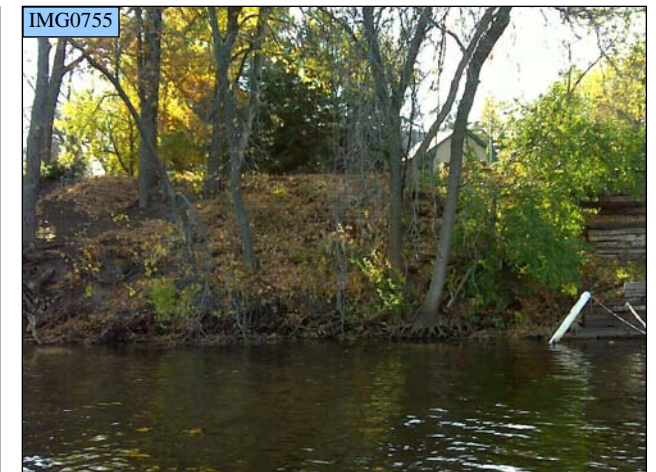
**Additional Info:** This site is marked by several slumping trees and a lot of exposed soil. These trees could be lost in a few years if the erosion continues. It appears the grass is mowed all the way to the edge of the bank, which often leads to erosion.

Site Information	Estimated Annual Soil Loss	Severe Erosion Length	Typical Slope	Property Ownership	Atlas Page #	Photo #
	38 tons	67 feet	1.8 to 1	Private	166	754-756

**Potential Solution:** Promote vegetation growth by thinning the tree canopy to allow more sunlight to reach the ground. Also allow a buffer of un-mowed vegetation to grow along the top of the bank.

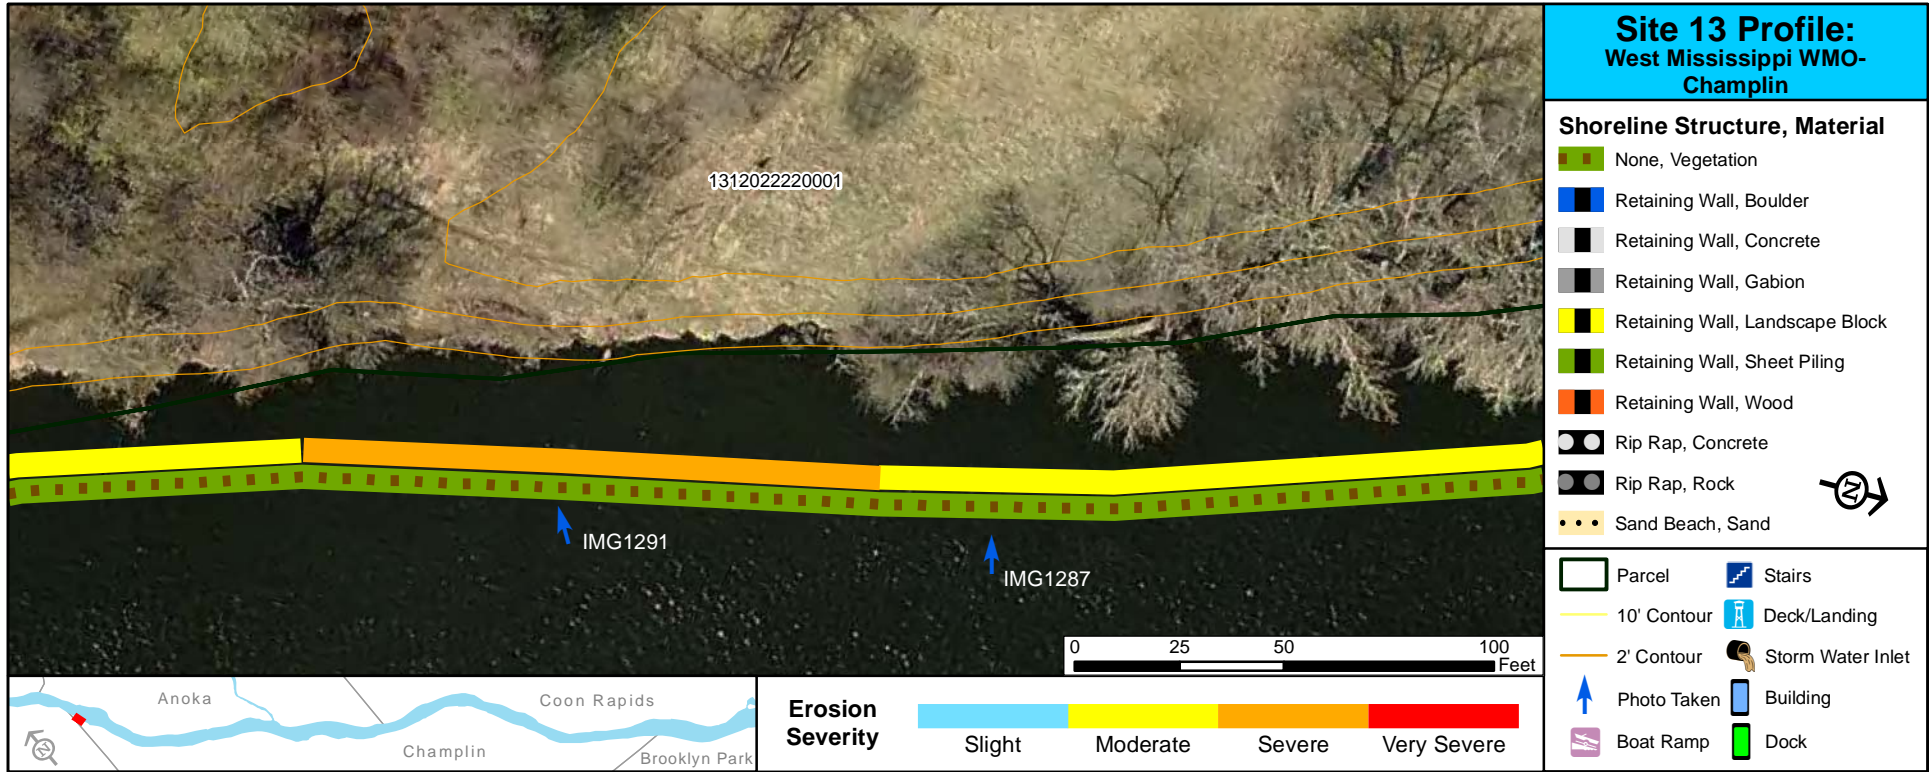
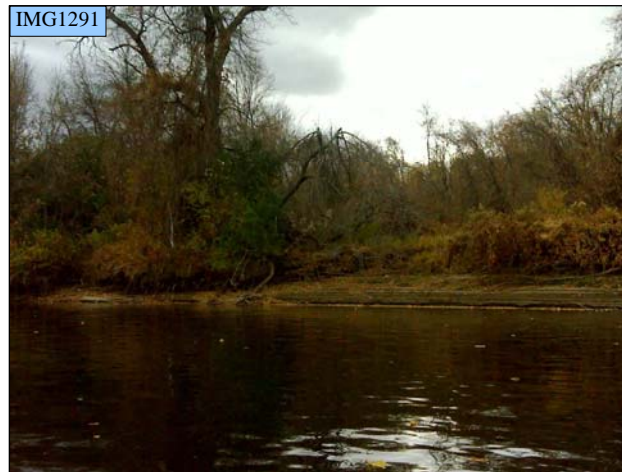
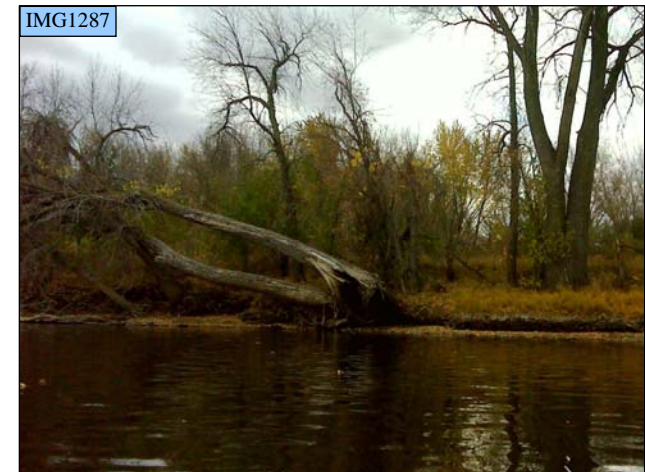
**Additional Info:** This site is part of Donnie Galloway Park in Champlin. Most of the shoreline in this park is unprotected and eroding at least moderately. One large tree has fallen recently here and vegetative overhang is widespread. The bank is only a few feet tall, so the total soil loss here is not great.

Site Information	Estimated Annual Soil Loss	Severe Erosion Length	Typical Slope	Property Ownership	Atlas Page #	Photo #
	32 tons	138 feet	2.0 to 1	City of Champlin	116	1287-1294

**Potential Solution:** Because the site is not on a cut-bank, hard armoring may not be necessary. Instead, lining the bank with cut cedar trees might allow sediment to rebuild the bank. Planting native shrubs such as dogwood along the shore would help to hold the soil long-term.
