# Rum River Field Assessment throughout the Upper Rum River WMO Area

*Upper Rum River Watershed Management Organization*

## Rum River Field Assessment

15 April 2010

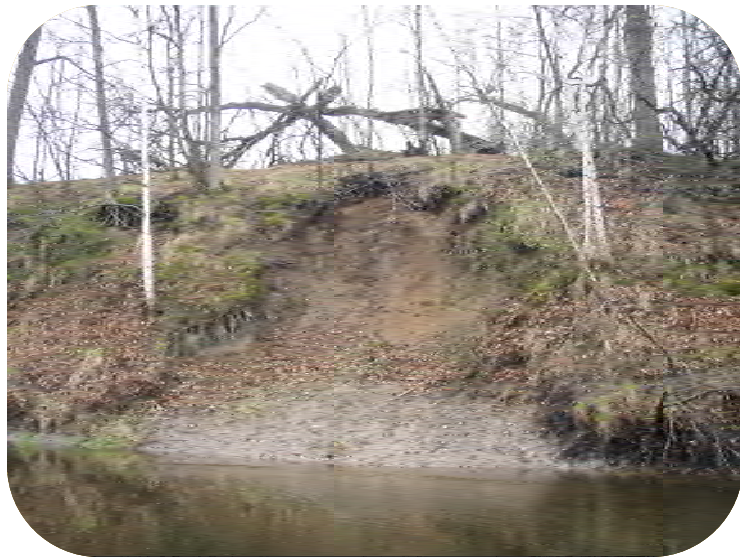
**Photo 7** – Outfall pipe high on slope causing bank failure. 6-8" dia pipe.

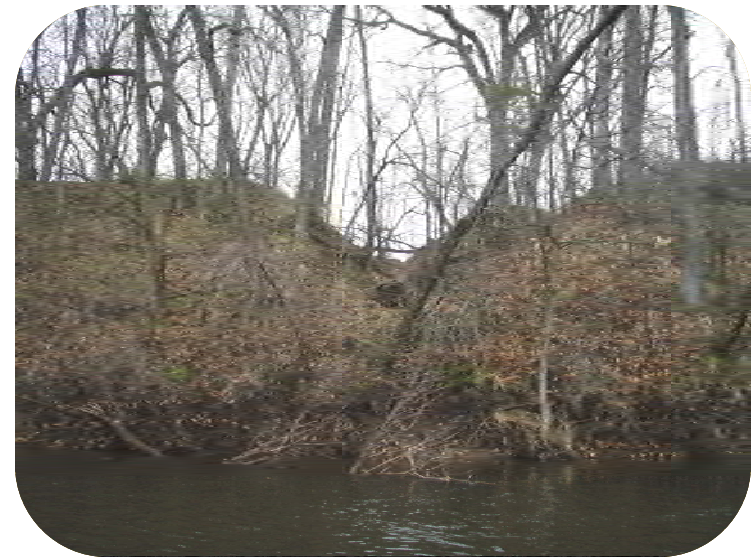
**Photo 8** – Minor gully. No active erosion.

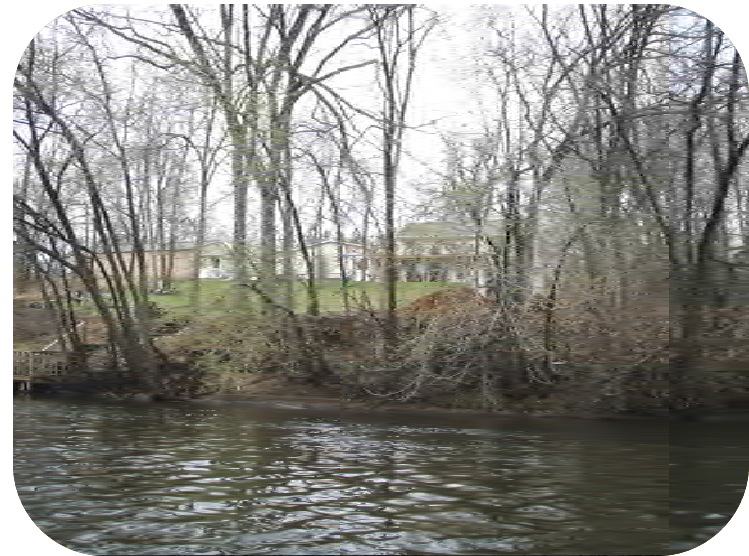
**Photo 10** – Cleared all large near-shore trees. Pushed soil over riverbank. Also see photos 11,12, &13.

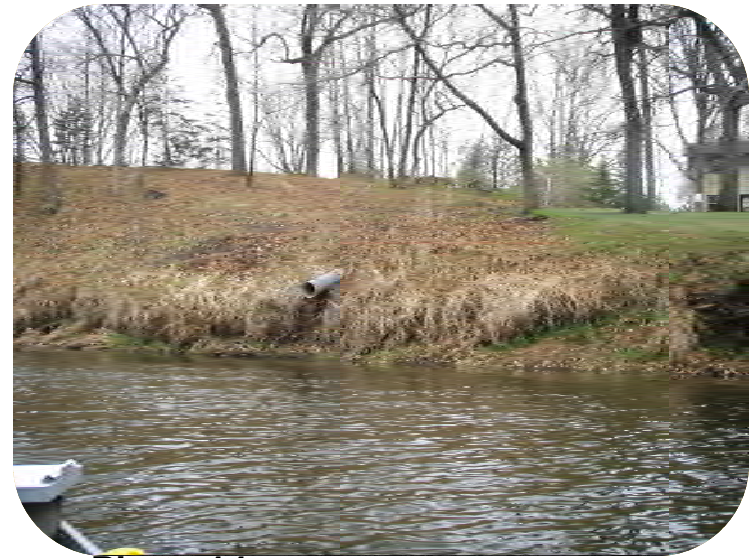
**Photo 14** – Overhanging 12" diameter outlet positioned on center of slope.

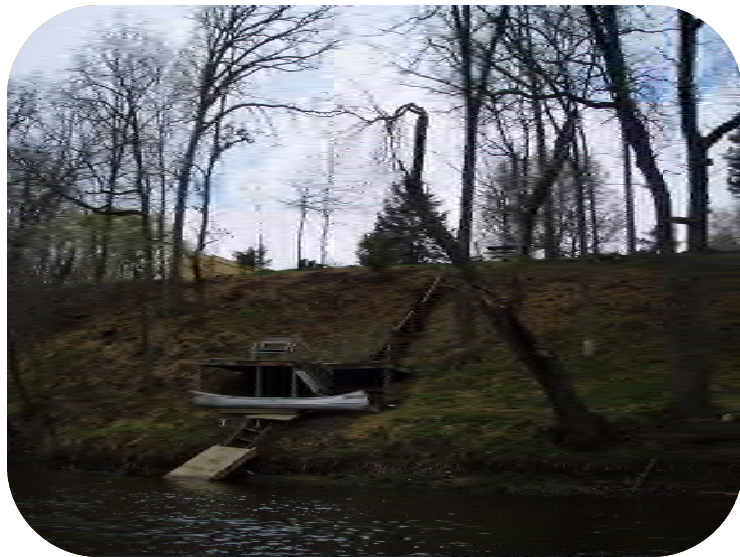
**Photo 15** – Cleared understory veg., left large trees. Bare soil sparsely straw covered. Also see photos 16, 17.

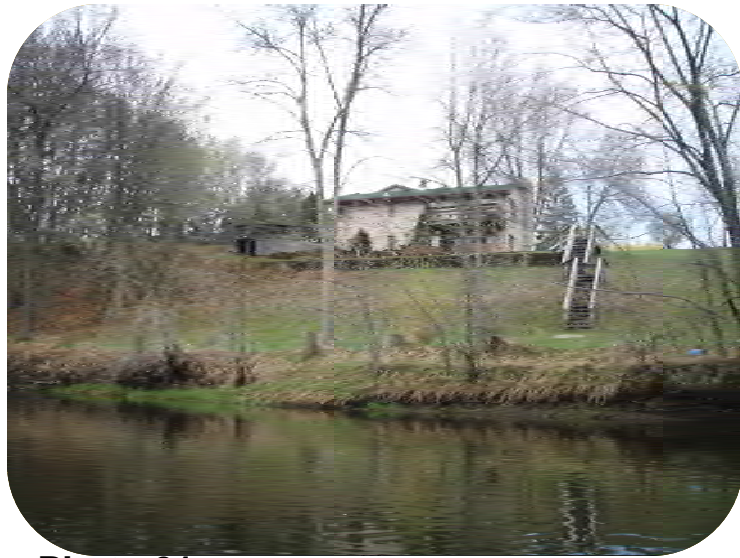
**Photo 21** – Removed all large trees at water's edge, left waist-high stumps. Classified as scattered clearing.

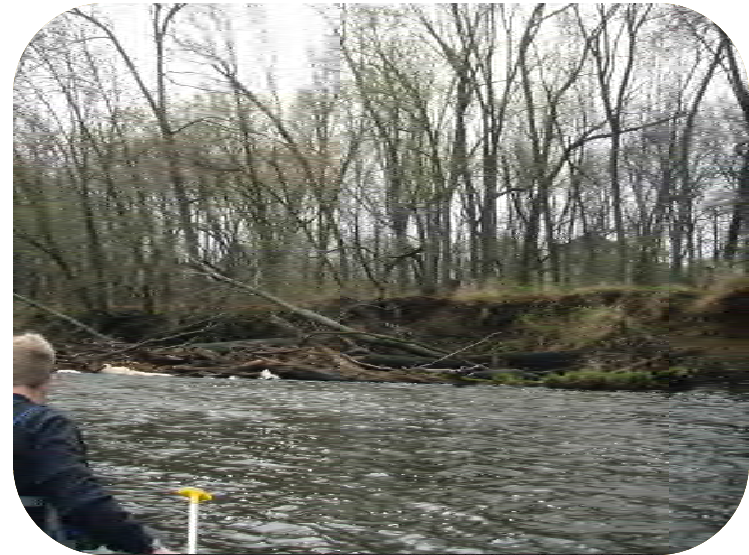
**Photo 28** – Moderate erosion severity, approx. 50 ft. long. Low priority.

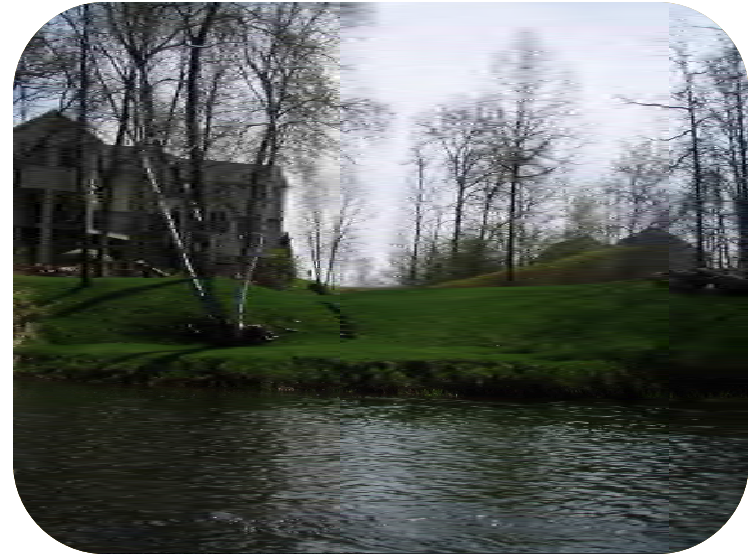
**Photo 34** – Grass mowed to water's edge. Poor practice.

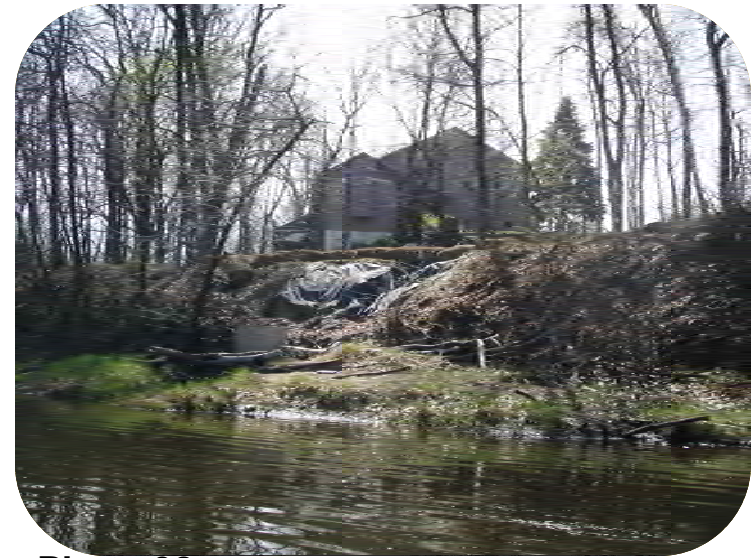
**Photo 38** – 12" pipe at toe of bank. Moderate erosion with homeowner-attempted repair. Also see Photo 39.

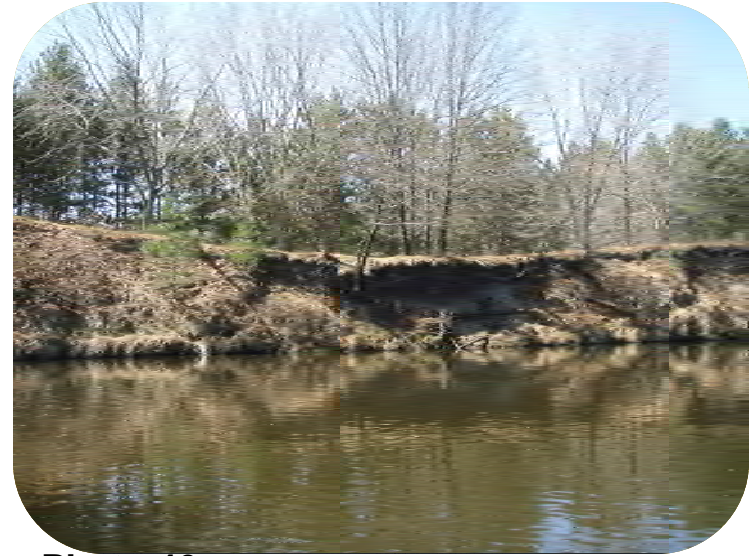
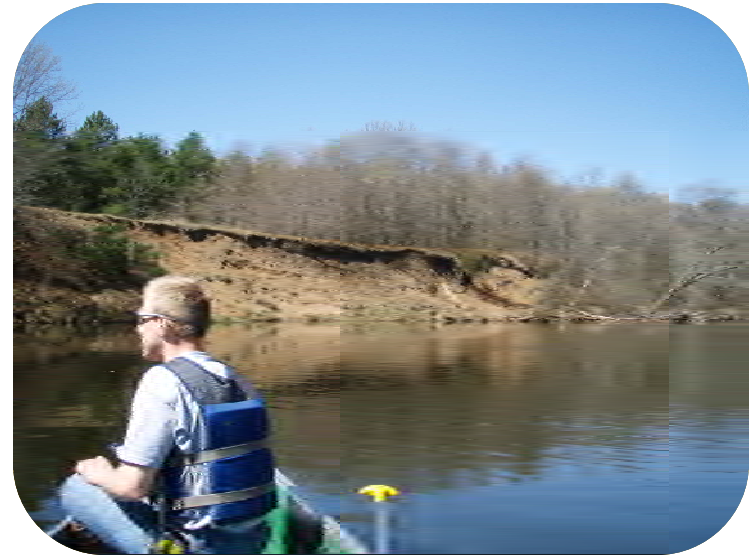
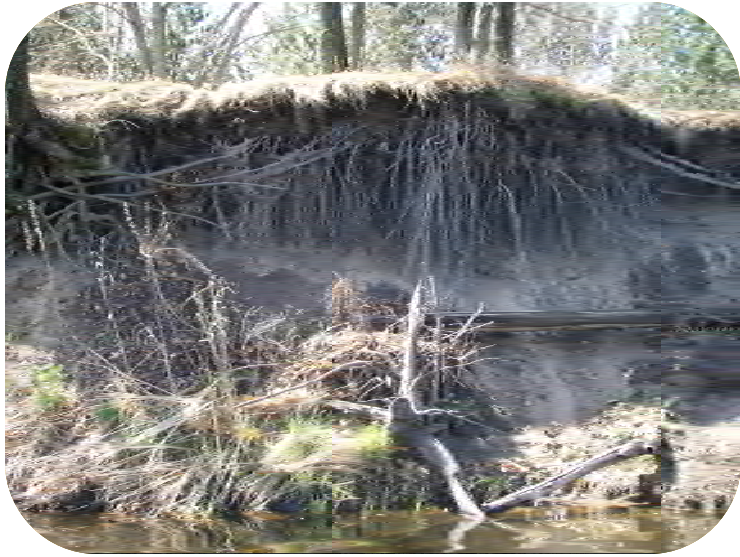
**Photo 46** – Severe erosion. Also see Photos 47, 48, 49, 50, 51, 52, and 53.

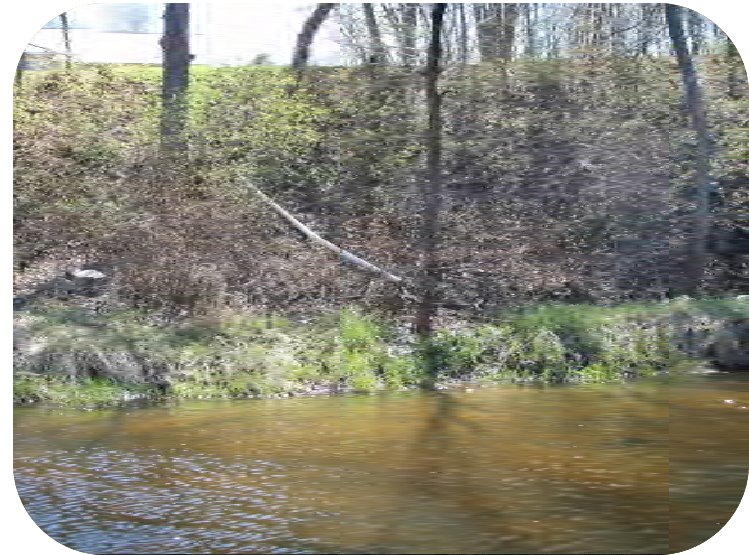
**Photo 76** – Approx. 3 in. diam. PVC outlet near toe of slope with high flow and erosion.

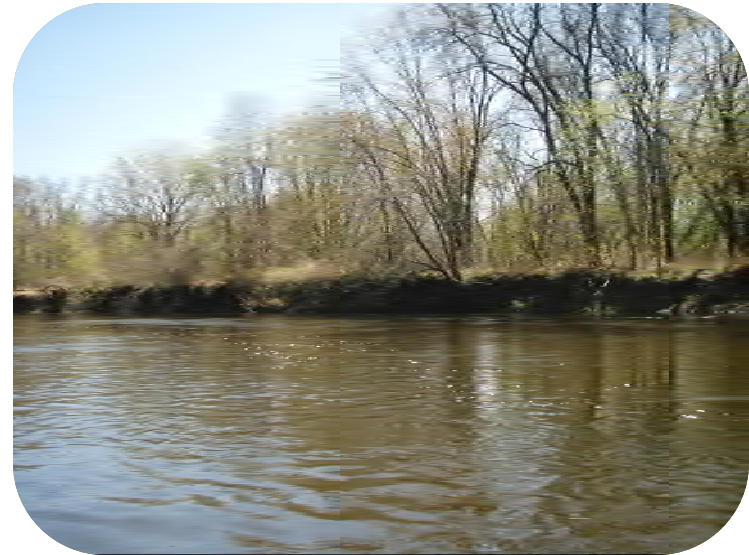
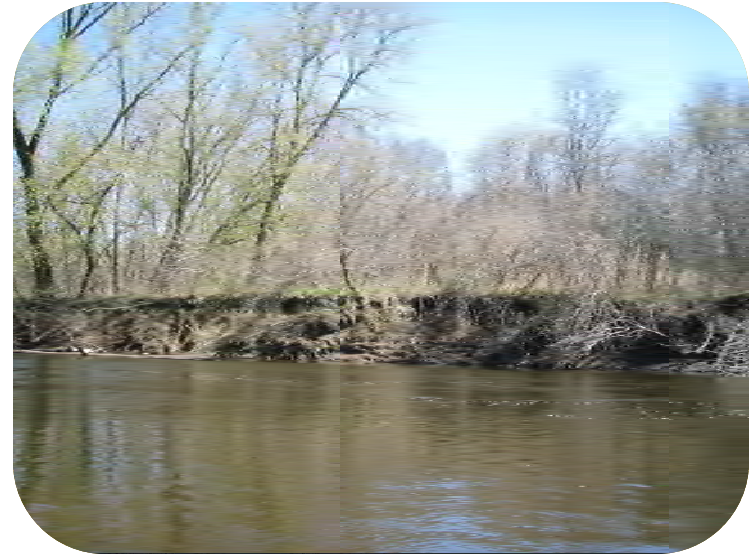
**Photo 87** – Moderate erosion in forested area. Also see Photos 88, 89, and 90.

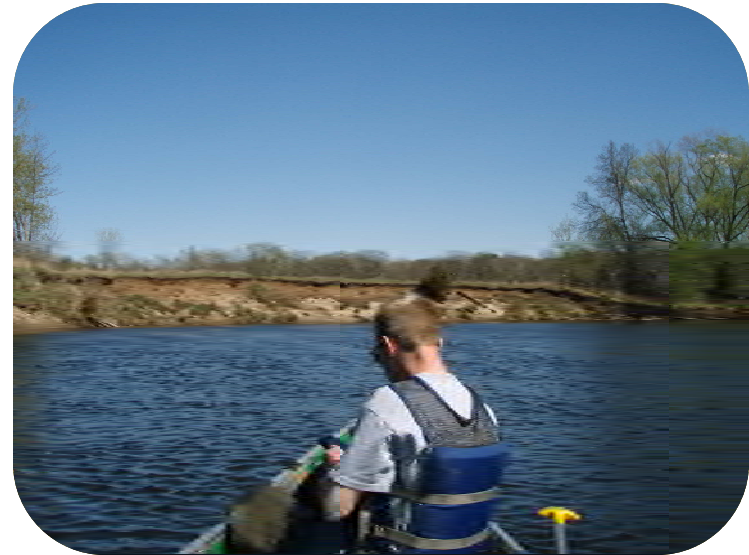
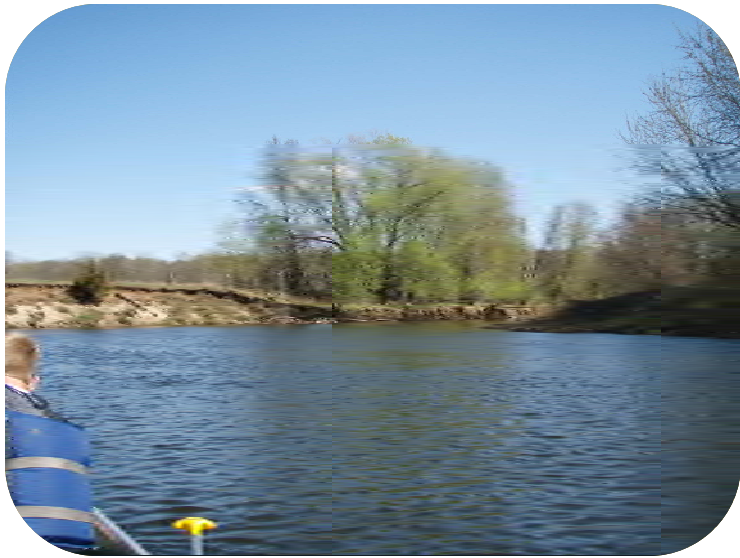
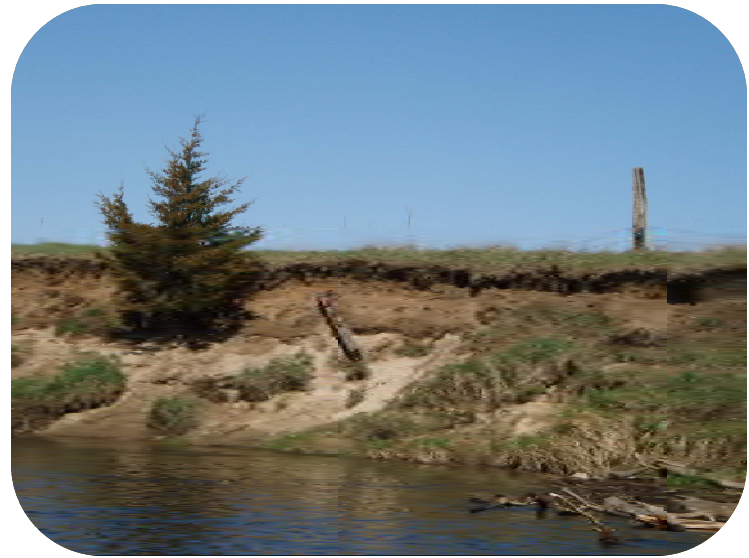
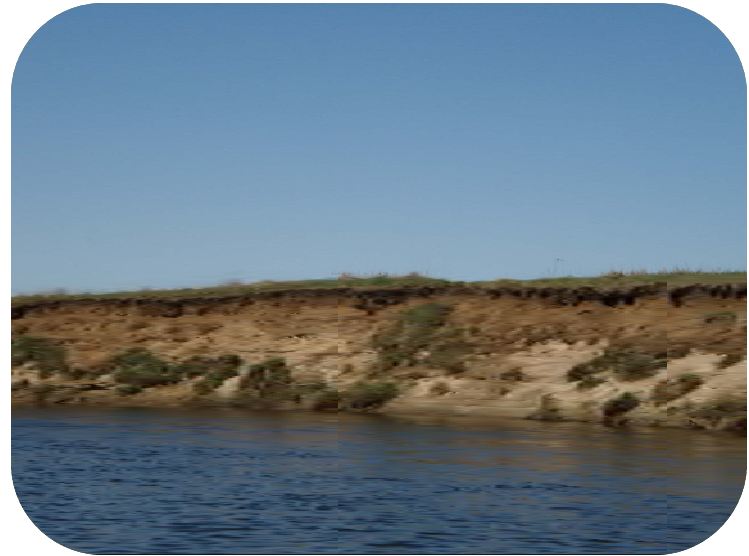
**Photo 91** – Severe erosion, 20 ft. back with fence over water. Also see Photos 92, 93, 94, 95, and 96.

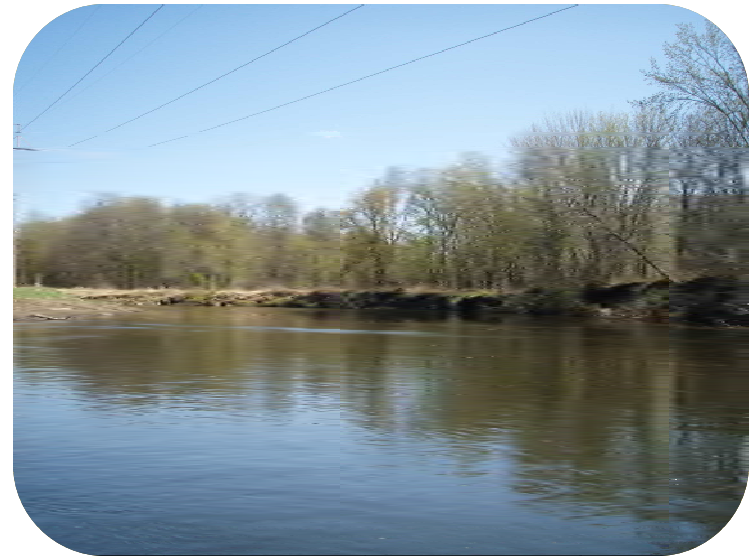
**Photo 99** – Moderate erosion. Also see Photos 100, 101, and 102.

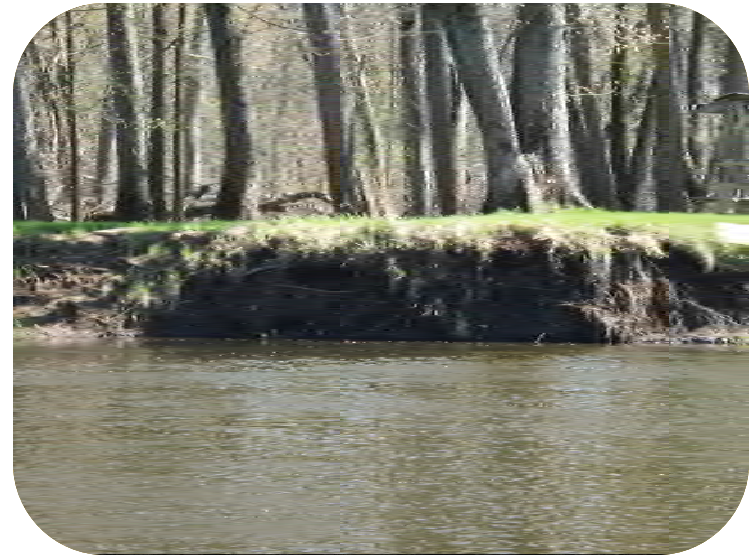
**Photo 103** – Mowed turf grass to water's edge. Also see Photo 104.

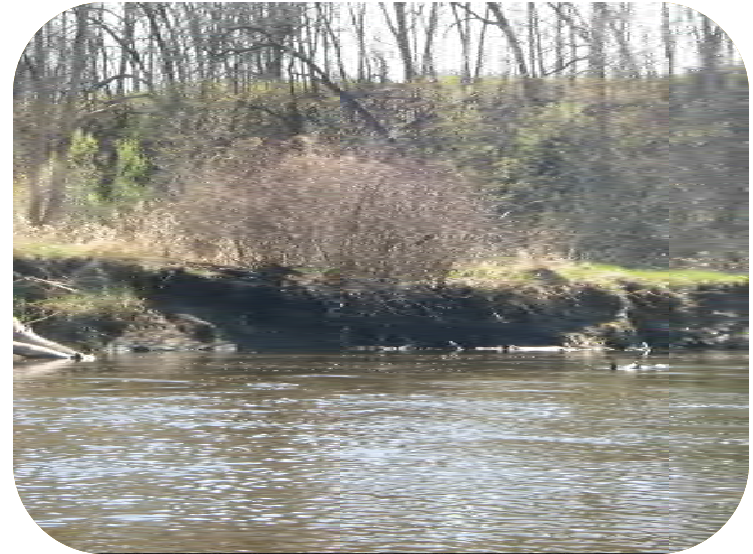
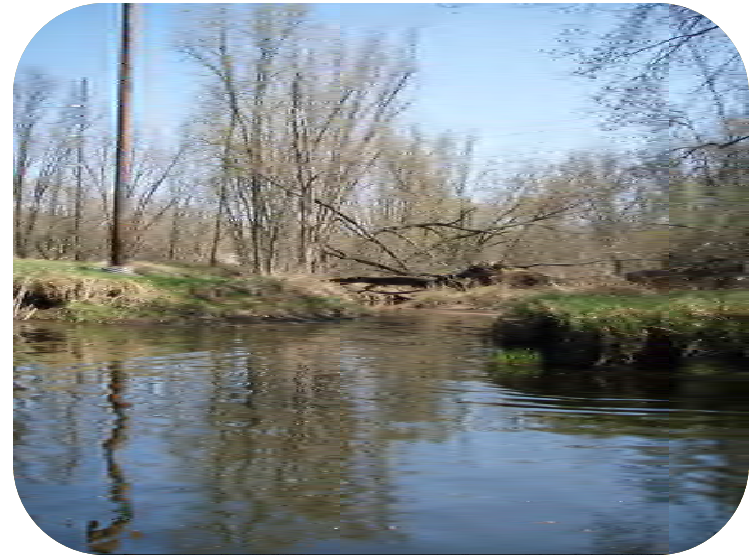
**Photo 114** – Moderate erosion. Also see Photo 115.

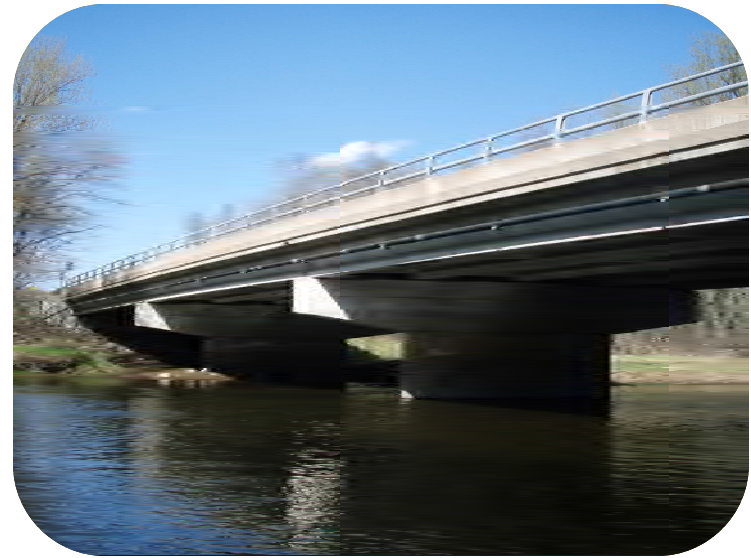
**Photo 117** – Mild erosion.
