2007 Anoka Water Almanac

Water Quality and Quantity Conditions of Anoka County, MN

A Report of Activities by Watershed Organizations and the Anoka Conservation District

Prepared by Anoka Conservation District

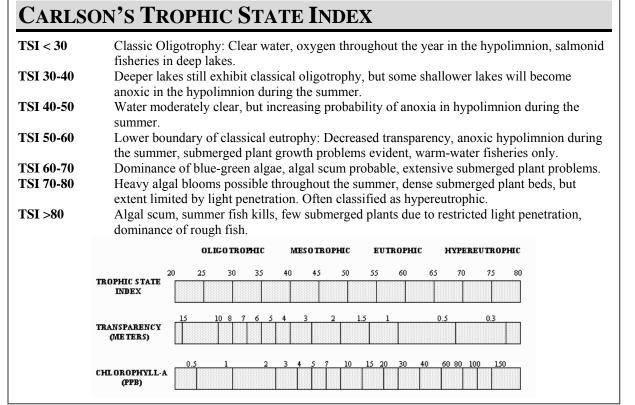
Carlson's Trophic State Index Scale

A- Carlson's Trophic State Index (see figure below) is a number used to describe a lake's stage of eutrophication (nutrient level, amount of algae). The index ranges from oligotrophic (clear, nutrient poor lakes) to hypereutrophic (green, nutrient overloaded lakes). The index values generally range between 0 and 100 with increasing values indicating more eutrophic conditions. Unlike the lake letter grading system, the Carlson's Trophic State Index does not compare lakes only within the same ecoregion; it is a scale used worldwide.

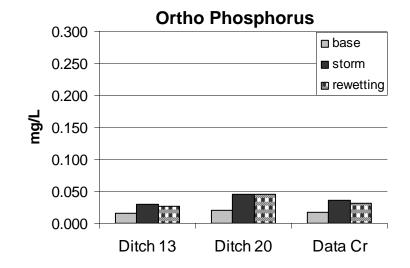
Ortho Phosphorus at Data Creek and tributaries in 2007. (n=1 for baseflow, 4 for storms, and 4 for rewetting)

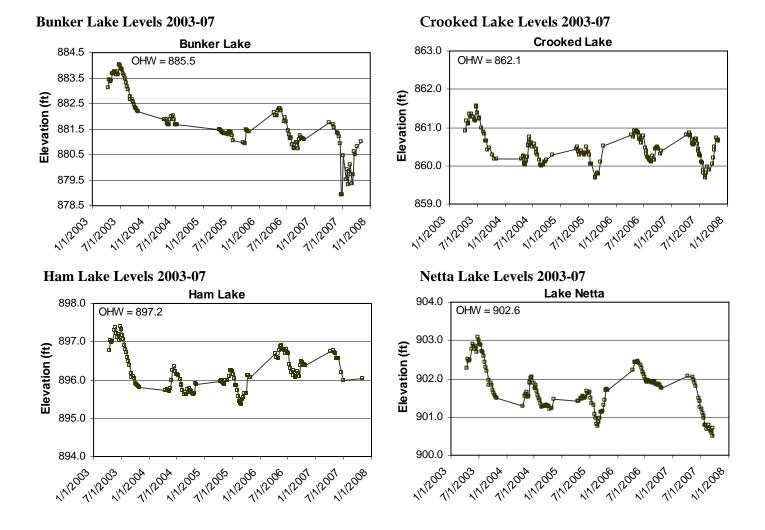
Ordinary High Water Levels (OHW), the elevation below which a DNR permit is needed to perform work, are listed for each lake on the graph.

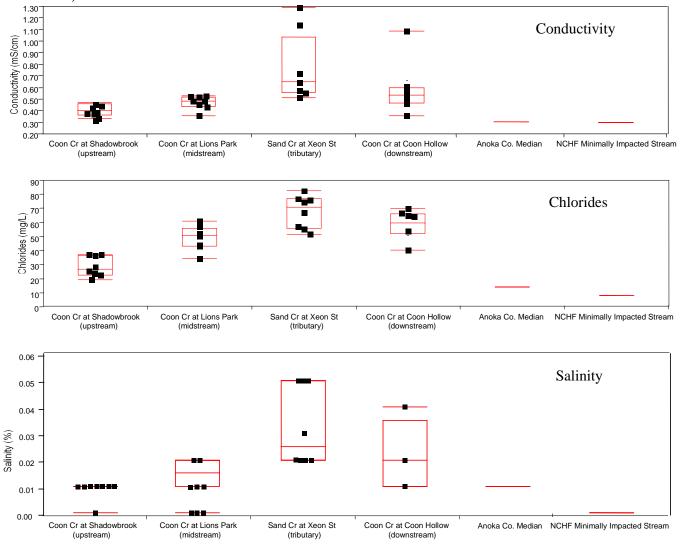
**Conductivity, chlorides, and salinity at Coon Creek and Sand Creek 2007.** Dots are individual readings. Box plots show the median (middle line), 25th and 75th percentile (ends of box), and 10th and 90th percentiles (floating outer lines).

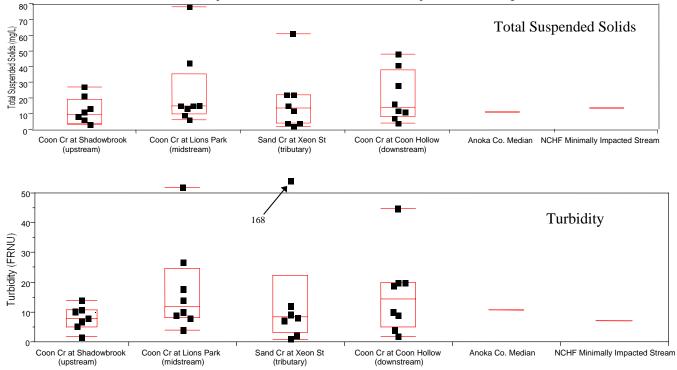
The November 28th, 2007 samples were particularly interesting with respect to TSS and turbidity. This date was just before ice up. It was a baseflow period when few, if any surface flows into the stream would have occurred recently because of freezing temperatures. Yet, the water at all of the Coon and Sand Creek sites was strongly greenish brown. This had not been observed during baseflow in summer. Turbidity, which is measured by light refraction and therefore most sensitive to large particles, was more than two times higher than any other reading during the year at the furthest downstream site. Sand Creek turbidity was 6.5 times higher than any other reading during the year. TSS, which is measured by filtering and weighing suspended material and can better detect small particles, was not particularly high, except at Sand Creek.

**Total suspended solids and turbidity at Coon Creek and Sand Creek 2007.** Dots are individual readings. Box plots show the median (middle line), 25th and 75th percentile (ends of box), and 10th and 90th percentiles (floating outer lines).

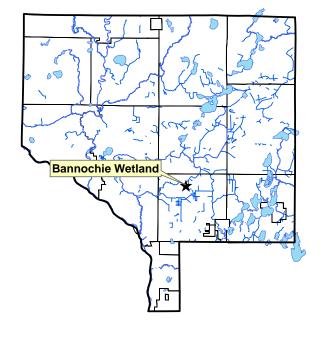
Site Information	
<b>Monitored Since:</b>	1997
Wetland Type:	2
Wetland Size:	~21.5 acres
<b>Isolated Basin?</b>	No
Connected to a Ditch?	Yes, on edges, but not the interior of wetland
Soils at Well Location:

10 0 1 10 000 1					
Horizon	Depth	Color	Texture	Redox	
Oe1	0-6	10yr 2/1	Organic	-	
Oe2	6-40	10yr 2/1-7.5yr2.5/1	Organic	-	
Surrounding Soils: Rifle and some Zimmerman					
		fine sa	and

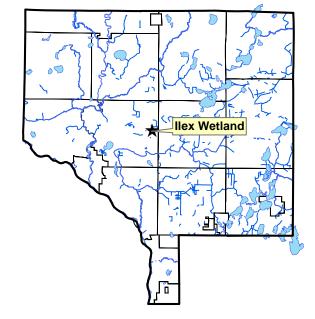
Bg	10-14	10yr4/2	Fine Sandy Loam	-
2Ab	14-21	N2/0	Sandy Loam	-
2Bg1	21-30	10yr4/2	Fine Sandy Loam	-
2Bg2	30-45	10yr5/2	Fine Sand	-
Surrounding Soils:			Loamy wet sand a	ind

Loamy wet sand and Zimmerman fine sand

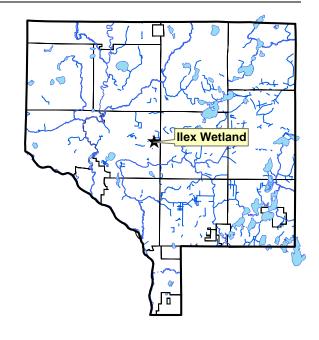
City Park at Ilex St and 159th Ave, Andover

Site Inform	<u>mation</u>				
Monitored	l Since:		2006		
Wetland 7	Гуре:		2		
Wetland S	Size:		~9.6 acres		
Isolated B	asin?		Yes		
Connected to a Ditch?		No			
Soils at W	ell Locat	ion:			
Horizon	Depth	Color	Texture	Redox	
Oa	0-9	N2/0	Organic	-	
Bg1	9-19	10yr4/2	Fine Sandy Loam	-	
Bg2	19-45	10yr5/2	Fine Sand	-	
Surrounding Soils:			Loamy wet sand and Zimmerman fine sand

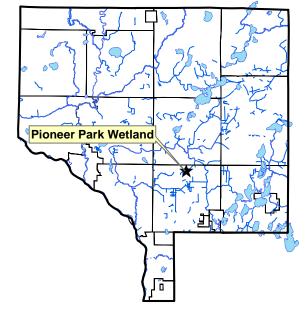
Depth	Color	Texture	Redox
0-4	10yr 2/1	Sapric	-
4-8	N 2/0	Sapric	-
		Mucky Sandy	
8-12	10yr 3/1	Loam	-
12-27	2.5y 5/3	Loamy Sand	-
27-40	2.5y 5/2	Loamy Sand	-
	0-4 4-8 8-12 12-27	0-4 10yr 2/1 4-8 N 2/0 8-12 10yr 3/1 12-27 2.5y 5/3	0-4         10yr 2/1         Sapric           4-8         N 2/0         Sapric           Mucky Sandy         8-12         10yr 3/1         Loam           12-27         2.5y 5/3         Loamy Sand

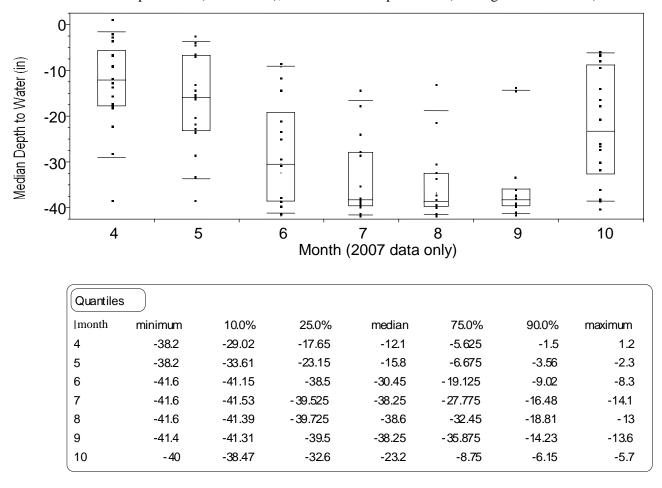
**2007 Reference Wetland Water Levels Summary.** Each dot represents the median depth to the water table at the edge of one reference wetland for a given month in 2006. The quantile boxes show the median (middle line), 25th and 75th percentile (ends of box), and 10th and 90th percentile (floating horizontal lines).

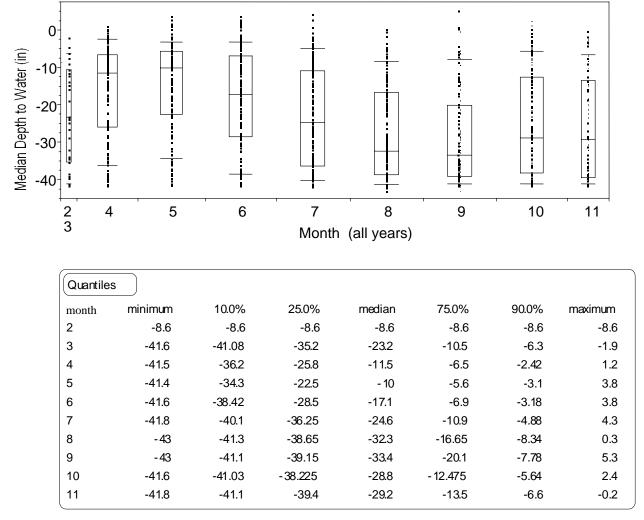
**1996-2007 Reference Wetland Water Levels Summary.** Each dot represents the mean depth to the water table at the edge of one reference wetland for a month between 1996 and 2007. The quantile boxes show the median (middle line),  $25^{th}$  and  $75^{th}$  percentile (ends of box), and  $10^{th}$  and  $90^{th}$  percentile (floating horizontal lines).

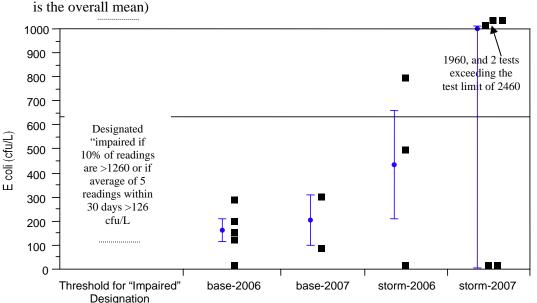
**E. coli Bacteria Results During Base and Storm Conditions** (Square dots are individual measurements, circles with vertical lines are mean +/- one standard deviation, the horizontal line is the overall mean)
