2008 Anoka Water Almanac

Water Quality and Quantity Conditions of
Anoka County, MN

A Report of Activities by
Watershed Organizations and the
Anoka Conservation District

March 2009

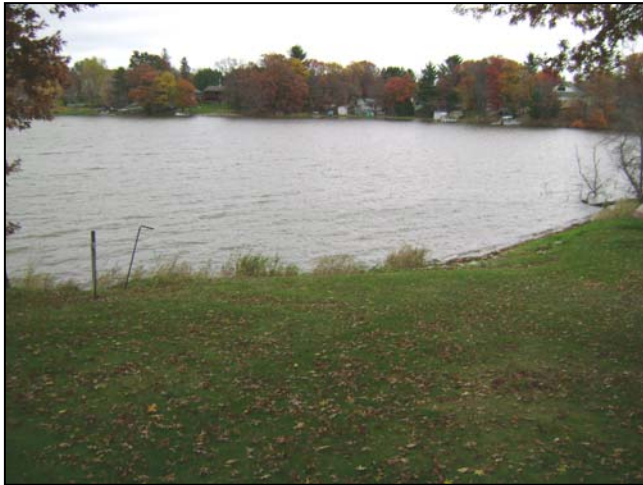
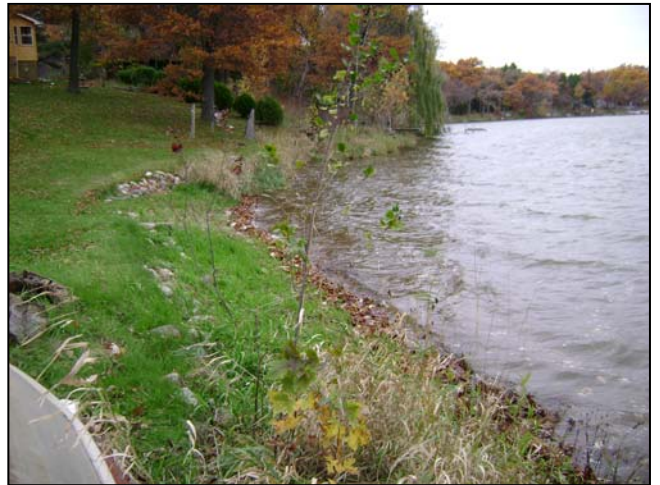
Pre-Project– April 2008

Moos Property Shoreline Restoration, Martin Lake
Pre-Project – April 2008

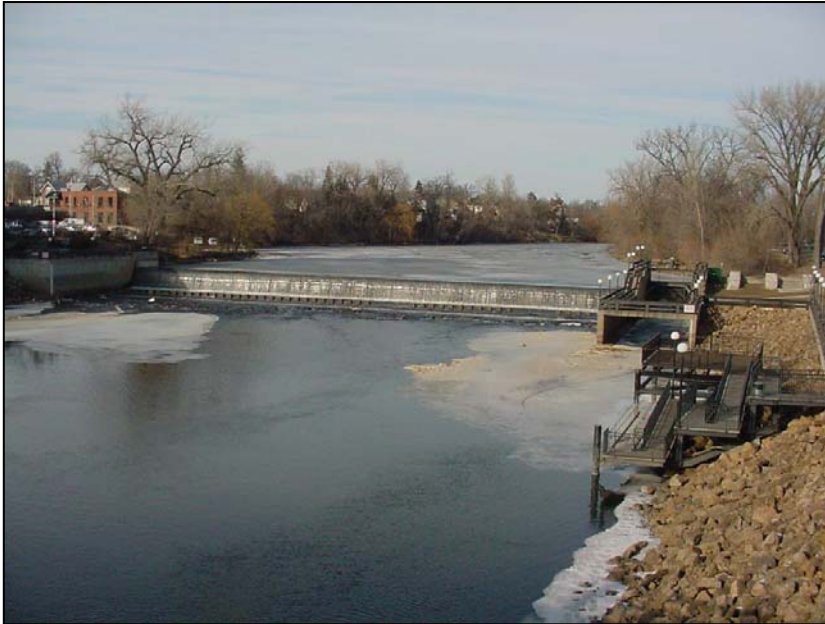
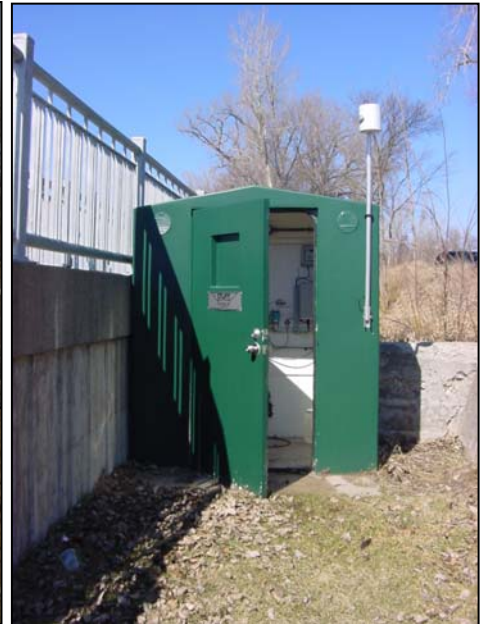
Rum River WOMP Monitoring Station

Description: The Watershed Outlet Monitoring Program (WOMP) is a Metropolitan Council stream and river monitoring program. In Anoka County, the program has an established monitoring station for the Rum River in Anoka, near its outlet to the Mississippi River. Water levels, flows, and 20+ water quality parameters are measured. Loading rates for important pollutants are estimated continuously and the Metropolitan Council provides in-depth analysis and reporting (not provided here). The Anoka Conservation District provides staffing for operations of the monitoring station.

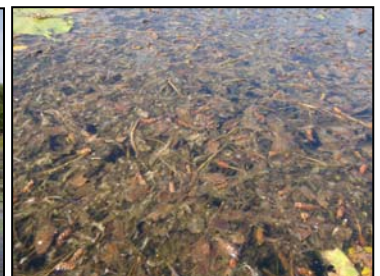
September 18, 2008. Decomposing large-leaf pondweed.

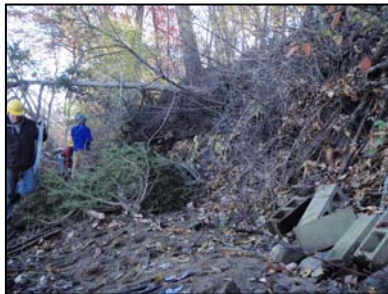
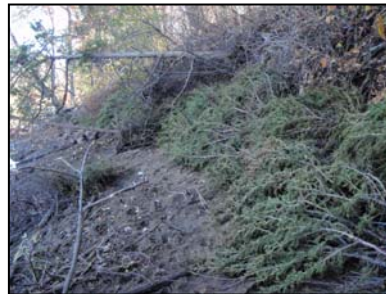
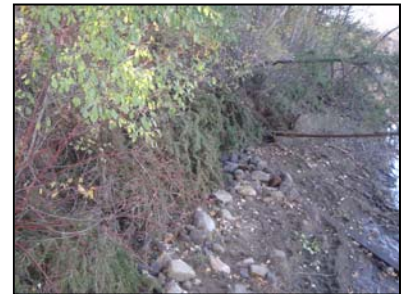
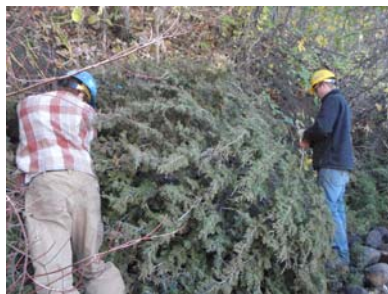
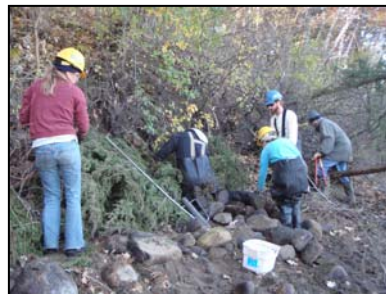
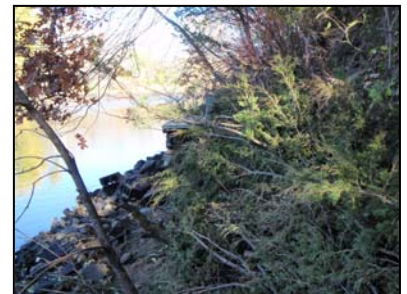
At both the Herrala and Rusin properties cedar tree revetments were used to correct streambank erosion and prevent future erosion. This technique involves anchoring cut cedar trees tightly along the bank. The dense branches simultaneously protect the bank from high flows and allow sediment to settle behind the trees during lower flows. Cedar trees are chosen because they are resistant to decay and have dense branches. Trees for these projects were harvested at no cost from a county park and a private property. Installation of this project was coordinated with the lowering of the Anoka dam for maintenance, making installation easier.

Rum Riverbank Stabilization – Herrala and Rusin Properties – Cedar tree revetments were installed during river drawn down for Anoka Dam maintenance. Duckbill anchors and galvanized cable secure the cut trees to the bank.

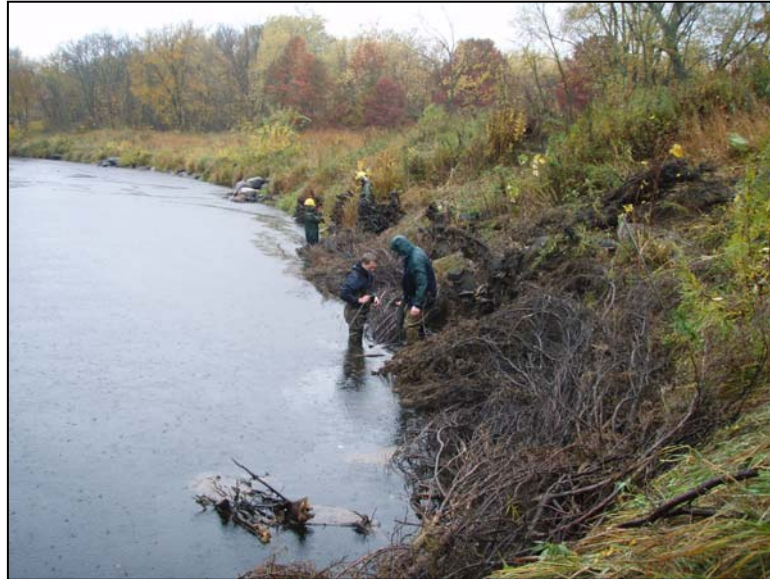
Rum Central Regional Park Cedar Tree Revetment

This project did not use LRRWMO cost share, but did occur in the Lower Rum River Watershed. The project was a continuation of an earlier, and much larger, stabilization of riverbank within the county park. This follow-up work included the installation of cedar tree revetments to further provide stabilization from bank failures, erosion, and to provide near-shore fish and wildlife habitat. This project was led by the Anoka Conservation District and Anoka County Parks.

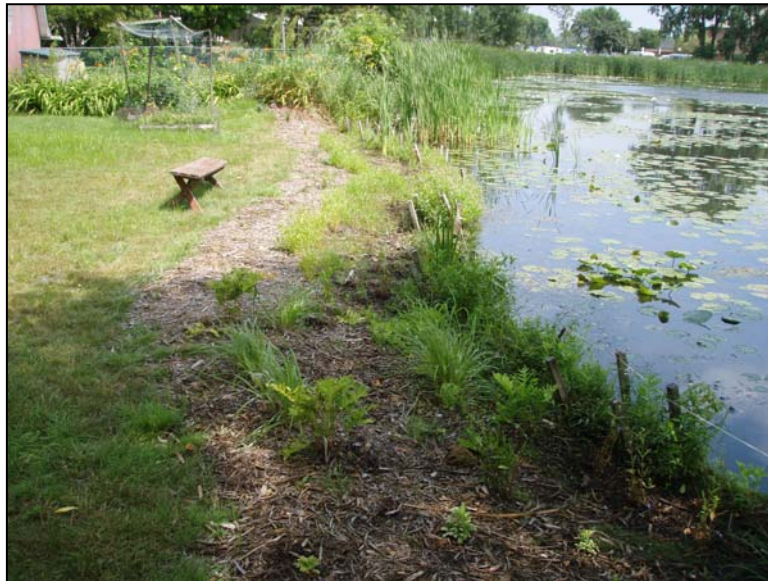
Metcalf Lakeshore Restoration, Moore Lake

The Metcalf property lies on the shore of Moore Lake. The purpose of this project was to provide some near-shore habitat and some filtering of runoff to the lake. Prior to the restoration, the shoreline consisted of debris. The plant community was dominated by turf grass, a variety of invasive plant species, and limited native plant species. The debris was removed, a small strip of native plants was established at the water's edge, and a biolog was placed near shore for additional protection. This project was funded primarily by the landowner, but with some funding from Anoka County Ag Preserves grants, watershed district grants, and with technical assistance from the Anoka Conservation District.

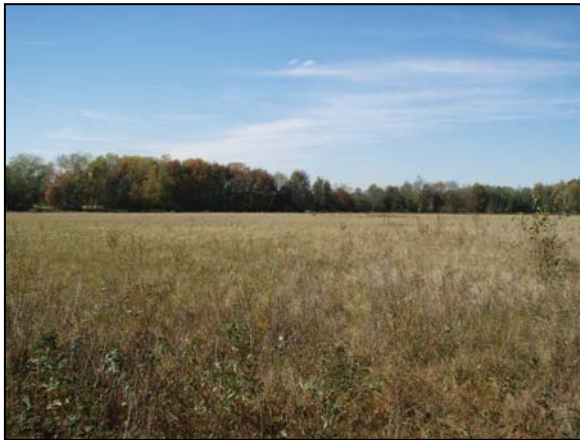
Looking at the wetland center

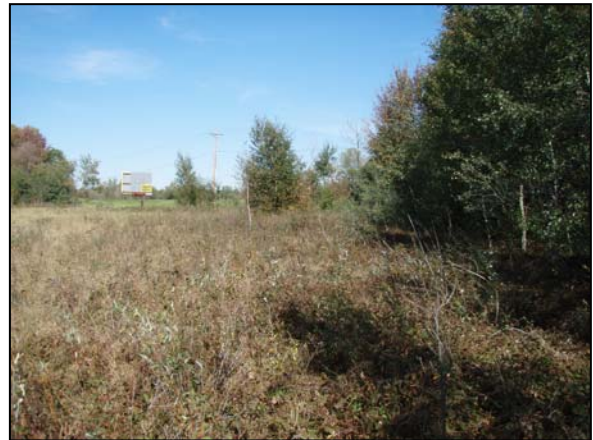
Looking at the wetland edge

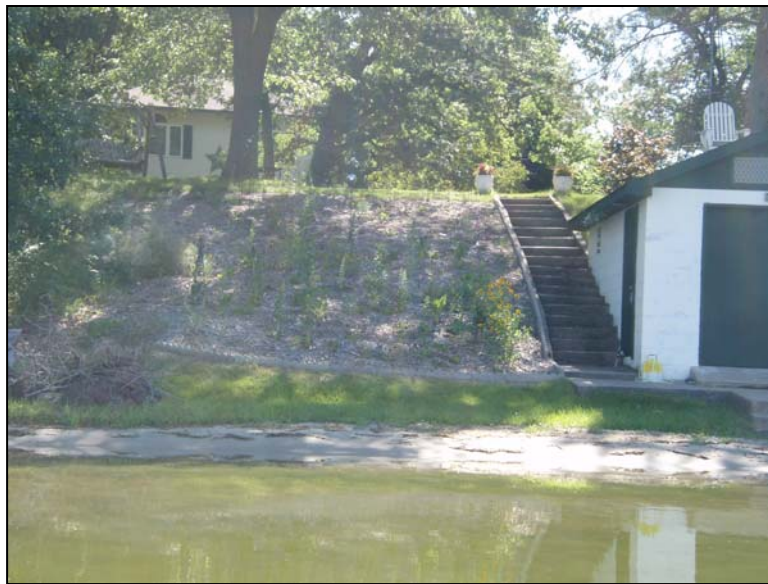
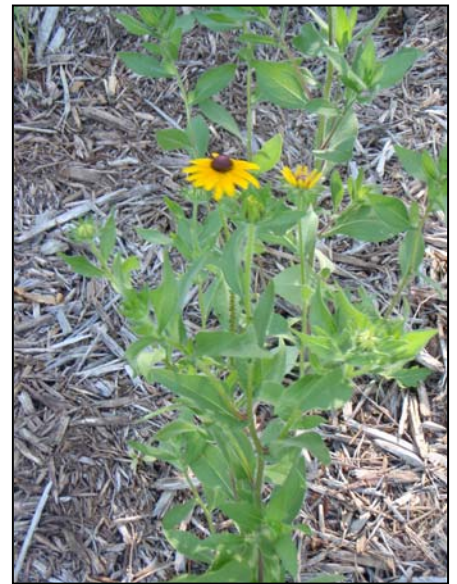
Lakeshore Restoration—Lindenberg Property: Native plants replaced mowed lawn on a lakeshore hillside.

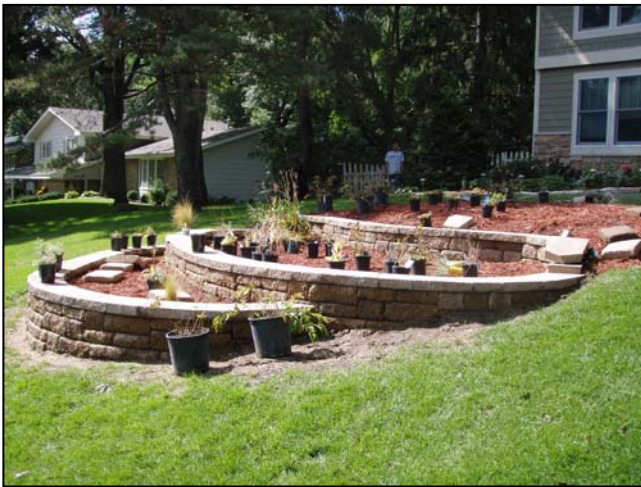
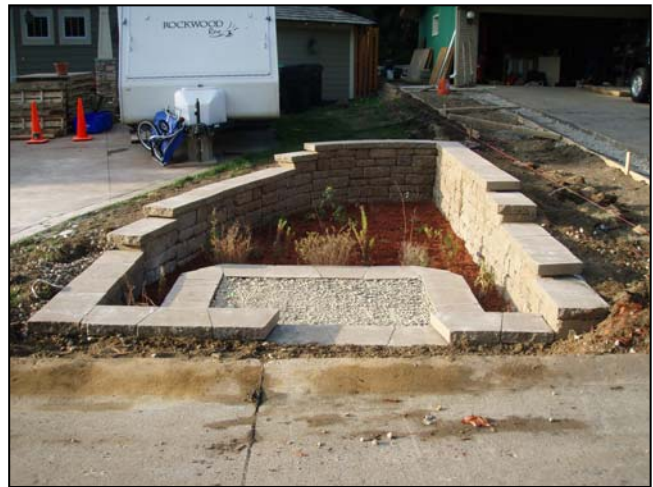
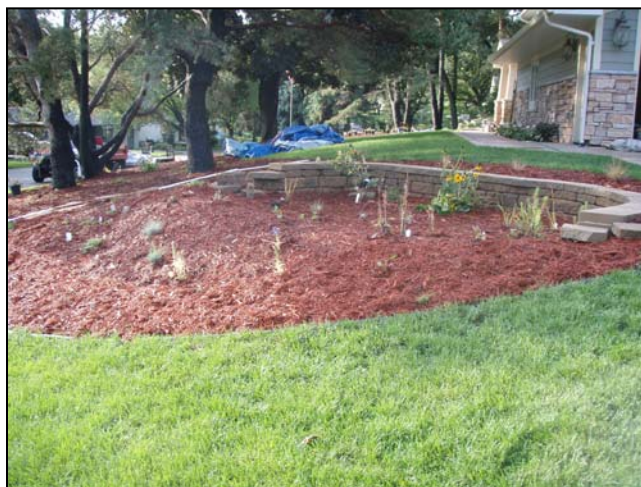
2008 Early Residence Rain Garden

This project is within the Laddie Lake subwatershed in southwestern Blaine, and involved replanting an entire residential front yard to native plants. A rain garden was installed to capture and infiltrate storm runoff from the roof. In the absence of this project, drainage was to Laddie Lake via the storm sewers with no treatment. This project was funded by the landowner, a cost share grant through the Anoka County Ag Preserves Program, and with technical assistance from the Anoka Conservation District.

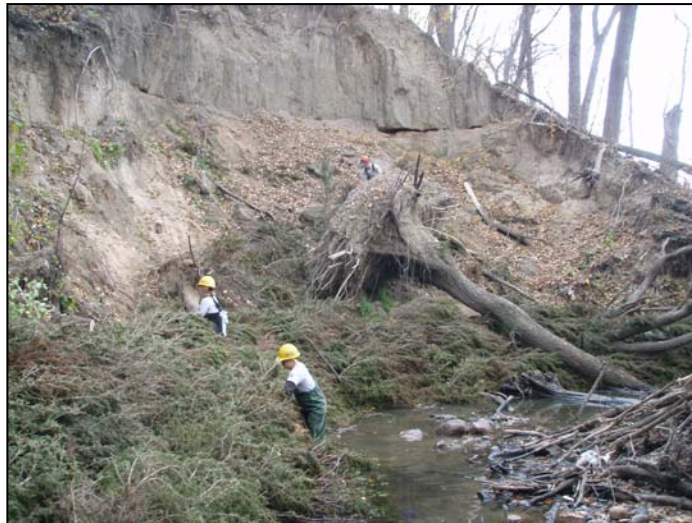
2008 Hanley Residence Streambank Stabilization, Glen Creek

The Hanley property lies along Glen Creek where it flows into the Mississippi River. The site consists of a steep slope from the top of the property to the creek 30 feet below. Active erosion and bank undercutting has led to severe bank failure that will threaten the Hanley residence in the future. For this project, a cedar tree revetment was chosen to slow erosion and buy time for a larger scale project to take shape. Benefits of cedar revetments include improved fish and wildlife habitat and repair of bank undercutting and erosion.
