2016 Anoka Water Almanac

Water Quality and Quantity Conditions of Anoka County, MN

A Report of Activities by
Watershed Organizations and the
Anoka Conservation District

Prepared by the
Anoka Conservation District

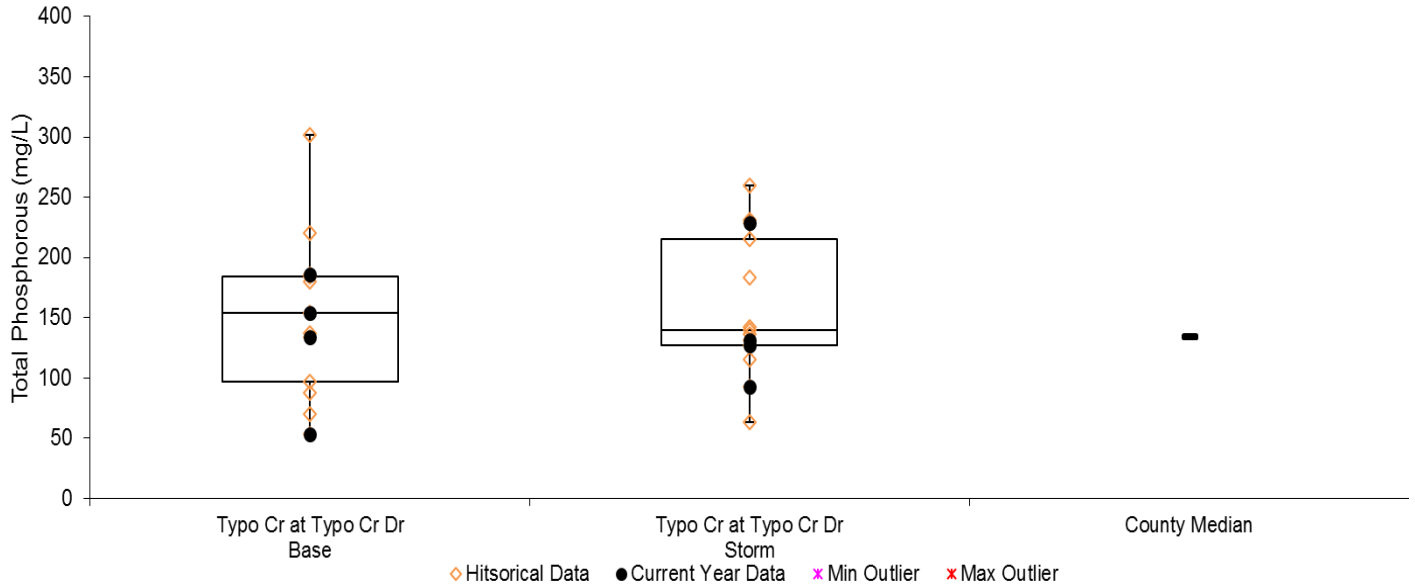
Total phosphorus during baseflow and storm conditions. Orange diamonds are historical data from previous years and black circles are 2016 readings. Box plots show the median (middle line), 25th and 75th percentile (ends of box), and 10th and 90th percentiles (floating outer lines).

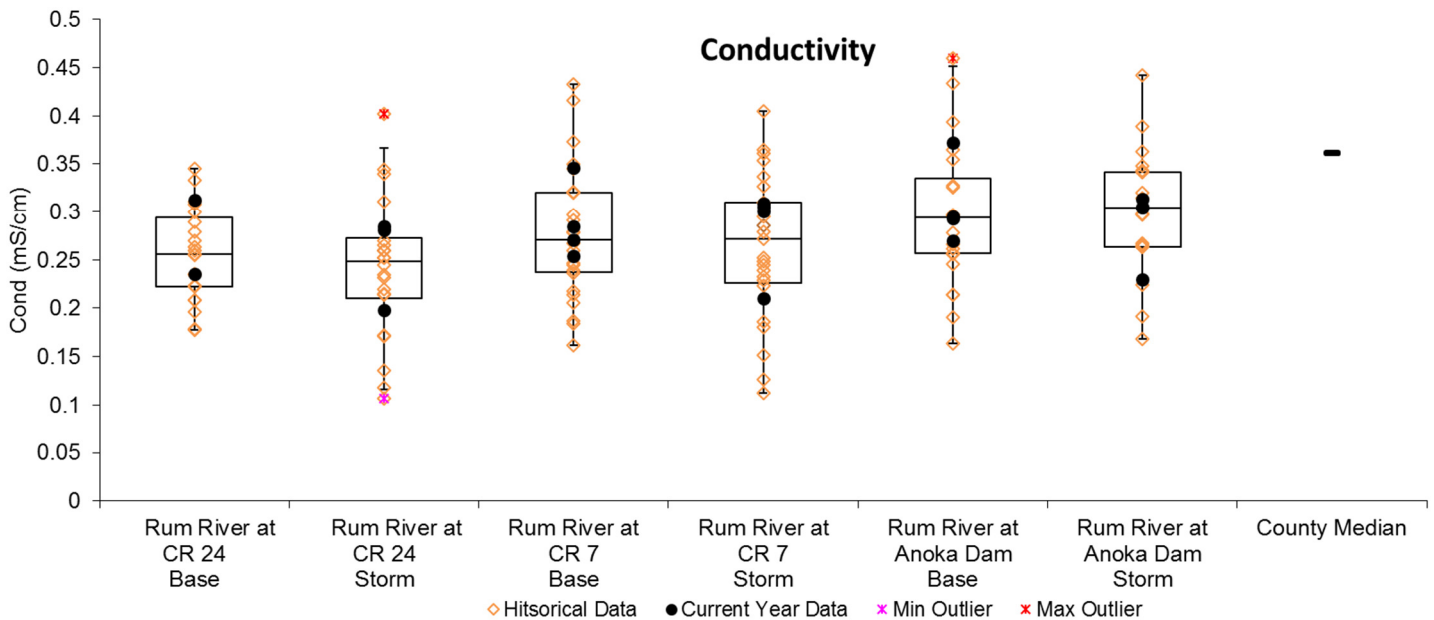
Conductivity during baseflow and storm conditions Orange diamonds are historical data from previous years and black circles are 2016 readings. Box plots show the median (middle line), 25th and 75th percentile (ends of box), and 10th and 90th percentiles (floating outer lines).

Conductivity is acceptably low in the Rum River, but increases downstream (see figures above) and is usually higher during baseflow. Median conductivity from upstream to downstream of the sites monitored in 2016 (all conditions) was 0.281 mS/cm, 0.293 and 0.300 mS/cm, respectively. All three sites are lower than the median for 34 Anoka County streams of 0.362 mS/cm. The 2016 maximum observed conductivity in the Rum River was 0.37 mS/cm which is the close to the median for all other Anoka County streams, and levels in general were far lower than in 2015.

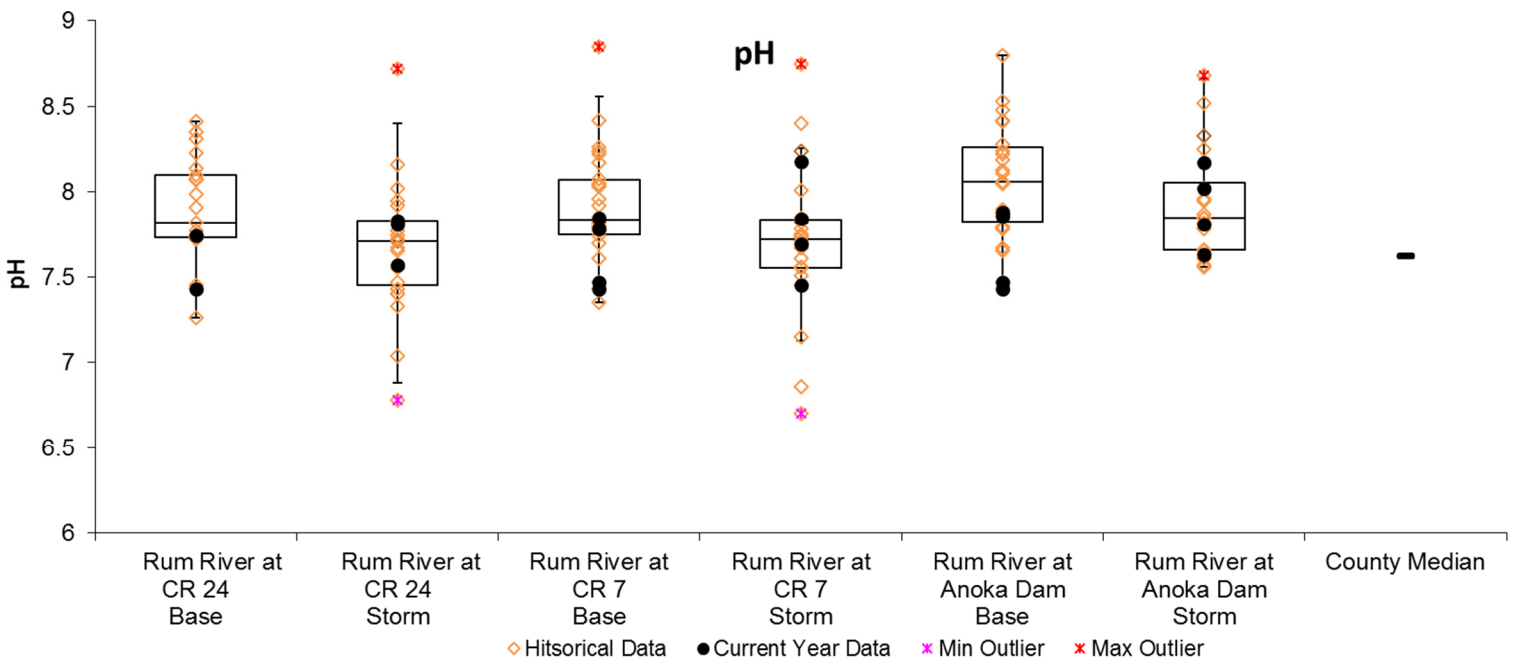
pH during baseflow and storm conditions Orange diamonds are historical data from previous years and black circles are 2016 readings. Box plots show the median (middle line), 25th and 75th percentile (ends of box), and 10th and 90th percentiles (floating outer lines).

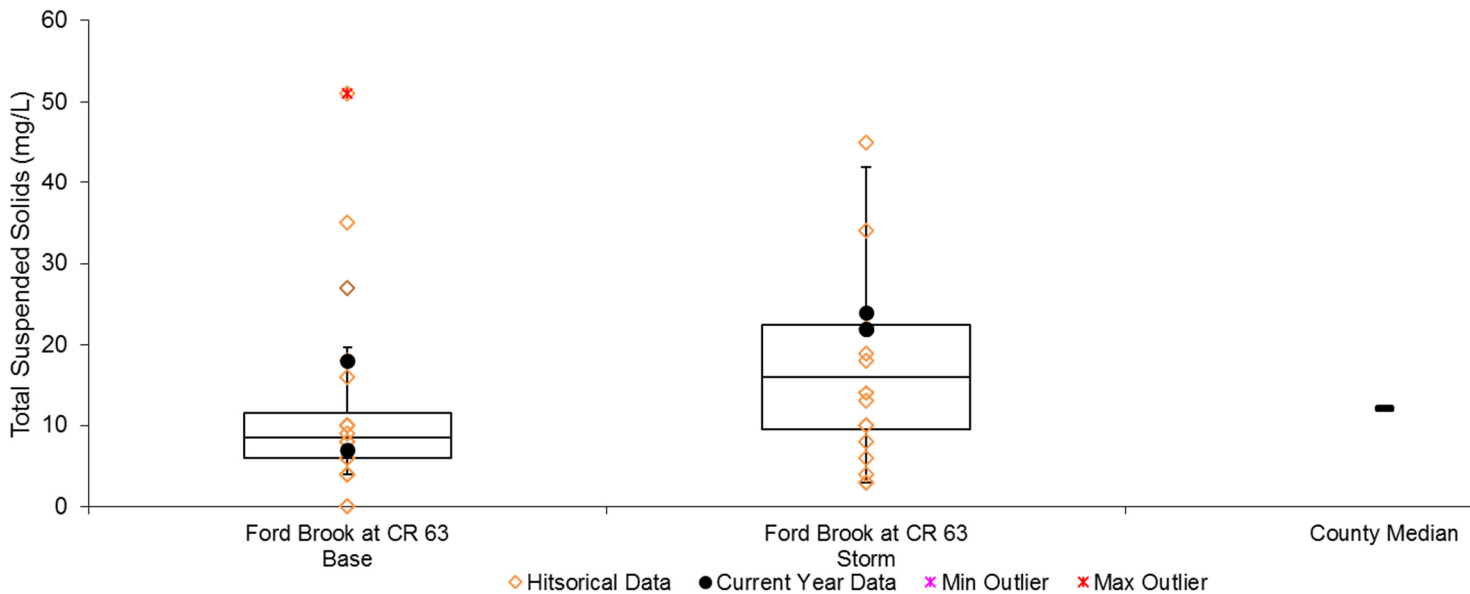
Total Suspended Solids at Ford Brook. Orange diamonds are historical data from previous years and black circles are 2016 readings. Box plots show the median (middle line), 25th and 75th percentile (ends of box), and 10th and 90th percentiles (floating outer lines).
