2018 Anoka Water Almanac

Water Quality and Quantity

Conditions of Anoka County, MN

**A Report of Activities by
Watershed Organizations and the
Anoka Conservation District**

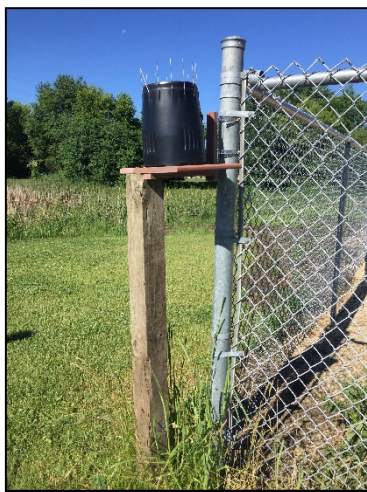
Tipping bucket rain gauge.

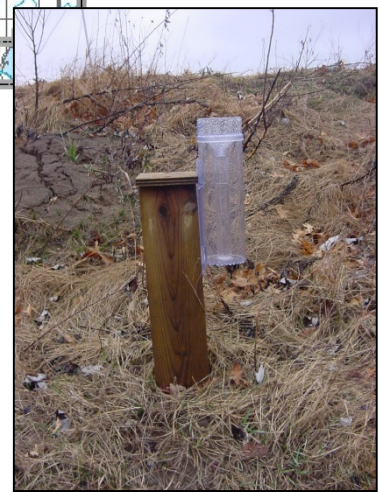
Cylinder rain gauge.

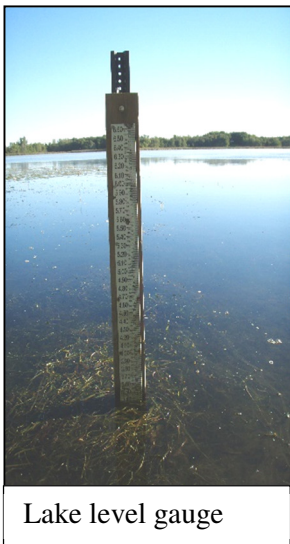
Lake level gauge

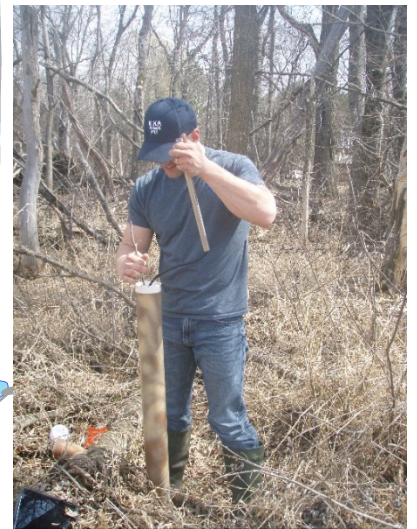
Wetland gauge deploy.

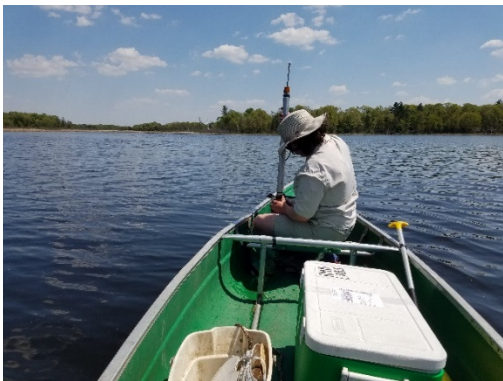
Lake water quality sample collection.

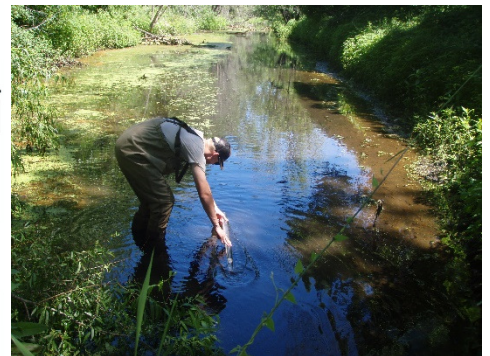
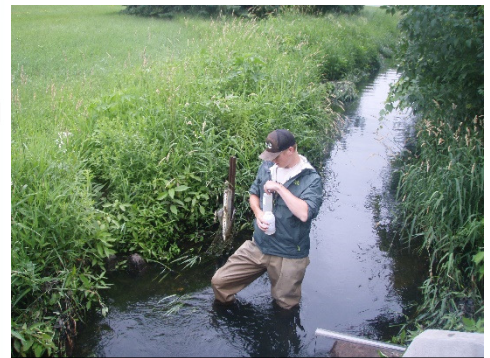
Stream water quality sample collection.

Stream water is monitored four times during base flow conditions and four times immediately following storm events between the months of April and September (some special studies have different sampling regimes). Grab samples are a single sample of water collected to represent water quality for a given moment or stream condition. A composite sample, conversely, consists of collecting several small samples over a period of time and mixing them. Stream sampling is performed using a Hydrolab Quanta multi-probe in the stream and concurrently collecting grab samples for laboratory analysis.

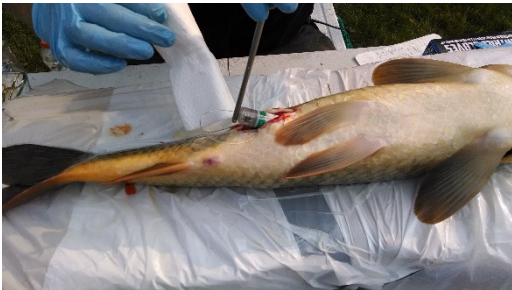
Radio transmitter being surgically implanted in a carp. 40 carp were implanted with radio loggers, 20 each from Typo and Martin Lakes. Radio loggers will help track the schooling, feeding, and movement patterns of the carp to aid in future harvesting efforts.

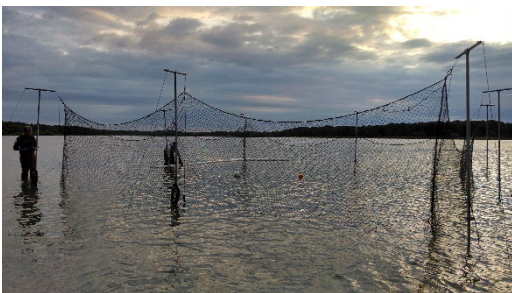
A sprung box net in Typo Lake. Nets were set, baited, and sprung at four sites each in Typo and Martin Lake for a total of 30 nettings on 8 different days from June through September, 2018.

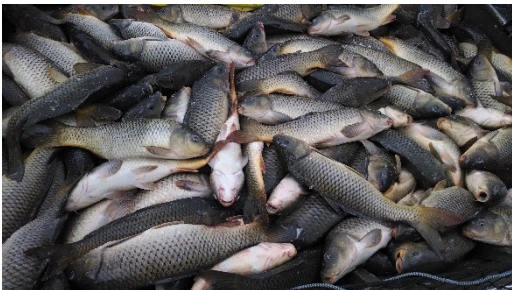
A boat full of harvested carp. A total of 3,552 carp were removed from Typo Lake during the summer of 2018. 3,366 carp were removed from Martin Lake during August through September 2018. Harvest efforts in both lakes will continue through 2019.

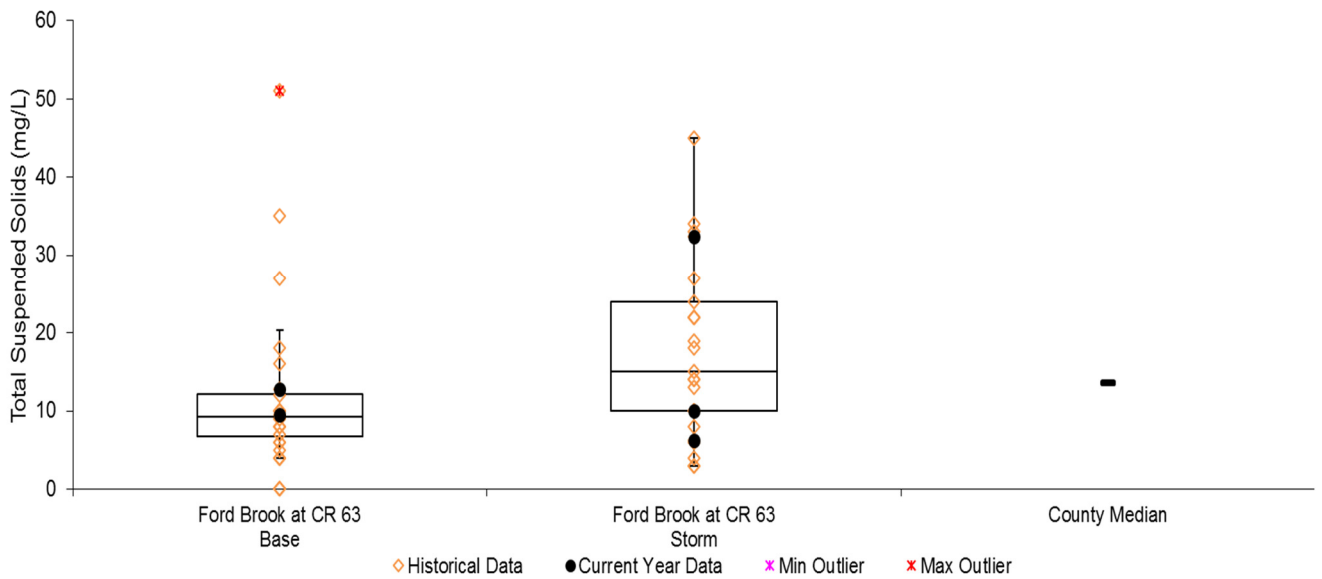
Total Suspended Solids at Ford Brook. Orange diamonds are historical data from previous years and black circles are 2018 readings. Box plots show the median (middle line), 25th and 75th percentile (ends of box), and 10th and 90th percentiles (floating outer lines).

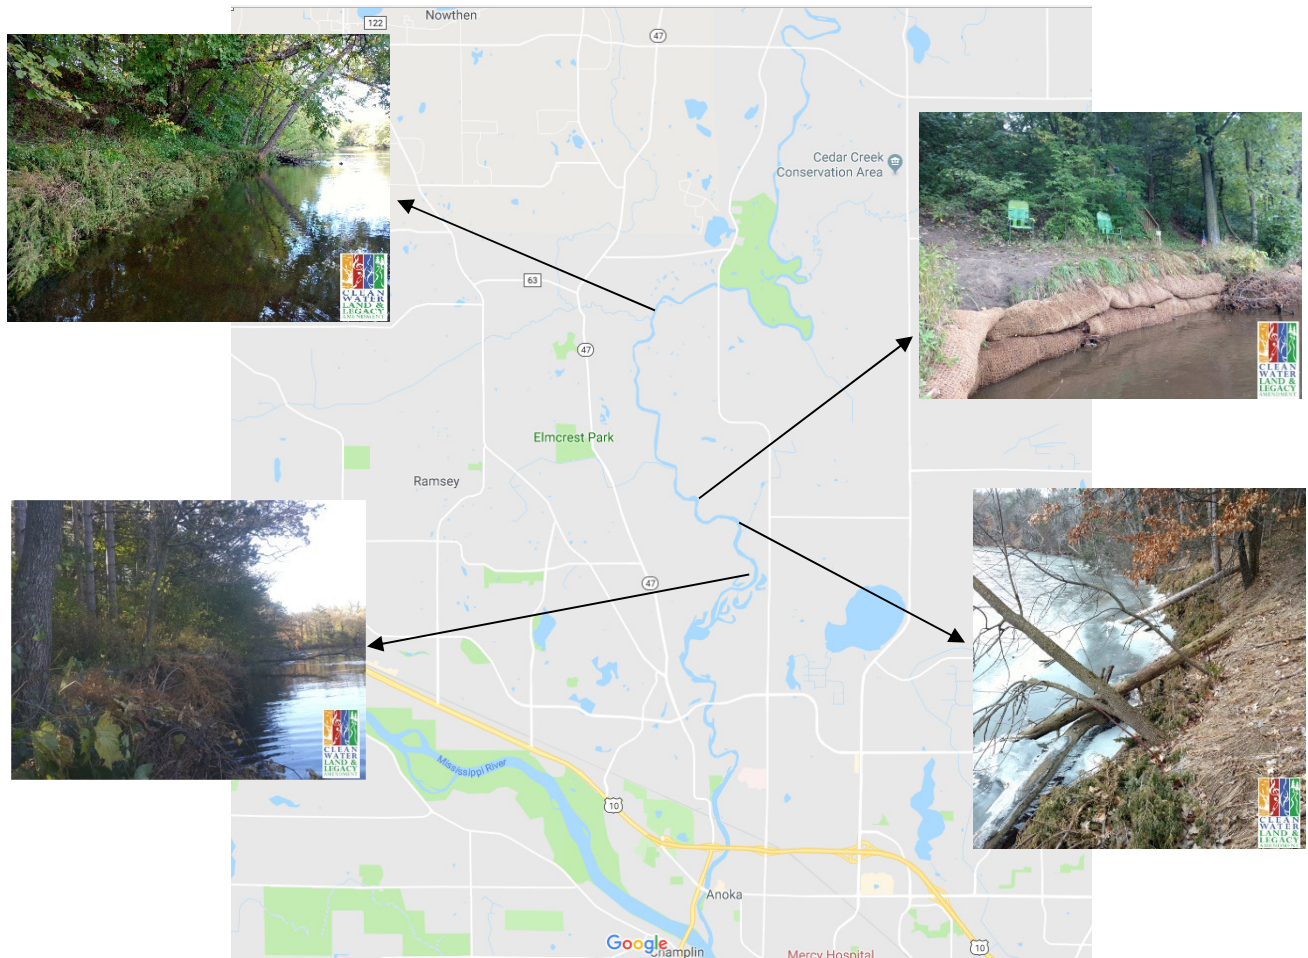
Bank Stabilization Projects in Anoka County in 2018

Results: Stabilized 2,223 linear feet of riverbank on the Rum River in Anoka and Isanti Counties.

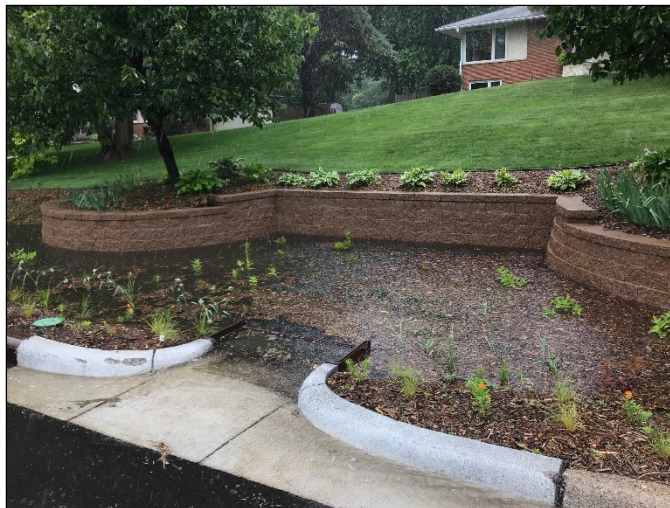
- Rain Gardens
 - Construction oversight and final project closeout for a residential curb-cut rain garden in Columbia Heights (Silver Lake).

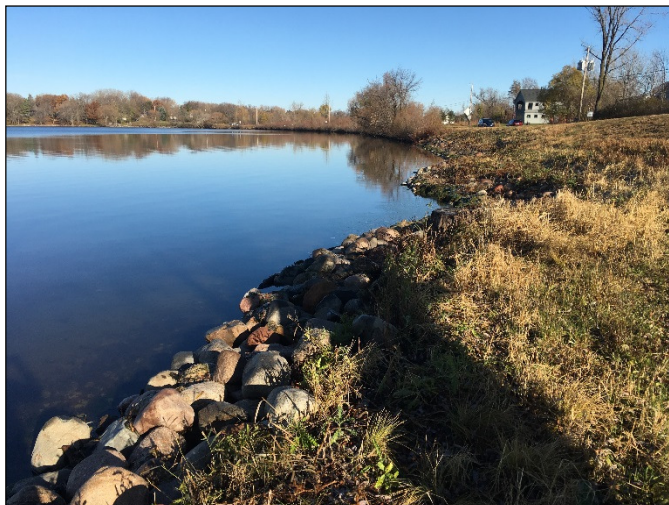
- Shoreline Stabilizations
 - Design, cost-share coordination, construction oversight, and final project closeout for 678 linear feet of lakeshore stabilization in Trail Side Park in the City of Centerville (Centerville Lake).

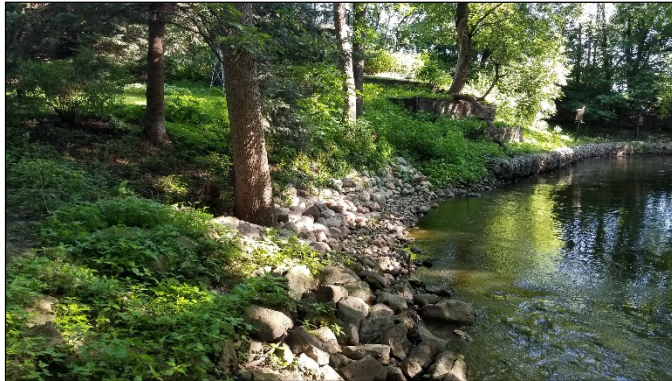
- Streambank Stabilizations
 - Construction oversight and final project closeout for a streambank stabilization in the City of Fridley (Rice Creek).

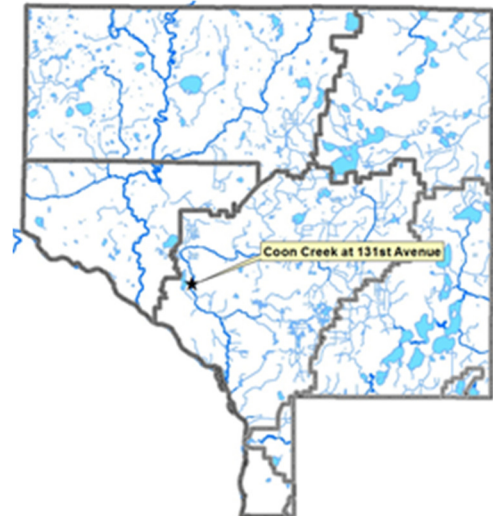
Coon Creek is a major drainage through central Anoka County. This monitoring location is within a residential neighborhood in Coon Rapids, located just downstream of 131st Street NE. Land use in the upstream watershed ranges from rural residential to highly urbanized. The creek is approximately 35 ft. wide and 1.5 to 2 ft. deep at the monitoring site during baseflow.

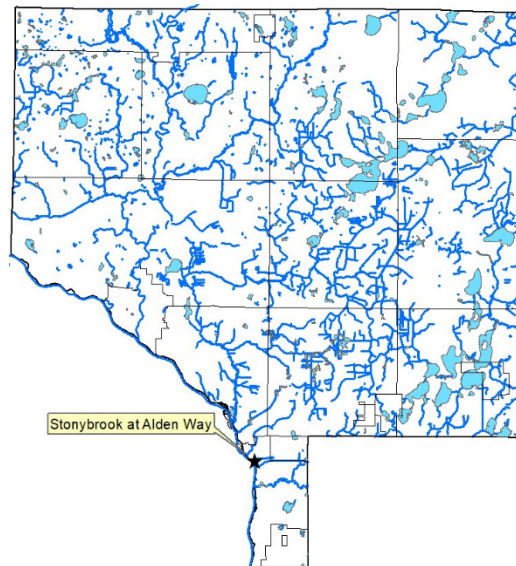
2018 was the second year in which continuous water quality was monitored during storm events in Stonybrook using a YSI EXO data sonde. The purpose of continuous water quality monitoring is to document water quality changes throughout storm events. This helps diagnose water quality problems and reflect differences in runoff between larger, less flashy systems, such as Sand Creek and flashy, subterranean/storm drain systems such as Stonybrook and Oak Glen. Runoff from within the watershed passes the monitoring site quickly following a storm.

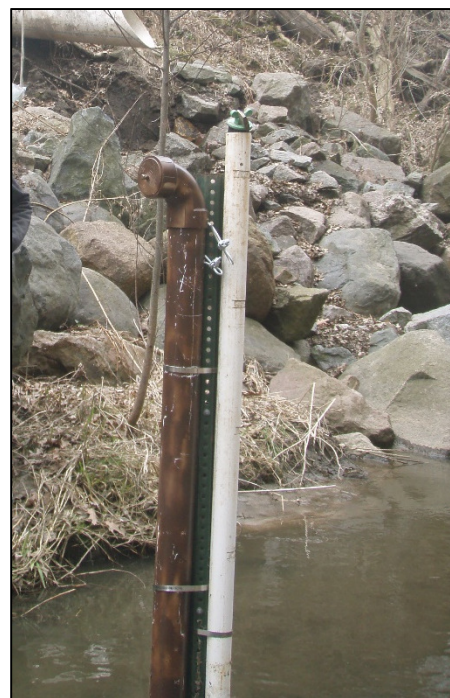
YSI EXO water quality sonde casing (white) and an OTT continuous water level monitoring device casing (brown) in Oak Glen Creek. There is a staff gage on the green post facing the other direction.

The site was monitored immediately before, during, and after four storms with a YSI EXO data sonde. The sonde was suspended inside a PVC pipe with a locked lid. The PVC pipe was secured to a metal fence post. The sonde sensors protruded from the bottom of the pipe approximately 3 inches from the stream bottom, ensuring they would stay submerged even if flow was low. The sonde was programmed to take readings every 15 minutes. Readings included pH, salinity, specific conductance, temperature, dissolved oxygen, and turbidity. The sonde was calibrated before each deployment
