2020 Anoka Water Almanac

Water Quality and Quantity
Conditions of Anoka County, MN

A Report of Activities by
Watershed Organizations and the
Anoka Conservation District

March 2021

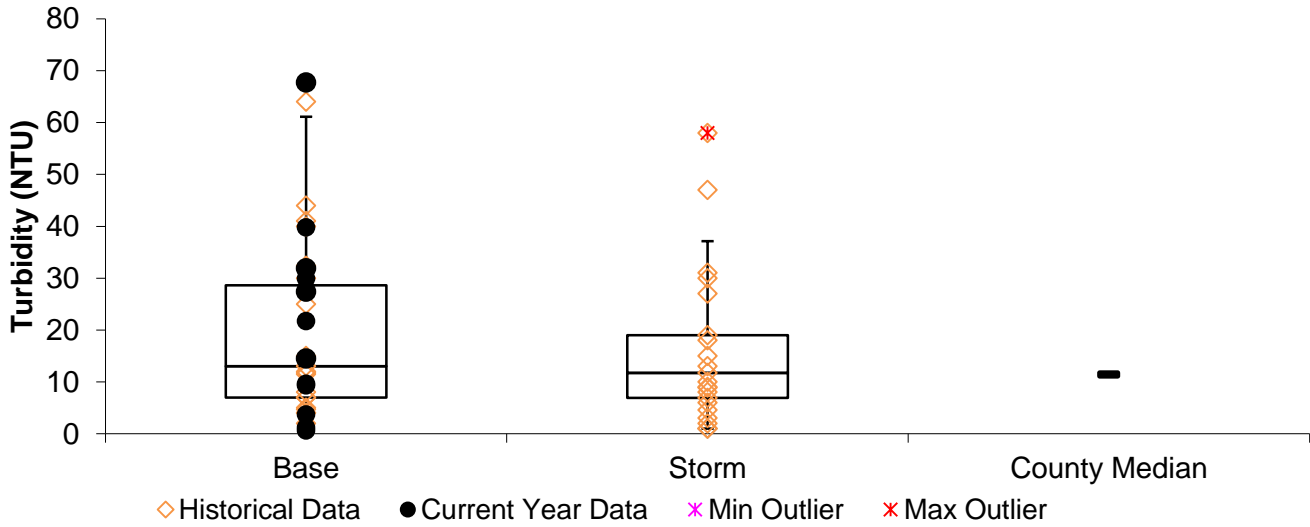
Turbidity during baseflow and storm conditions Orange diamonds are historical data from previous years and black circles are 2020 readings. Box plots show the median (middle line), 25th and 75th percentile (ends of box), and 10th and 90th percentiles (floating outer lines).

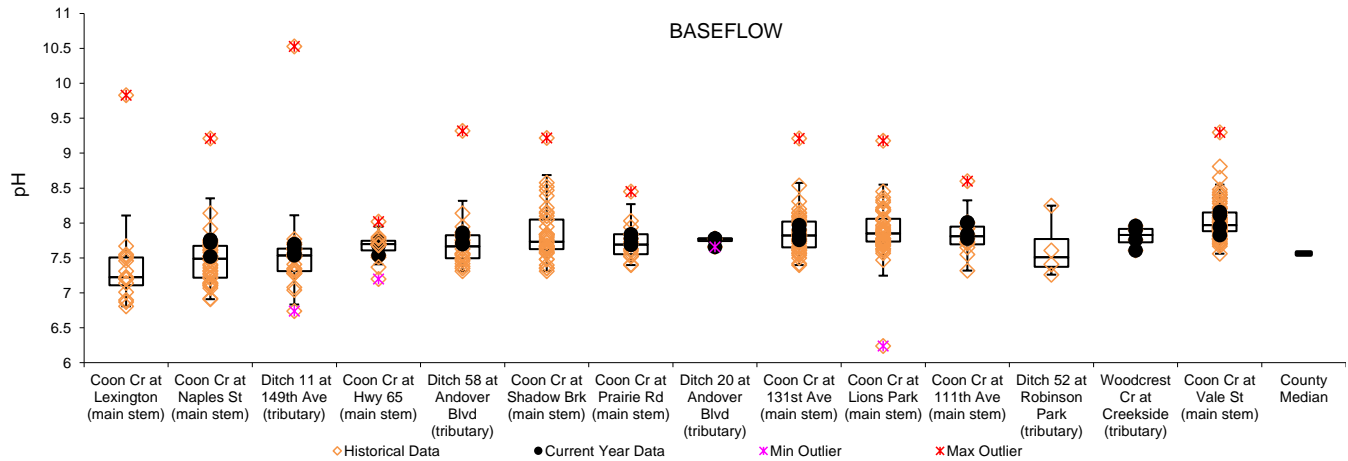
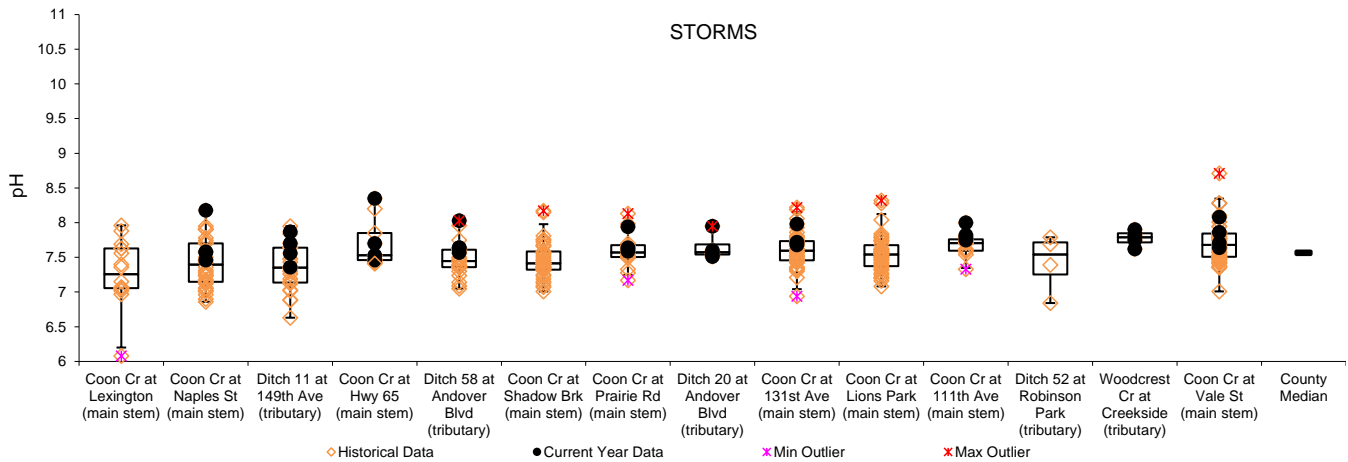
pH at Coon Creek Orange diamonds are historical data from previous years and black circles are 2020 readings. Box plots show the median (middle line), 25th and 75th percentile (ends of box), and 10th and 90th percentiles (floating outer lines).

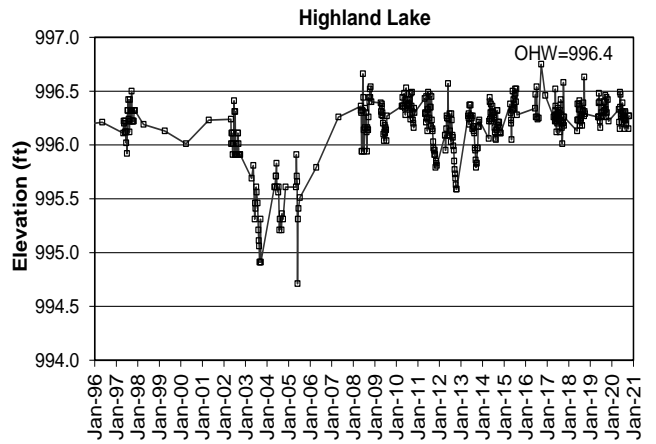
Highland Lake Levels last 25 years
