Excerpt from the 2021 Water Almanac

Chapter 2: Sunrise River Watershed

Prepared by the Anoka Conservation District

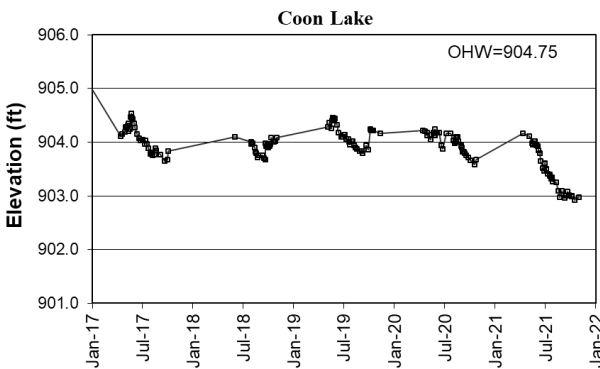
Coon Lake Levels – last 5 years

Individual lakes varied. Typo, Fawn, and Martin Lake levels fluctuated at a similar scale to previous years. Coon and Linwood Lake seemed to be most affected by the drought conditions. Coon Lake dropped 1.2 feet during 2021, but lower water levels have been observed in other years including 1988-1990, 2000, and 2009. Linwood Lake dropped over 1.5 feet during the course of the season and had its second lowest ever recorded water level, just 0.05 feet higher than the record low observed in 1988. As shown in the tables below, all five lakes were lower on average in 2021 than the four years prior.

Lake	Year	Average	Min	Max
COON	2017	904.09	903.65	904.53
	2018	903.92	903.68	904.1
	2019	904.14	903.8	904.46
	2020	904.01	903.58	904.24
	2021	903.52	902.92	904.16

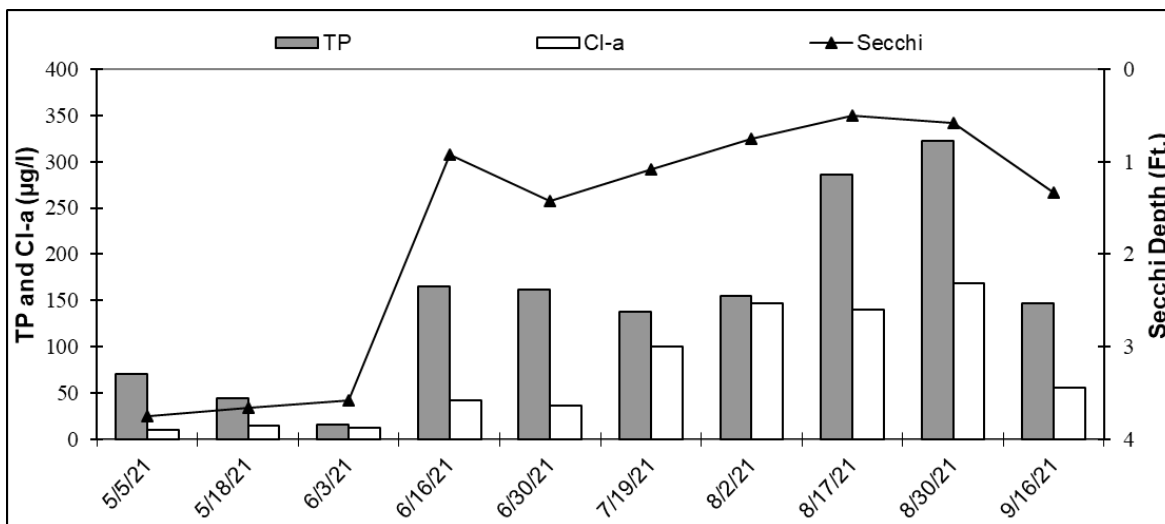
2021 Results

pH		8.37
Specific Conductance	mS/cm	0.30
Turbidity	FNRU	53.65
D.O.	mg/l	9.93
D.O.	%	108.95
Temp.	°F	73.09
Salinity	%	0.11
Cl-a	µg/l	48.50
T.P.	µg/l	151.00
Secchi	ft	1.21

In 2021, Typo Lake had poor water quality compared to other lakes in this region (NCHF Ecoregion), but did show improvement from 2020, receiving an overall D letter grade. Average total phosphorus (TP) was 150.5 $\mu\text{g/L}$, which was a decrease from the 2020 average of 220.0 $\mu\text{g/L}$. While total phosphorus levels continue to far exceed the 60 $\mu\text{g/L}$ state standard for shallow lakes, average concentrations appear to be decreasing over the past two decades (average 270 $\mu\text{g/L}$ during 2000-09, and 174 $\mu\text{g/L}$ 2012-2020).

Chlorophyll-a (Cl-a) levels in 2021 averaged 72.5 $\mu\text{g/L}$. This is similar to 2020 (73.5 $\mu\text{g/L}$) and other previous years (average 70 $\mu\text{g/L}$ 2015-20). Cl-a concentrations have stayed below the historical average for the lake (99 $\mu\text{g/L}$ 1993-2020) but are still many times higher than the State standard for Cl-a in shallow lakes of 20 $\mu\text{g/L}$.

Average Secchi transparency in 2021 was 1.8 feet, which tied for the second-highest average on record (1974-2021 n=22). Transparency has improved throughout the last decade, but remains poorer than the State standard for shallow lakes transparency of 1 meter (3.3 feet).

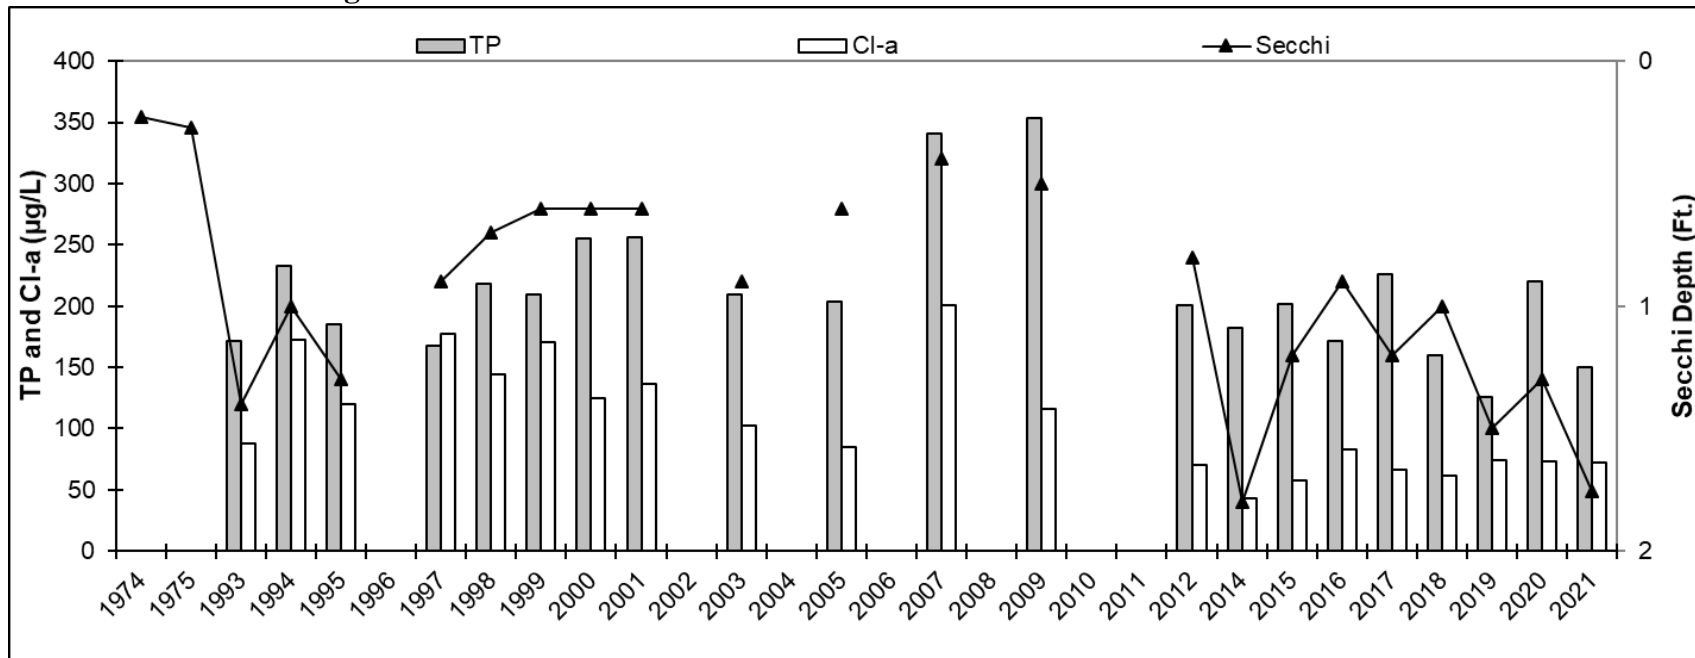
Historical Annual Averages

The MPCA (1993, '94, and '95) and the Anoka Conservation District (1997-2001, '03, '05, '07, '09, '12, 2014-2021) have conducted twenty-one years of water quality monitoring. Overall, water quality has improved from 1993 to 2021 in a statistically significant way (repeated measures MANOVA with response variables TP, Cl-a, and Secchi depth; $F_{2, 18}=5.98$, $p<0.01$). When we tested these response variables individually with one-way ANOVAs, TP shows no significant change across this time period. A superficial look at graphs of these parameters suggests that total phosphorus is generally stable between 150 $\mu\text{g/L}$ and 250 $\mu\text{g/L}$ with an overall decreasing trend that is not significant at this time. Cl-a, however, is showing a statistically significant decline ($p<0.001$). Secchi transparency is showing a statistically significant increase ($p<0.05$) when high nutrient years of 2007 and 2009 are excluded. The major driver of improved water quality is decreasing Cl-a concentration, but improving seechi transparency is also a positive driving factor.

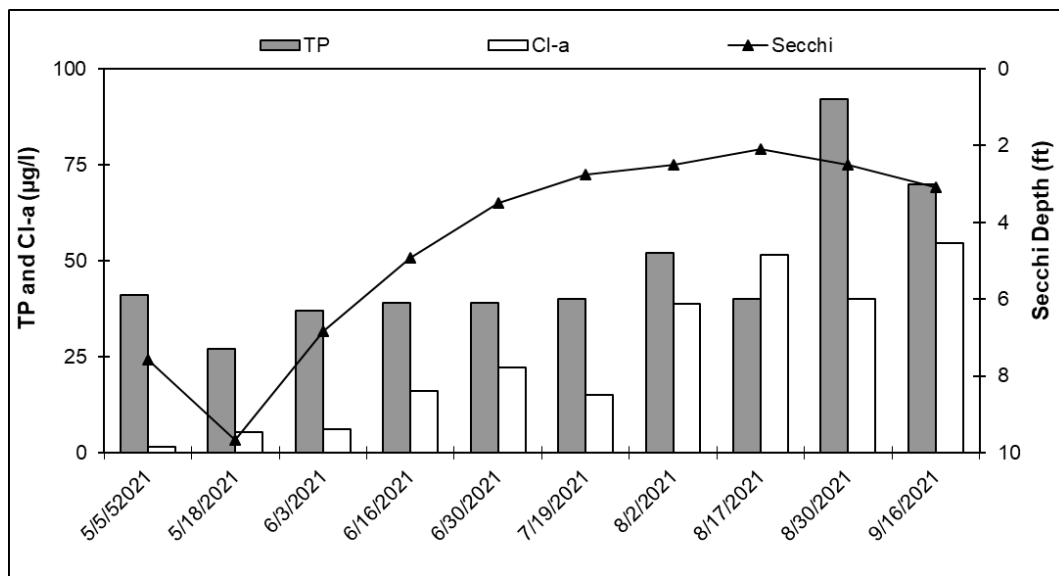
2021 Results

pH		8.19
Specific Conductance	mS/cm	0.31
Turbidity	FNRU	20.00
D.O.	mg/l	10.46
D.O.	%	116.35
Temp.	°F	74.68
Salinity	%	0.15
Cl-a	ug/L	19.15
T.P.	ug/l	40.00
Secchi	ft	3.29

In 2021, Martin Lake had an overall C letter grade with a record low average for total phosphorus concentrations, 47.7 µg/L. In 2021, chlorophyll-a averaged 25.2 µg/L, similar to the 2020 average of 31.4 µg/L and other years since 2012. While the most recent 5-year average for chlorophyll-a of 28.4 µg/L is much lower than the 2005-2009 average of 108.3 µg/L, chlorophyll-a remains above the state impairment standard of 20 µg/L. Average Secchi transparency in 2021 was 4.5 feet, a substantial increase from 3.0 feet in 2020. The average Secchi transparency in 2021 was above the state standard of 3.3 feet.

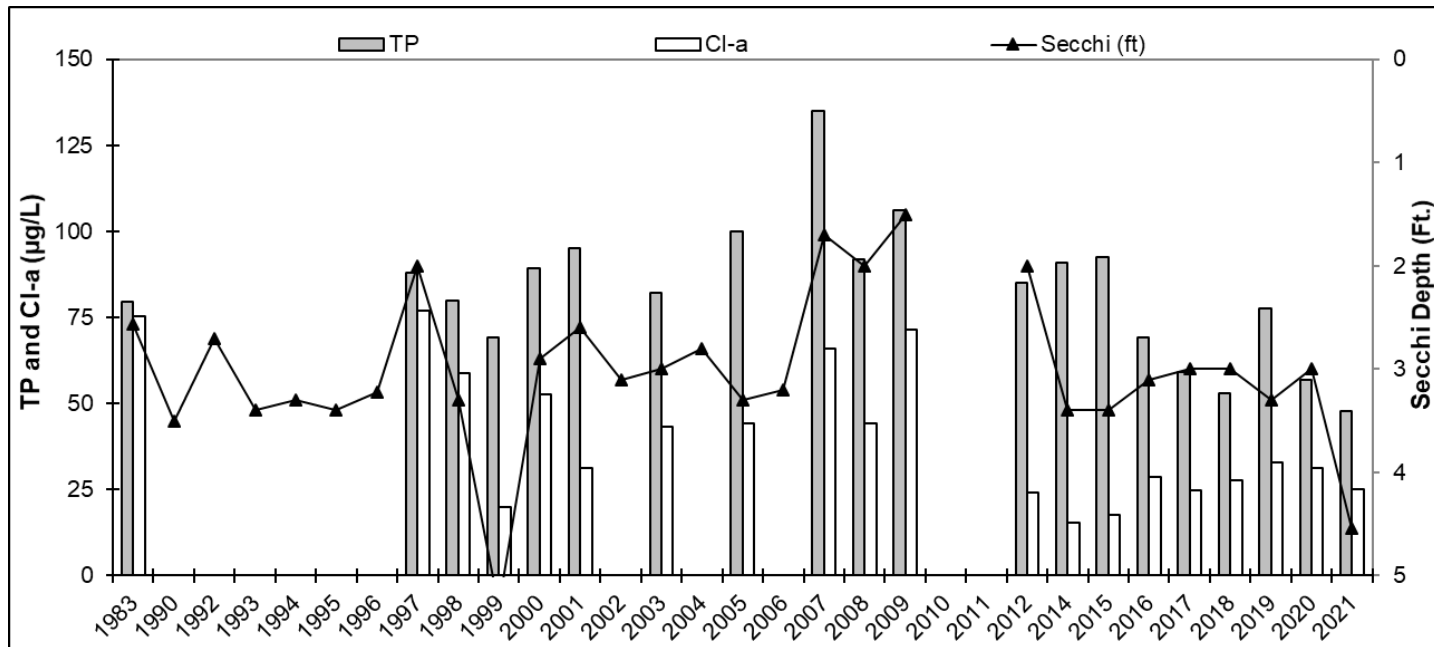
Historical Annual Averages

Twenty-one years of water quality data have been collected by the MPCA (1983), Metropolitan Council (1998, 2008), and ACD (1997, 1999-2001, 2003, 2005, 2007, 2009, 2012-2021). Citizens monitored Secchi transparency 17 other years. Anecdotal notes from DNR fisheries data indicate poor water quality dating back to at least 1954. Although still poor, water quality in Martin Lake has shown an improvement from 1983 to 2021 that is statistically significant (repeated measures MANOVA with response variables TP, Cl-a, and Secchi depth; $F_{2, 17}=6.54$, $p < 0.05$). This is especially true for the last decade. Further examination of the data shows that while TP and Secchi transparency have not changed in a statistically significant way since 1983, chlorophyll-a concentrations have shown a statistically significant decrease ($p < 0.01$) over this time. Water quality in Martin Lake declined through the late 1990s and reached its worst quality in 2007. In the 11 years sampled since 2007, both TP and Secchi transparency have improved on a statistically significant basis ($p < 0.01$).

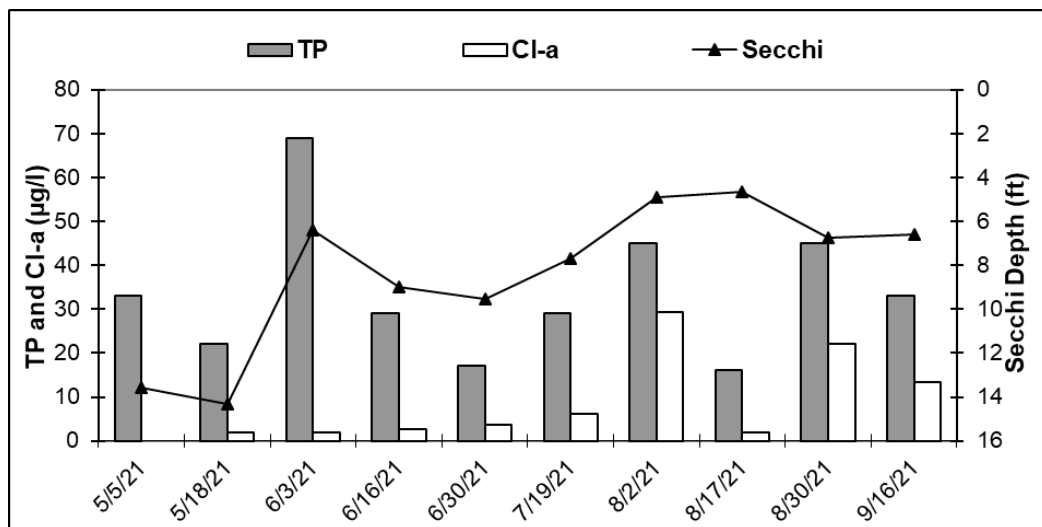
2021 Results

pH		7.93
Specific Conductance	mS/cm	0.26
Turbidity	NTU	9.25
D.O.	mg/l	9.58
D.O.	%	109.35
Temp.	°F	73.41
Salinity	%	0.12
Cl-a	µg/L	3.60
T.P.	µg/l	31.00
Secchi	ft	7.21

Boot Lake's nutrient levels are typical of shallow lakes in the area. The average total phosphorus level in 2021 was 33.8 µg/L, average chlorophyll-a was 9.2µg/L, and average Secchi transparency was 8.3 ft. (2.5 m). These are better than the state water quality standard for shallow lakes (total phosphorus <60 µg/L, chlorophyll-a <20 µg/L, Secchi transparency >1m), and earn Boot Lake an overall B letter grade on Met Council's grading scale for metro area lakes. This is an improvement from the C letter grade Boot Lake received in 2018. Boot Lake supports a diverse plant community, and attracts abundant waterfowl.

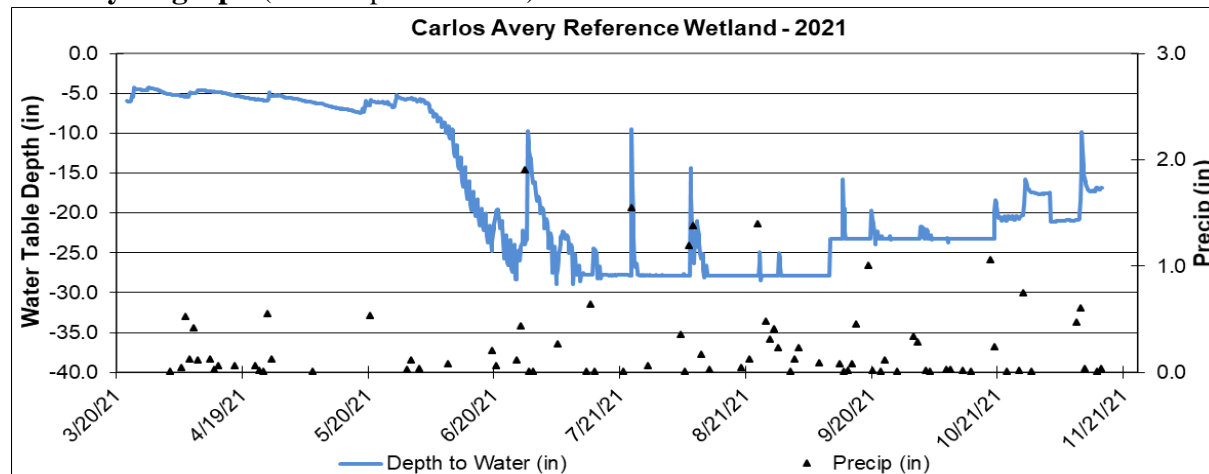
2021 Hydrograph (Well Depth 28 inches)

Other Notes: This is a broad, expansive wetland within a state-owned wildlife management area. Cattails dominate within the wetland. Anoka County was in a state of drought starting in June, with most of the growing season spent in a severe drought condition, which caused some monitoring wells to go dry. This monitoring well typically does not go dry and has taken readings lower than 28 inches in past years. The well depth will be assessed in 2022.

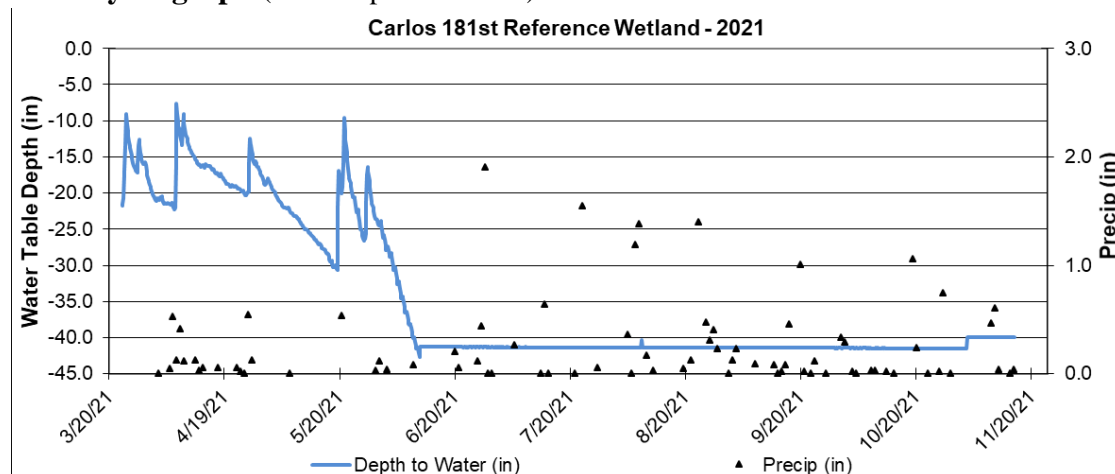
2021 Hydrograph (Well Depth 40 inches)

Other Notes: This site is owned and managed by the MN DNR. Access is from 181st Avenue. Anoka County was in a state of drought starting in June, with most of the growing season spent in a severe drought condition, which caused some monitoring wells to go dry.

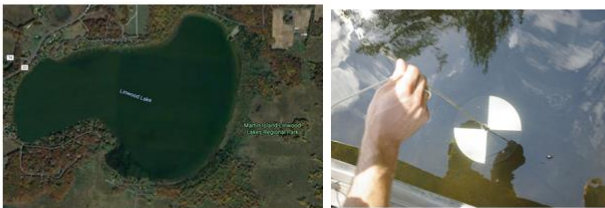
The volunteer visits a designated monitoring location, a minimum of twice a month, and takes Secchi disk reading. An example of what a Secchi Disk looks like, is shown below. The Secchi disk is lowered into the water and the depth is recorded at the point where the disk disappears the volunteer. This reading represents the clarity of the water which is one of the main drivers water quality in a lake. Additional information is also recorded including; weather conditions, water color, physical condition, recreational suitability, and anything noteworthy for that day.

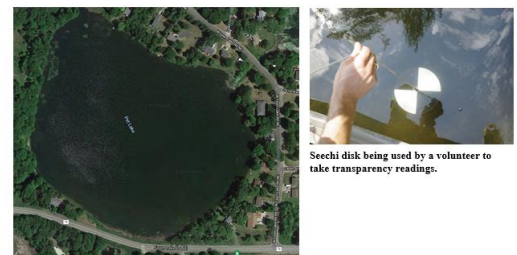
Secchi disk being used by a volunteer to take transparency readings.

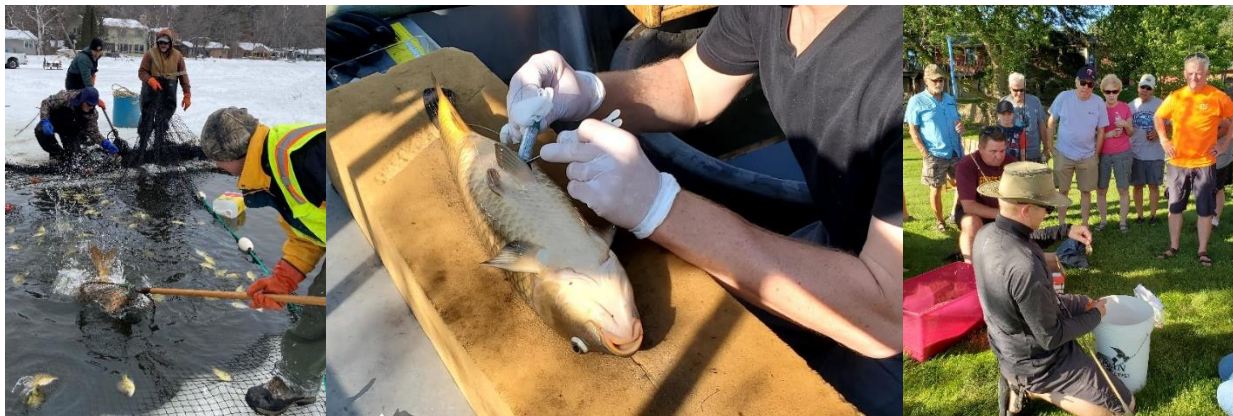
Under ice seine effort on Linwood Lake on left. Radio tagging by Carp Solutions, LLC. on Martin Lake, center. Carp fishing clinic at Martin Lake on right.

- Debris was removed from the NE bay on Linwood Lake to allow successful future seine netting.
- 12 new radio tags were implanted into carp in Martin Lake to guide commercial seines to schooled carp.

- 1 commercial seine at Martin Lake. One carp captured.
- A carp fishing clinic was taught by the owner of Carp Solutions, LLC, Dr. Przemek. He provided instruction and techniques used in his homeland of Poland. Participants, who were mostly Martin Lake residents, went home with a carp fishing rig and bait.
