Excerpt from the 2021 Water Almanac

Chapter 5: Rice Creek Watershed

Prepared by the Anoka Conservation District

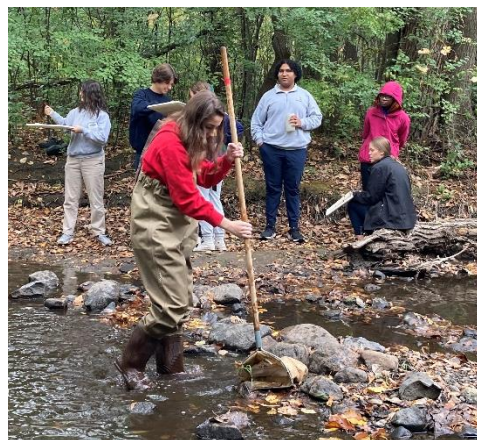
Summarized Biomonitoring Results for Rice Creek at Hwy 65, Fridley

Totino Grace High School monitored this stream in the fall of 2021, facilitated by the Anoka Conservation District. At this site, Rice Creek has a macroinvertebrate community indicative of poor stream health. While the number of families present has been similar to, or above the long-term average for Anoka County streams, most of these are generalist species that can tolerate polluted conditions. The most dominant family found seven of the past eight years is Hydropsychidae, a generalist family. The number of EPT families present has been below the county average in all years. EPT are generally pollution-sensitive, but the caddisfly family Hydropsychidae, is an exception to that rule. It thrives in relatively poor environmental conditions. Hydropsychidae was the only EPT taxa collected in 2021, and was seen in lower numbers than average.

The poor macroinvertebrate community in this creek is likely due to poor water quality and flashy flows during storms, not poor habitat. Habitat at the sampling site and nearby is good, in part because of past stream habitat improvement projects. The stream has riffles, pools, and runs with a variety of snags and rocks. The area immediately surrounding the stream is predominately a buckthorn forest, with walking trails. However, outside of this wooded corridor around the stream, the watershed is urbanized and storm water inputs are likely the cause of degraded water quality. During storms, water levels in the creek can rise sharply. This portion of Rice Creek is impaired for both fish and invertebrate biota.
