Excerpt from the 2022 Water Almanac

Chapter 2: Sunrise River Watershed

Prepared by the Anoka Conservation District

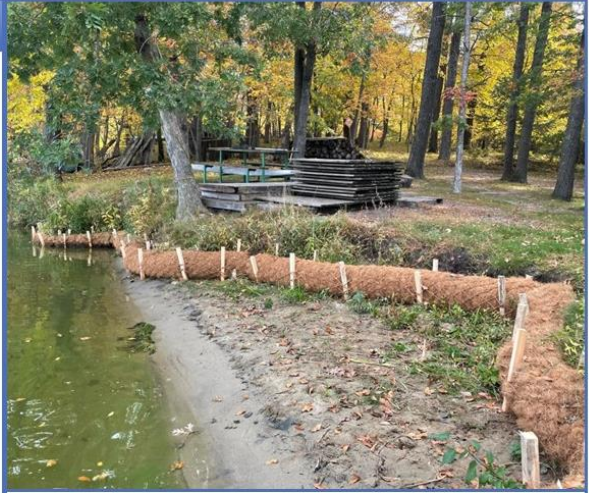
This project stabilized 70 linear feet on Martin Lake, which is a state impaired water and priority for the local watershed organization. Funding was from the landowner and the ACD cost-share program. ACD provided project administration, design services, and project installation.

Biolog installation. October 2022.

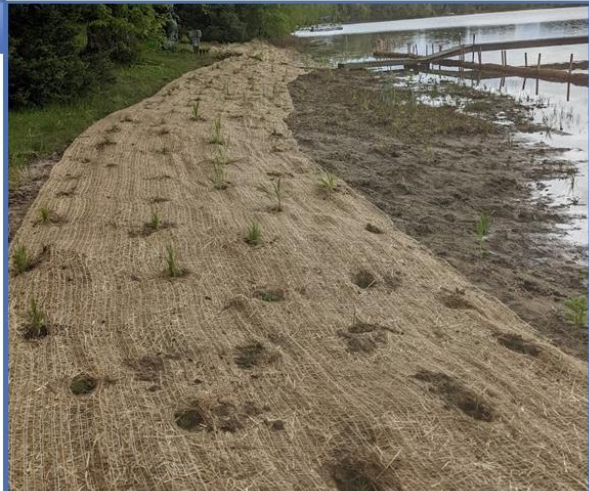
200 linear feet of shoreline was stabilized and planted. Coir (coconut fiber) logs were installed along shore. The logs provide protection from wave erosion, while the shoreline becomes fully vegetated. Thereafter, the plants provide shoreline protection. Above the waterline, the area was seeded with a native plant mix and supplemented with native plugs. The planting area was approximately 4,000 sq ft.

Project area. Installed July 2022.

Fawn Lake is a high quality lake with a small watershed, so shoreline practices are important to maintaining its good condition. ACD provided project administration, design services, and project installation.

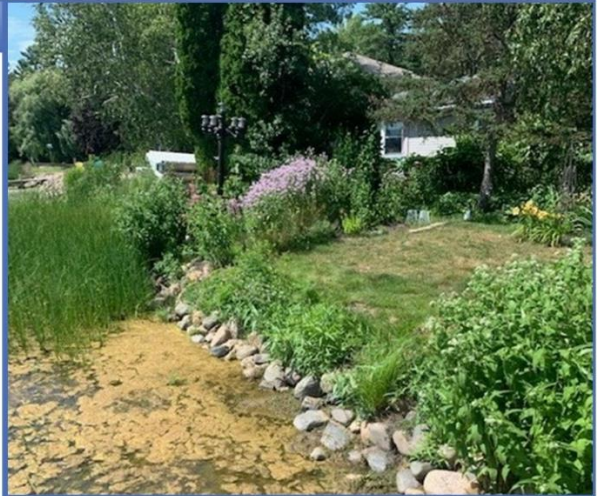
This project planted an area of approximately 720 sq ft. The owner removed sod, installed plants and is maintaining the plantings. ACD provided project administration and design services.

Shoreline after planting, July 2022.

This project was aimed at both long term lakeshore stability and near-shore habitat improvement. The owners have experienced shoreline erosion that has mostly been corrected with rock rip rap however ice heaving still occurs. Native plantings may reduce ice heaving and can conceal it when it occurs. Moreover, replacing turf grass with native plants offers pollinator habitat in a critical location: at the shoreline.

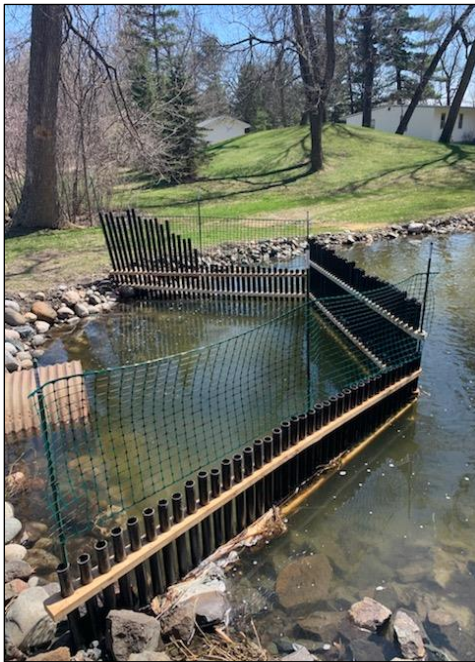
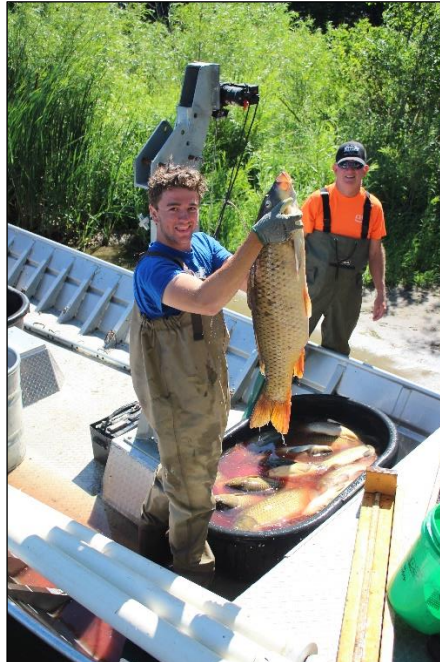
Left: Temporary carp barrier at Linwood Lake outlet.
 Right: July 2022 carp box netting at Martin Lake.

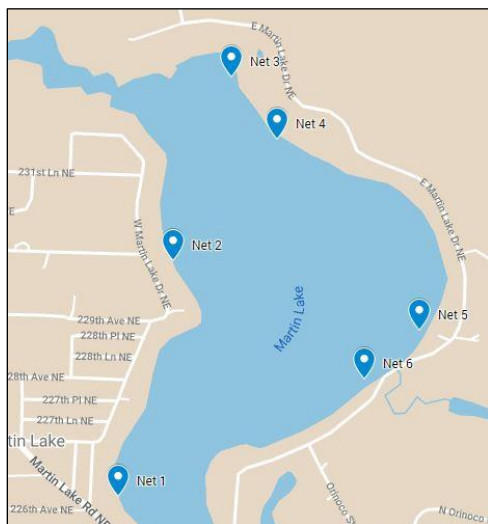
Box net locations in 2022 at Martin Lake (left) and Typo Lake (right).

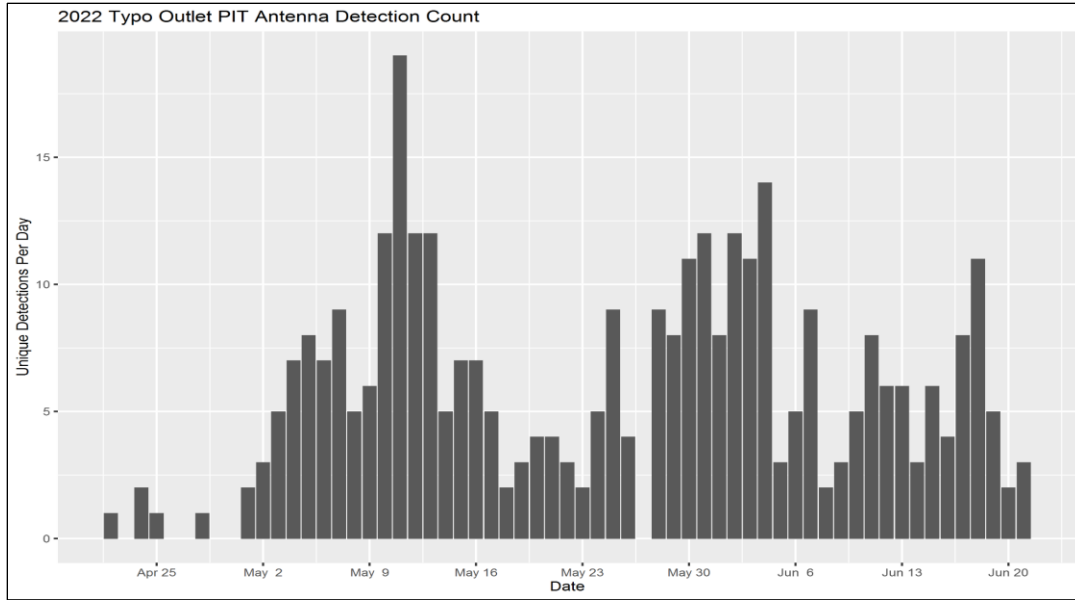
Graph of the number of unique PIT tags detected per day at PIT antennas at the outlet Typo Lake.

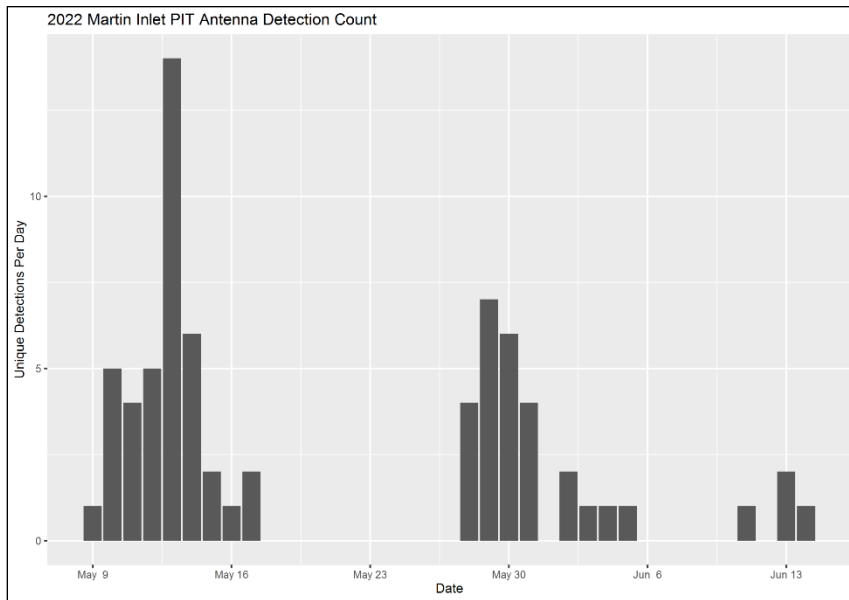
Graph of the number of unique PIT tags detected per day at the PIT antenna at the Typo Creek inlet of Martin Lake.
