Coon Lake Stormwater Retrofit Analysis

SUNRISE RIVER WATERSHED MANAGEMENT ORGANIZATION

August 2014

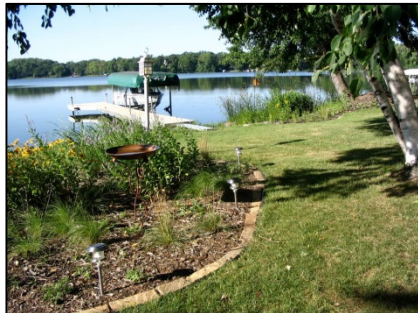
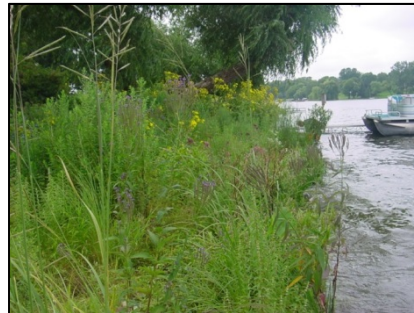
Conceptual images – Native Plant Restorations

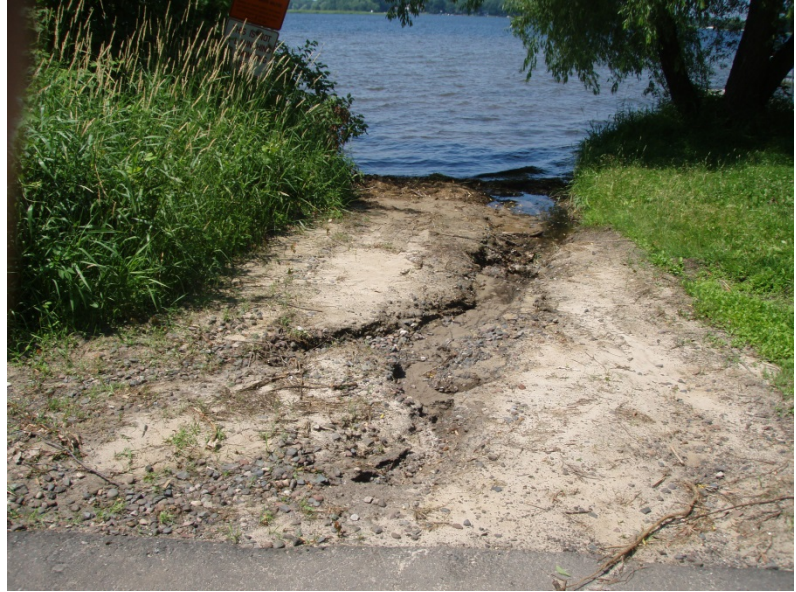
Description – The boat launch at the corner of Lincoln Dr. and Lakeshore Dr. is currently failing and eroding sediment and phosphorus into the lake due to large stormwater runoff velocities along Lincoln Dr. Erosion is also occurring between the end of the curb along Lincoln Dr. and the top of the boat launch. This erosion removed the grass turf, which has since been protected with erosion fabric. The proposed project will replace the sand and rock

currently on the launch with large aggregate and concrete planks. The aggregate rocks, between 1.5 and 3 in. in diameter, should extend from the launch to the end of the gutter line to reduce the erosive capacity of water flowing down the gutter line. Catchment-wide volume reduction and removal of TP and TSS could be increased to the levels shown in the following table. The values listed in the table represent only the pollutant reduction from stabilizing the launch and eliminating erosion at the site. No treatment is provided from this project to stormwater generated upstream of the launch.

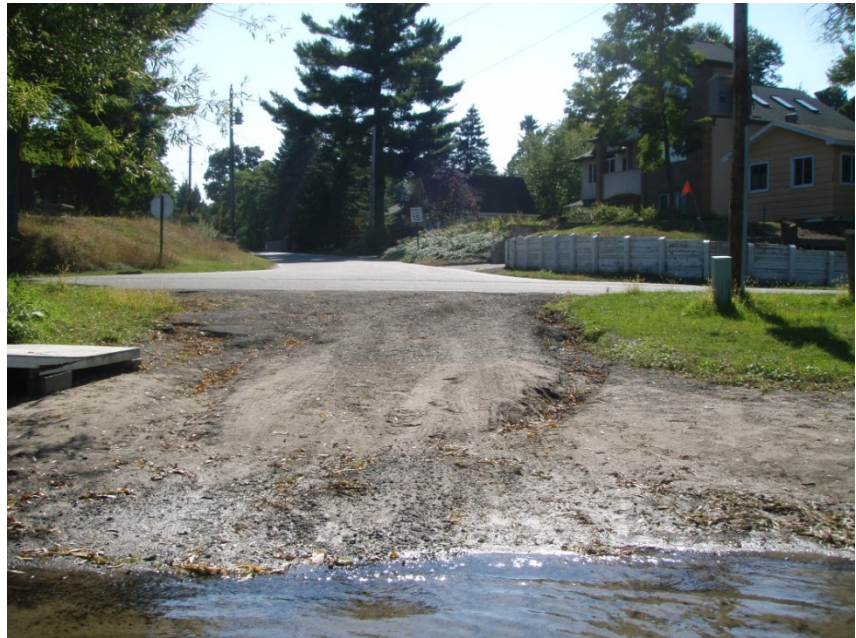
Description – The boat launch at the corner of Lakeshore Dr. and Forest Road is currently failing and eroding sediment and phosphorus into the lake due to large stormwater runoff velocities along Forest Road. The proposed project will replace the sand and rock currently on the launch with large aggregate (1.5-3 in. diameter rock) and concrete planks. A berm may also be recommended at the top of the launch to reduce flow velocity and direct water to turf where sediment settling and infiltration may occur.

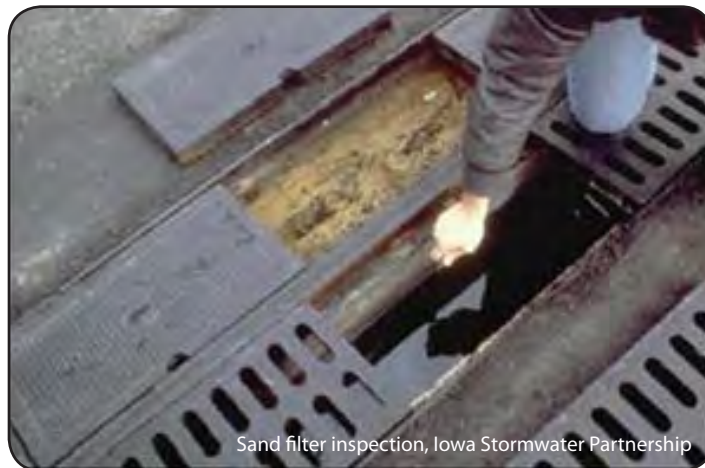
Sand filter inspection, Iowa Stormwater Partnership

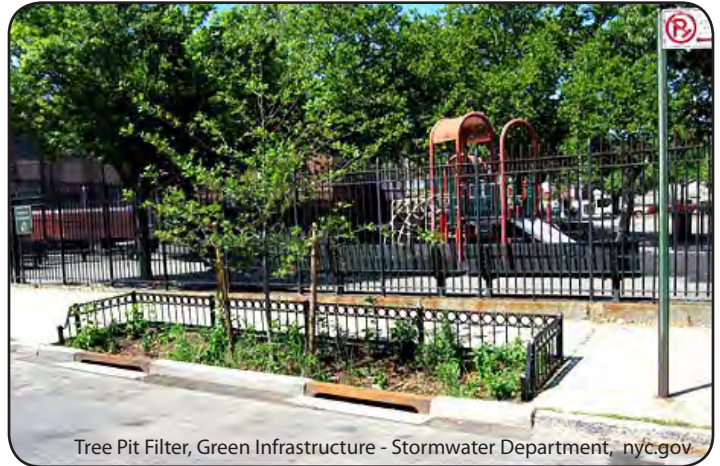
Tree Pit Filter, Green Infrastructure - Stormwater Department, nyc.gov
