PROJECT PROFILE

ROMBALSKI RESIDENCE

Rain Garden

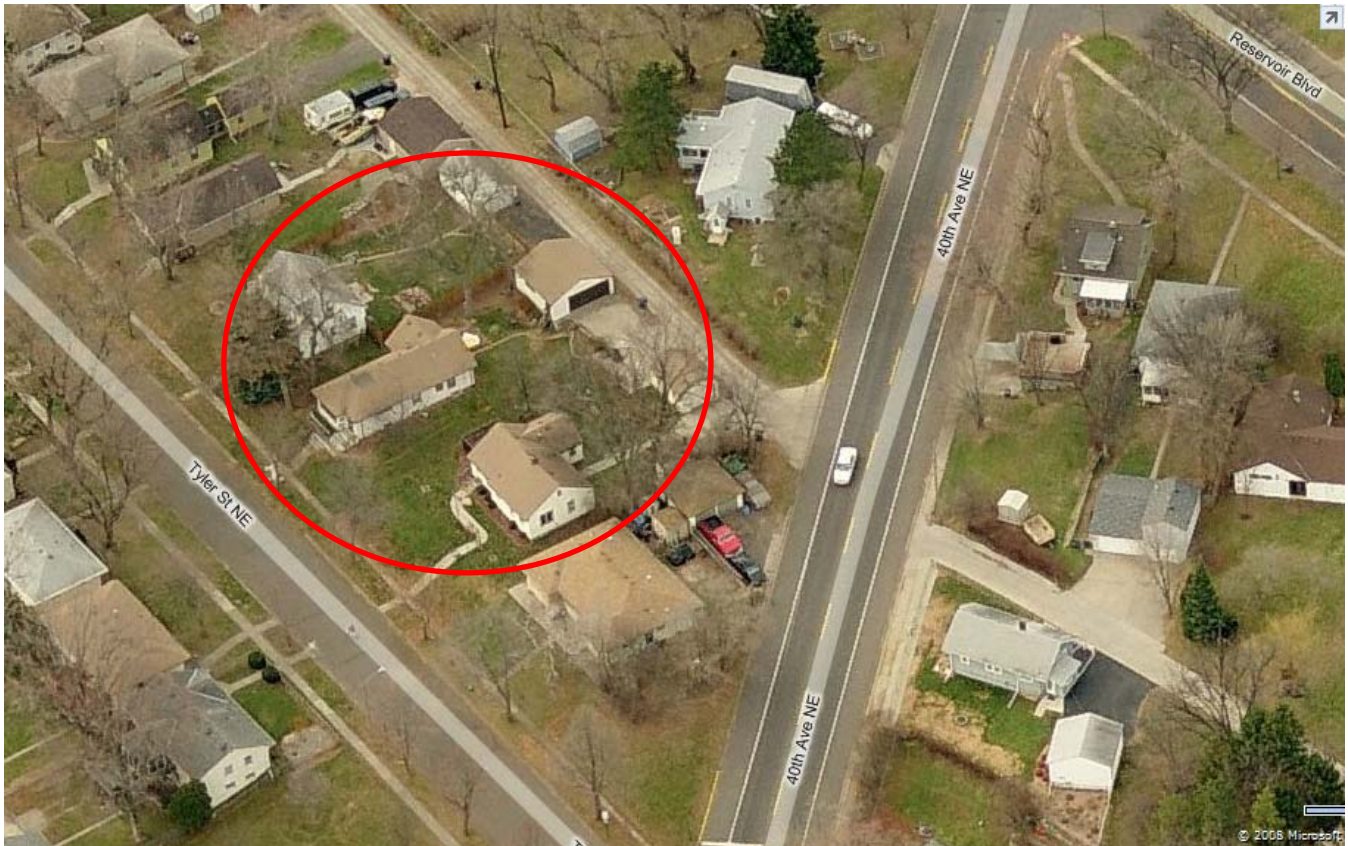
Pre-Rain Garden Conditions

Rain falling on the roof of the Rombalski home was directed by downspouts, unfiltered, onto the property, eventually making its way to the Mississippi River through the storm sewer system. This excess runoff from impervious surfaces can cause:

- An increased risk of flooding and bank erosion
- An influx of sediments, nutrients and pollutants
- An increase in water temperatures.

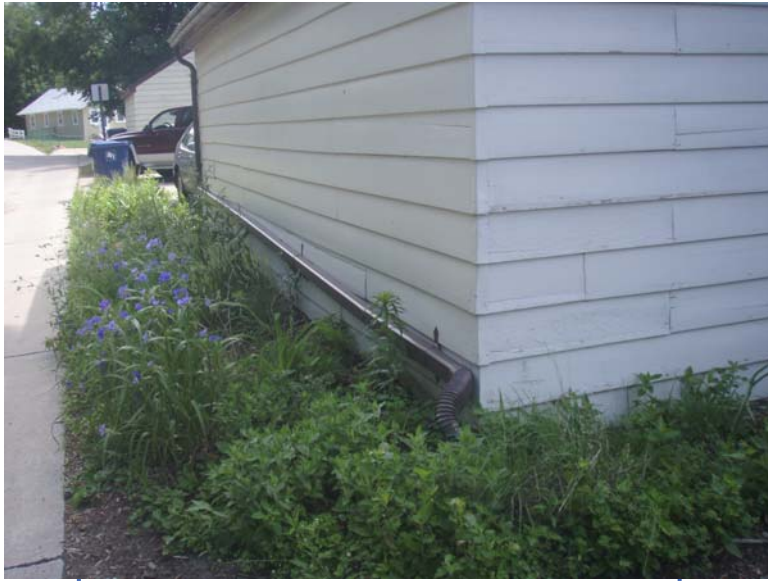
After Rain Garden Installation

Gutters were added to the garage to direct storm water into the new rain garden area.

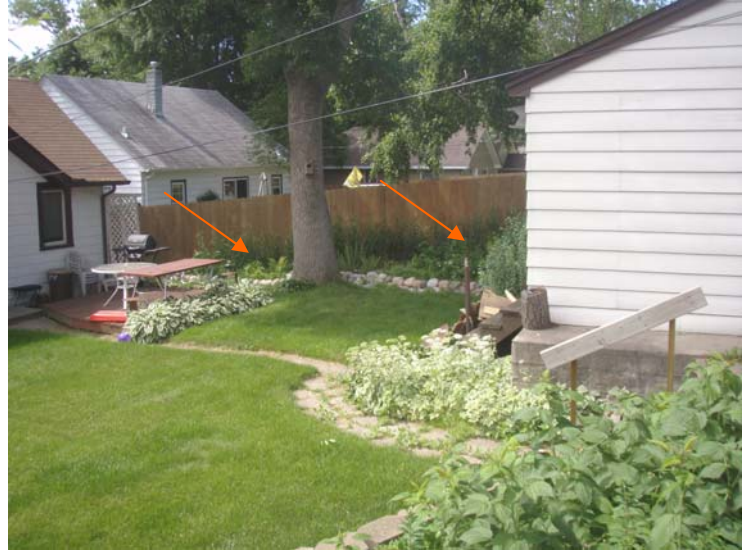
June 2008

These rain gardens are designed to treat runoff from both the garage and house roofs.

- Rain falling on the roofs is directed by downspouts and drain tile to the rain gardens where it is treated to remove nutrients and pollutants.
- Up to 149 ft³ of water can be treated by the rain garden.
- In all, the rain garden detains, or slows down, up to 125 ft³ of rain water allowing the removal of sediment and solid particulate matter.
- By slowing the flow of water into the river, the rain garden helps to reduce flooding and erosion.
