THOMPSON RESIDENCE

Rain Garden

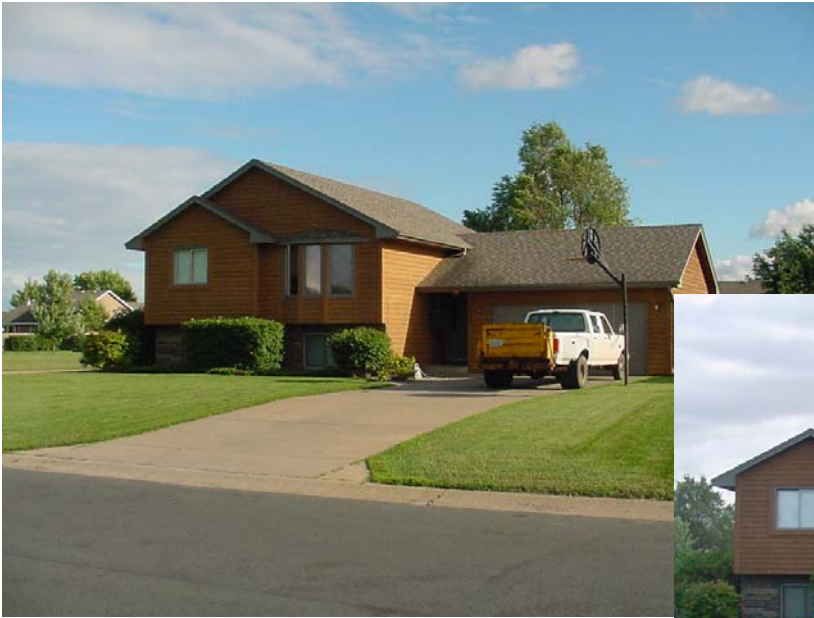
July 2003

Before Rain Garden Installation

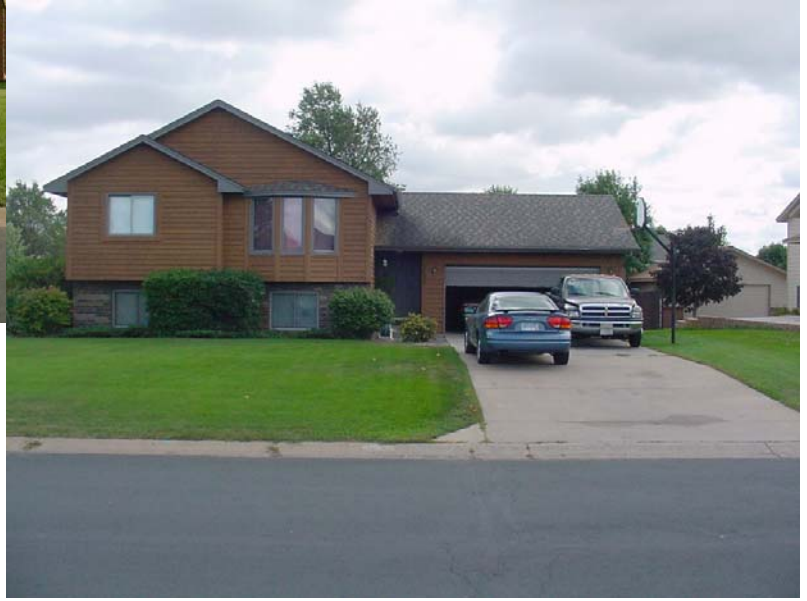
Rain falling on the roof flows into the street where it entered the storm sewer system.

Rain falling on the roof of the Thompson residence flowed into the street, eventually making its way to the Mississippi River via the storm sewer system. This excess runoff from impervious surfaces can cause:

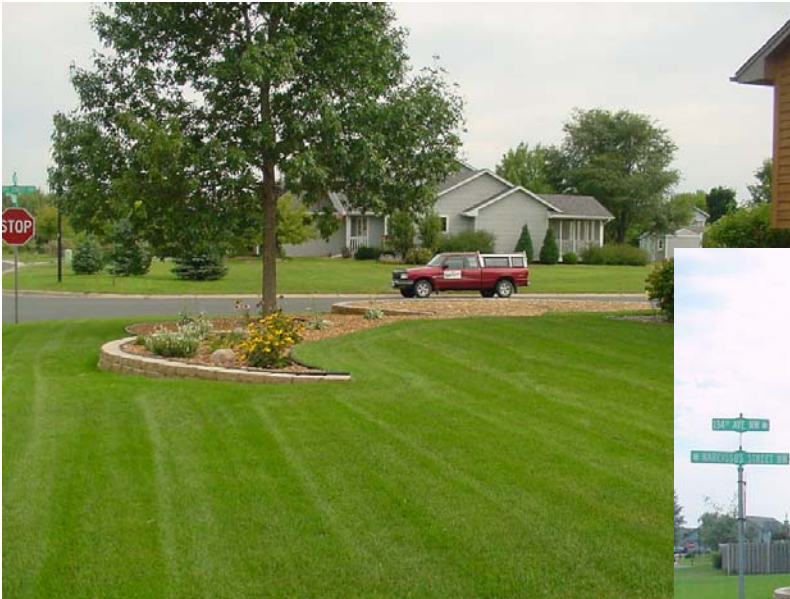
September 2004

After Rain Garden Installation

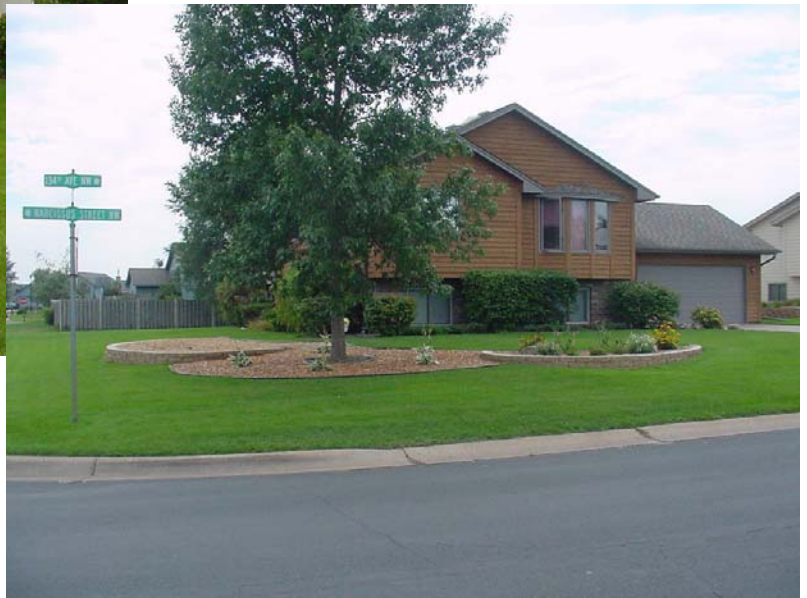
Rainwater is directed to the rain garden where it is treated, reducing nutrient and pollution input to the Mississippi River.
