Trott Brook Water Quality Restoration Assessment

May 15, 2025

Lower Rum River Watershed Management Organization
Watershed Based Implementation Funding (WBIF) from the MN Board of Water and Soil Resources
WBIF funds are from the Clean Water, Land and Legacy Amendment

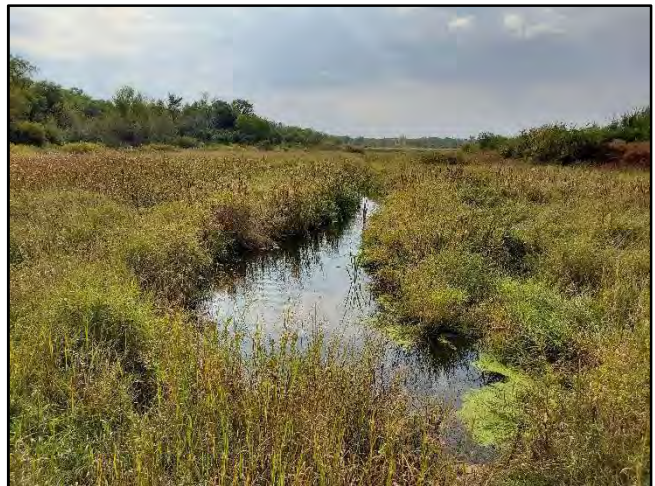
Figure 1 Photos of Trott Brook.

Trott Brook at Ermine St

Trott Brook at Armstrong Blvd

Trott Brook at Variolite St

Trott Brook at Highway 47 (St. Francis Blvd)

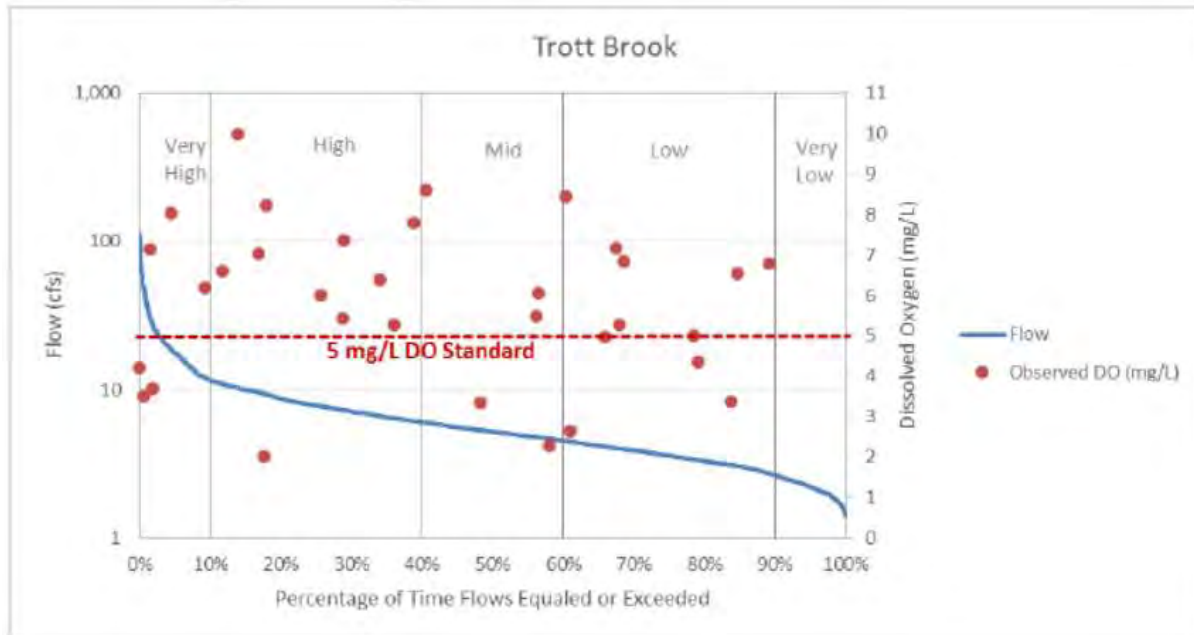
Figure 6 - Trott Brook at Nowthen Blvd dissolved oxygen flow duration curve. The red dashed line indicates the 5 mg/L dissolved oxygen standard. (MPCA, 2017_a)

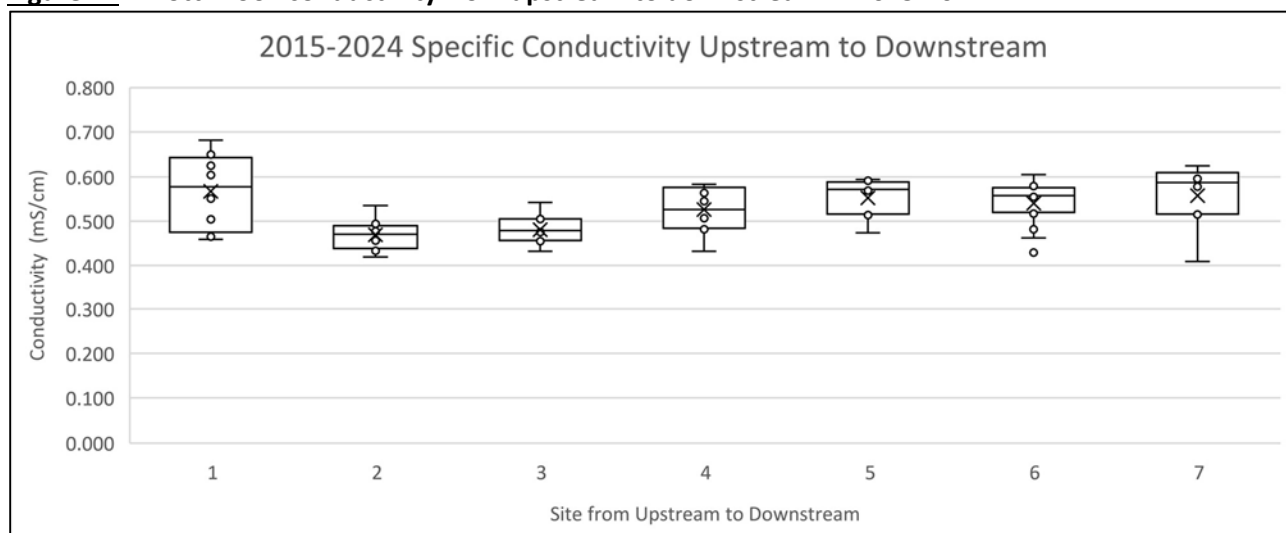
Figure 22 - Trott Brook conductivity from upstream to downstream in 2015-2024.

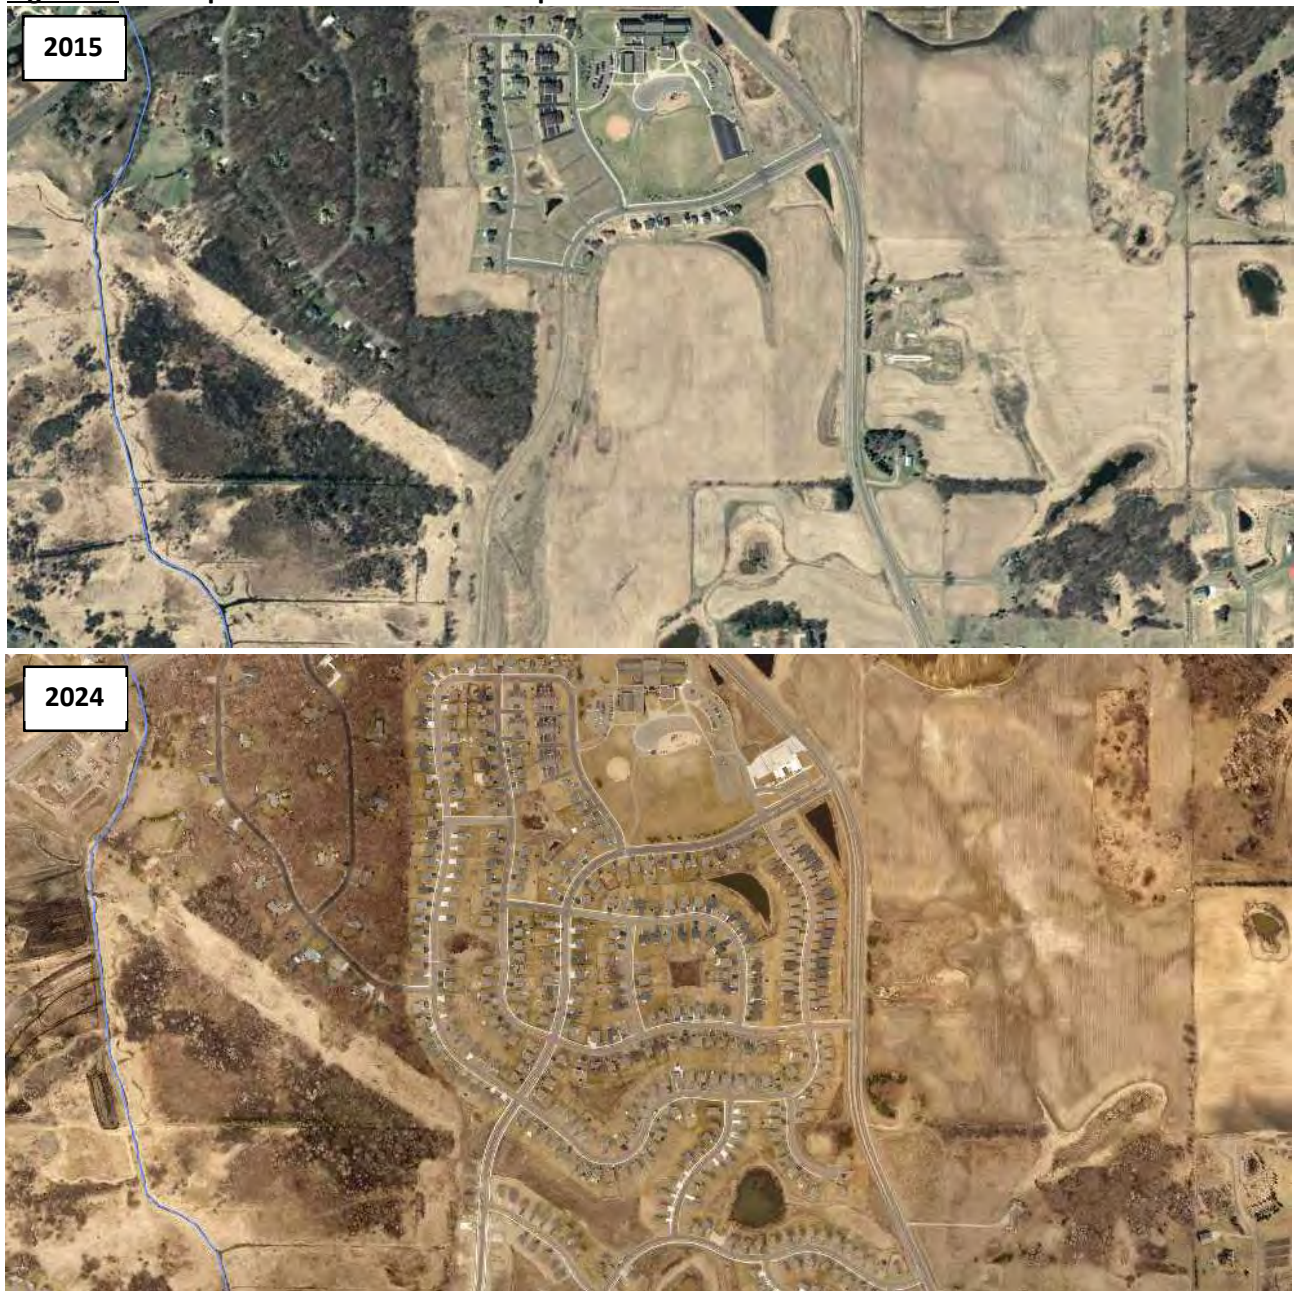
Figure 26 - Example of conversion to developed land uses in the Trott Brook subwatershed.

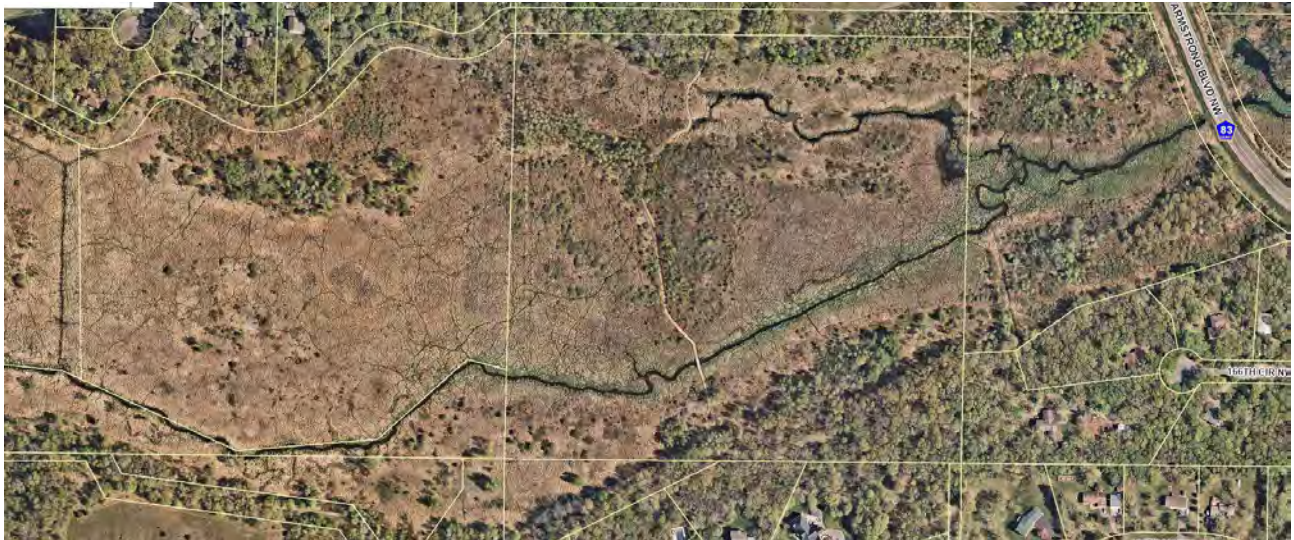
Figure 34 - Example of the prevalence of peatland wetlands and lateral ditches along Trott Brook.

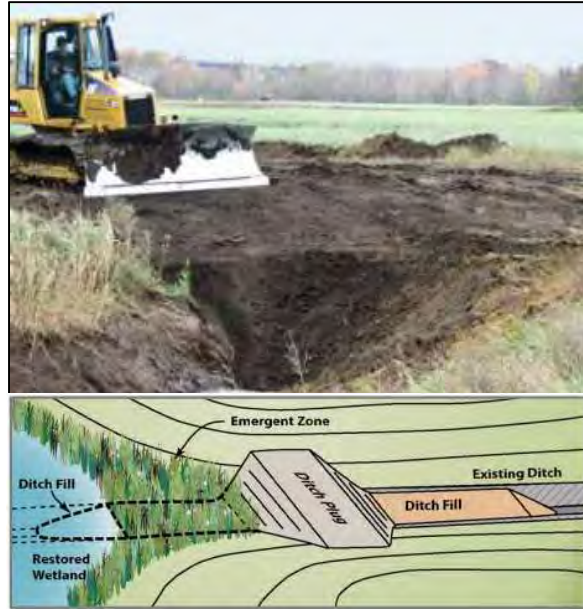
Figure 35 - Earthen lateral ditch plug concept and installation. Source: MN Wetland Restoration Guide, BWSR.
