Stream Water Quality

Typo Creek

2024 Stream Water Quality Summary

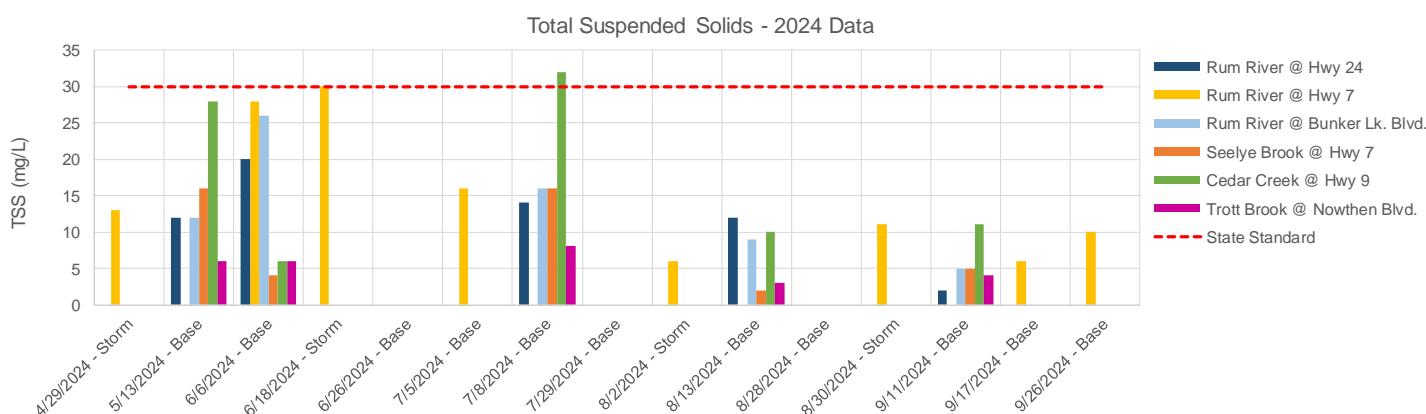
Rum River @ Hwy 7		
Parameter	2024 Average	Historical Average (2004-2023)
pH	7.76	7.84
Sp. Cond (mS/cm)	0.309	0.252
Turbidity (NTU)	6.4	9.4
DO (mg/L)	7.64	8.91
TP (ug/L)	117.3	96.1
Chloride (mg.L)	13.9	13.0
TSS (mg/L)	15.0	8.2

- **Dissolved pollutants**, as measured by **specific conductivity** and **chlorides**, are at low and healthy levels. However, both specific conductivity and chloride levels were higher in 2024 than previous monitoring years. Management discussion: Chlorides are a regional concern and proactive measures to ensure it does not become elevated in the Rum River watershed is recommended. Periodic monitoring every 2-5 years is recommended.

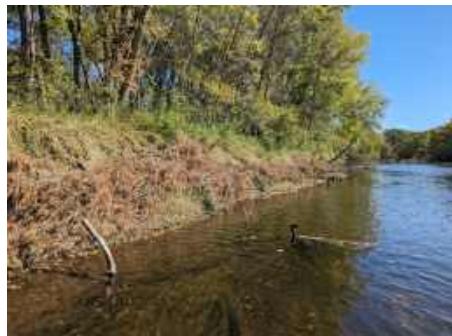
Rum Central Regional Park - Cedar Tree Revetments

In 2023, several projects led by the Anoka Conservation District were completed that help reduce sediment and phosphorous loading into the Rum River. ACD and partners currently have a well-funded riverbank stabilizations program because it offers multiple benefits to water quality, habitat, and protecting property.

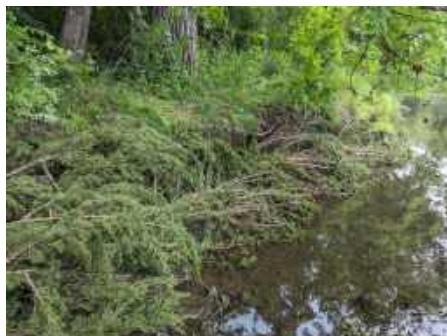
Cedar Creek Conservation Area - Cedar Tree Revetments

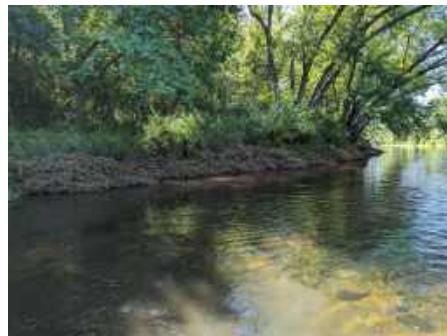
Anoka Nature Preserve - Cedar Tree Revetments

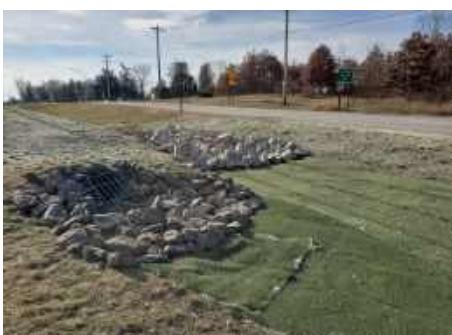
St. Francis High School - Swale Stabilization

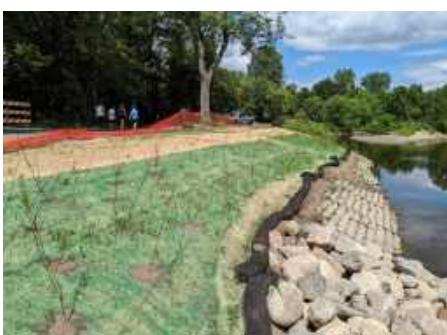
Rum Central Regional Park - Boat Launch Shoreline Repair

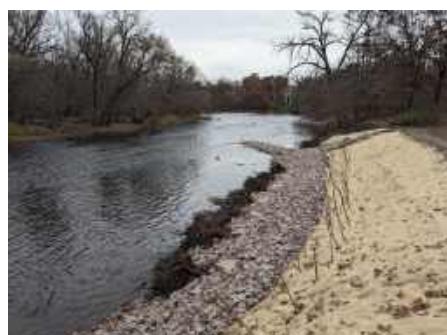
Dellwood River Park - Shoreline Repair and Stabilization
