Mississippi Riverbank Erosion Inventory: Coon Rapids to Fridley

November 2021

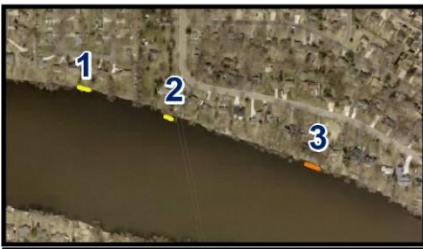
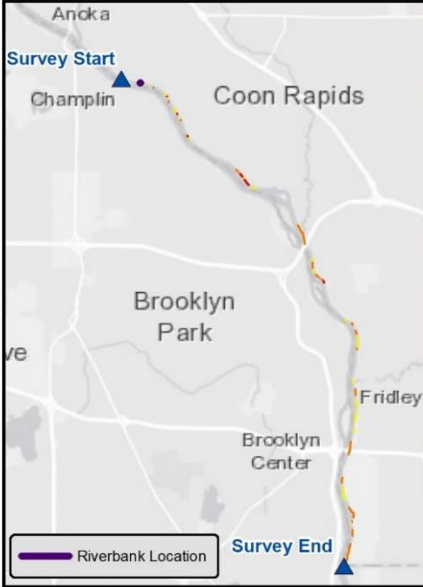
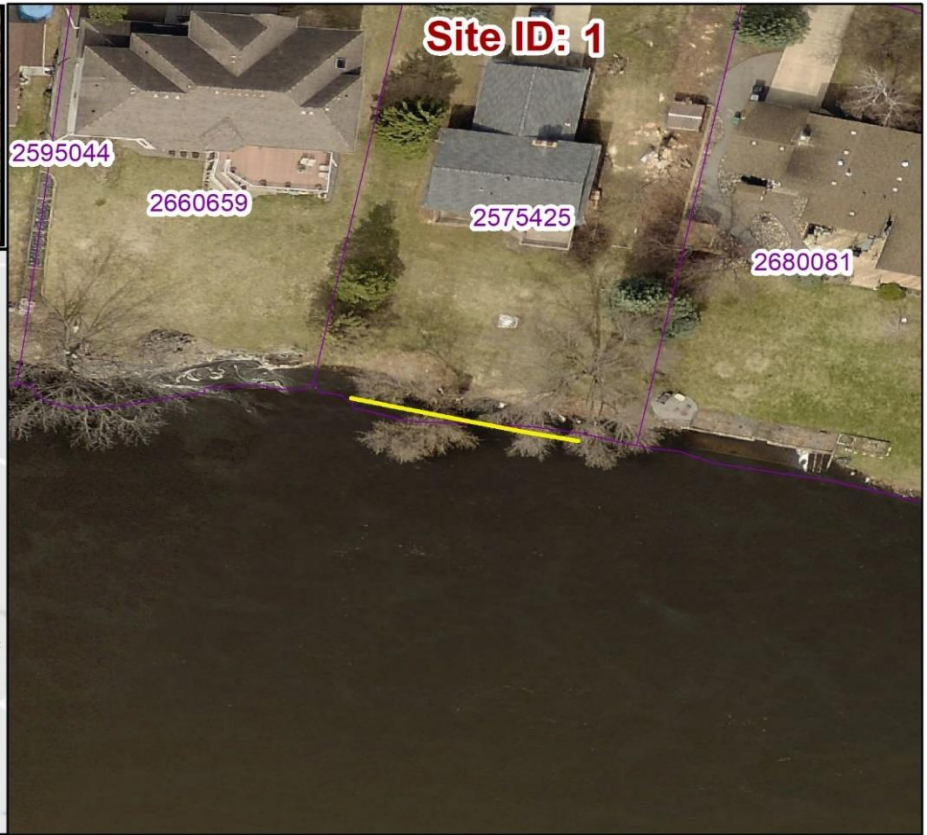
Length (ft)	63
Erosion Height (ft)	6
Bluff Height (ft)	6
Recession Rate (ft/yr)	0.1
Soil Loss (tons/yr)	5
Ownership	Private
Number of Owners	1
Stabilization Approach	Bio-eng.
Cost Estimate	21,632

Description: Leaning trees and vegetation overhang an eroding toe. There is a thick vine growing that appears to be negatively impacting the bank.

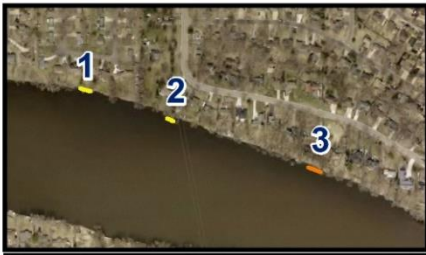
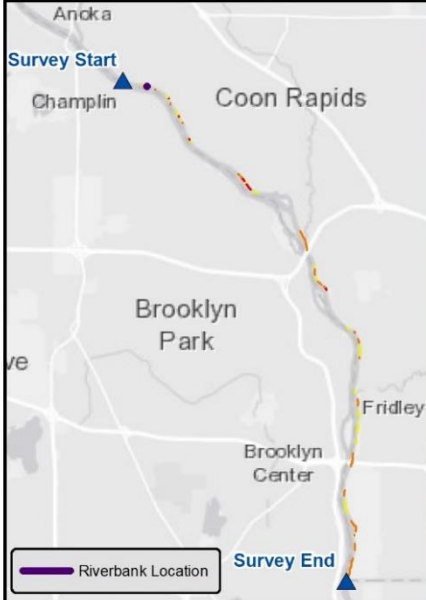
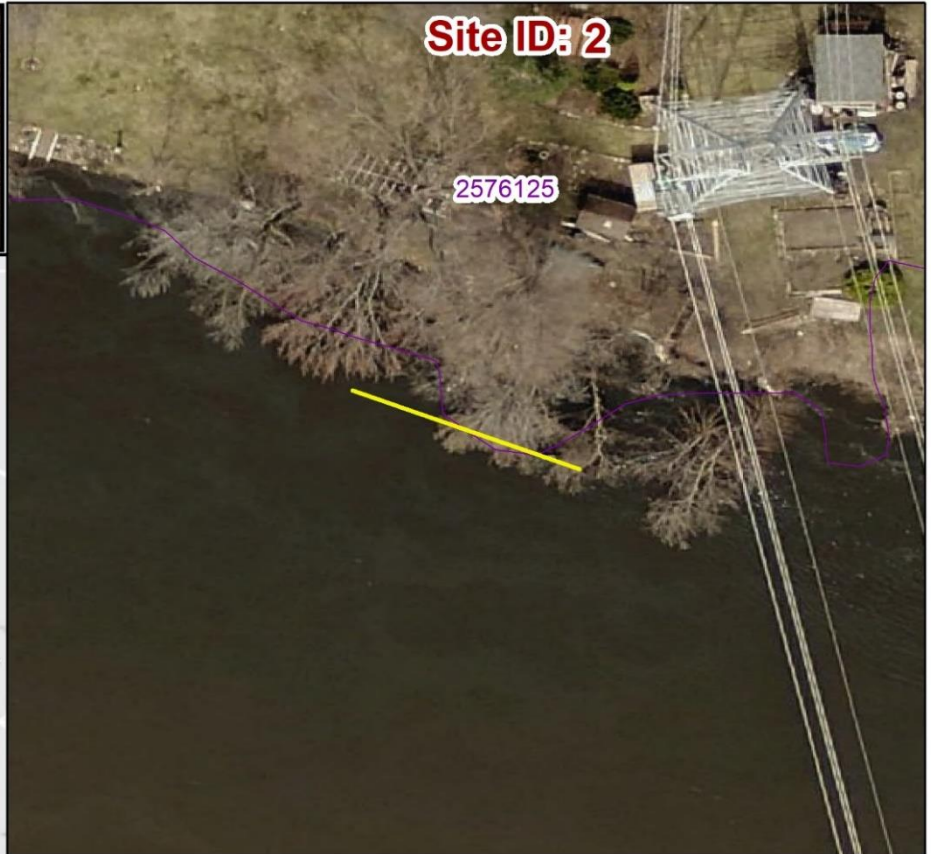
Length (ft)	38
Erosion Height (ft)	8
Bluff Height (ft)	8
Recession Rate (ft/yr)	0.1
Soil Loss (tons/yr)	4
Ownership	Private
Number of Owners	1
Stabilization Approach	Bio-eng.
Cost Estimate	19,579

Description: Some slumping, exposed soils, and overhanging trees.

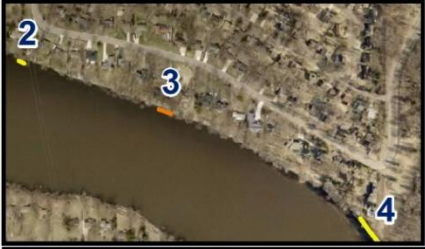
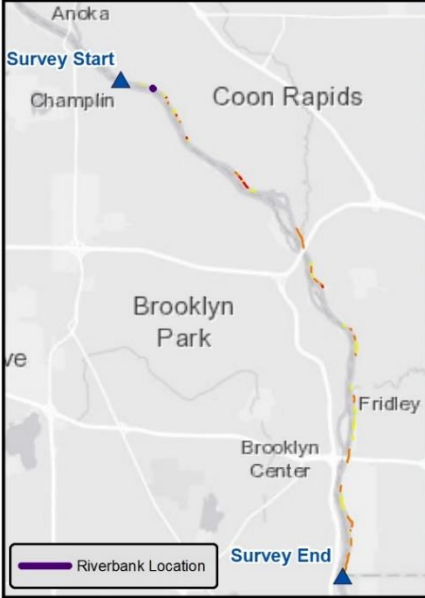
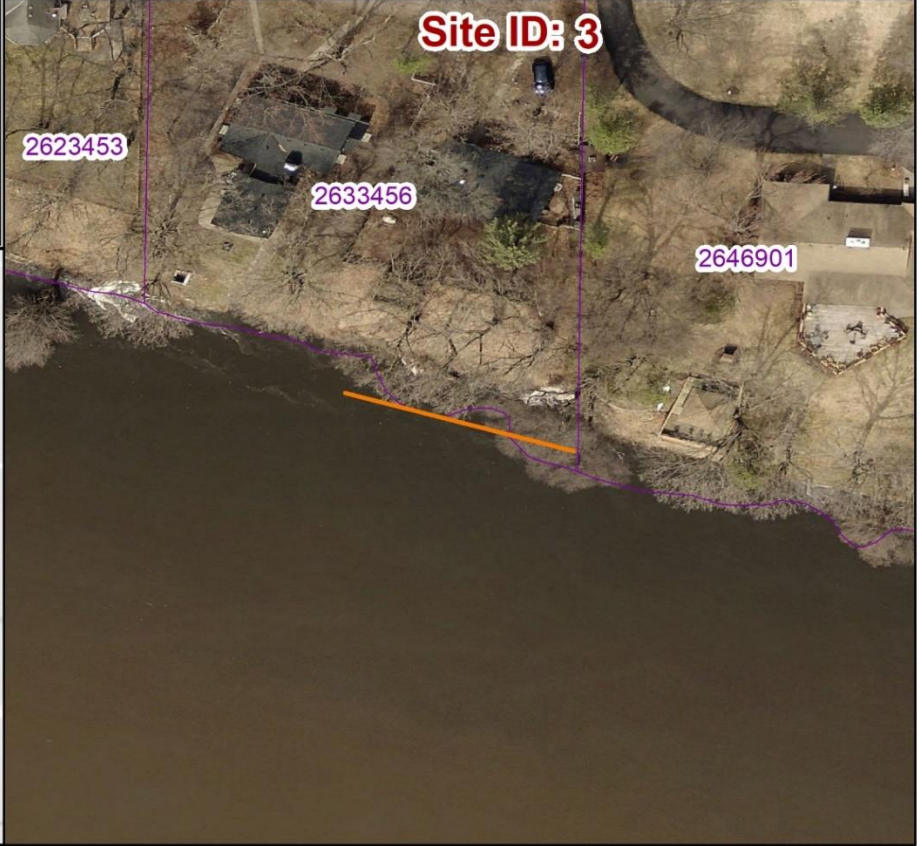
Length (ft)	77
Erosion Height (ft)	12
Bluff Height (ft)	12
Recession Rate (ft/yr)	0.3
Soil Loss (tons/yr)	29
Ownership	Private
Number of Owners	1
Stabilization Approach	Bio-eng.
Cost Estimate	36,757

Description: Erosion has exposed root systems and resulted in two trees collapsing into the river; this progression can be seen in the 2012 and 2016 photos.

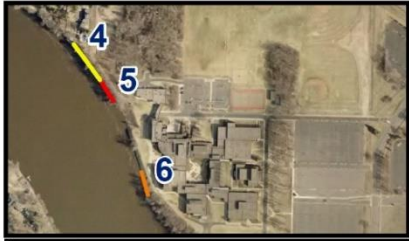
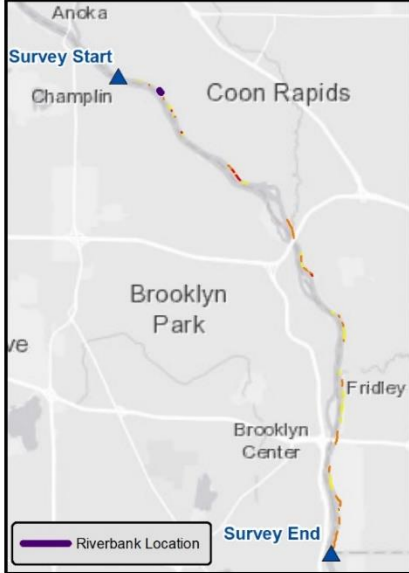
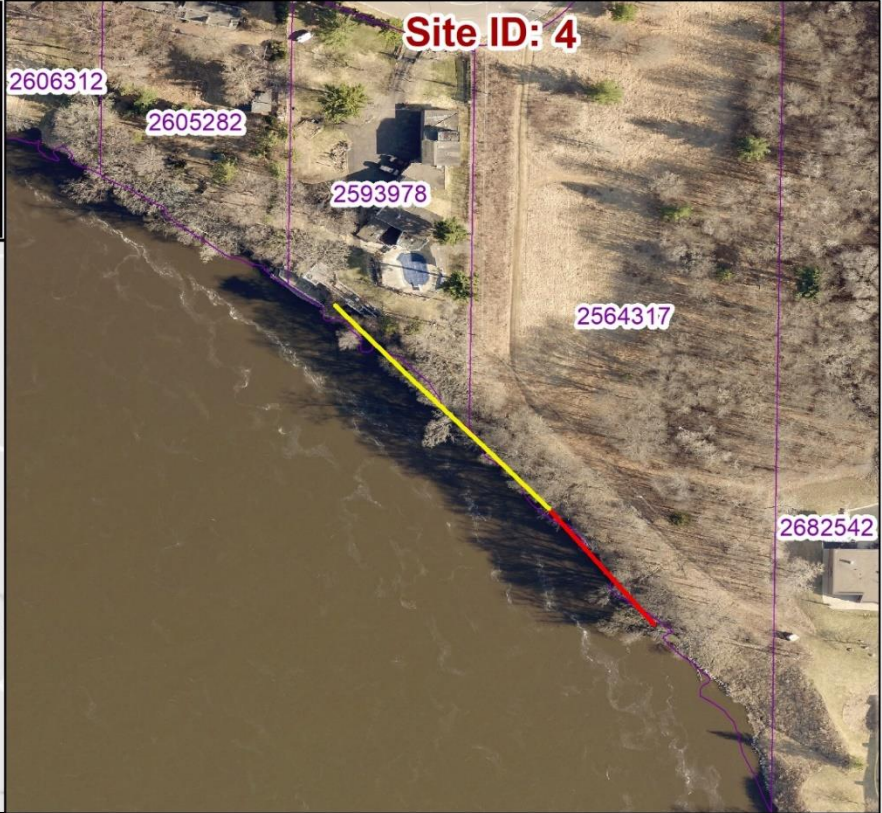
Length (ft)	283
Erosion Height (ft)	4
Bluff Height (ft)	20
Recession Rate (ft/yr)	0.1
Soil Loss (tons/yr)	15
Ownership	Private
Number of Owners	2
Stabilization Approach	Bio-eng.
Cost Estimate	172,218

Description: Very steep bank upstream from more severe erosion; still vegetated but with intermittent exposed root systems and minor slumps.

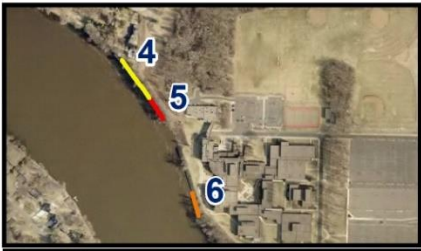
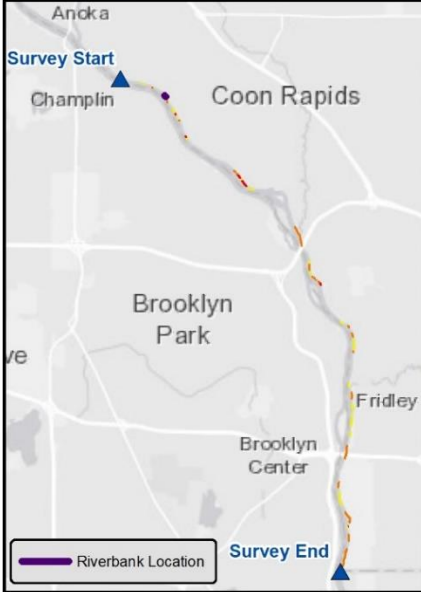
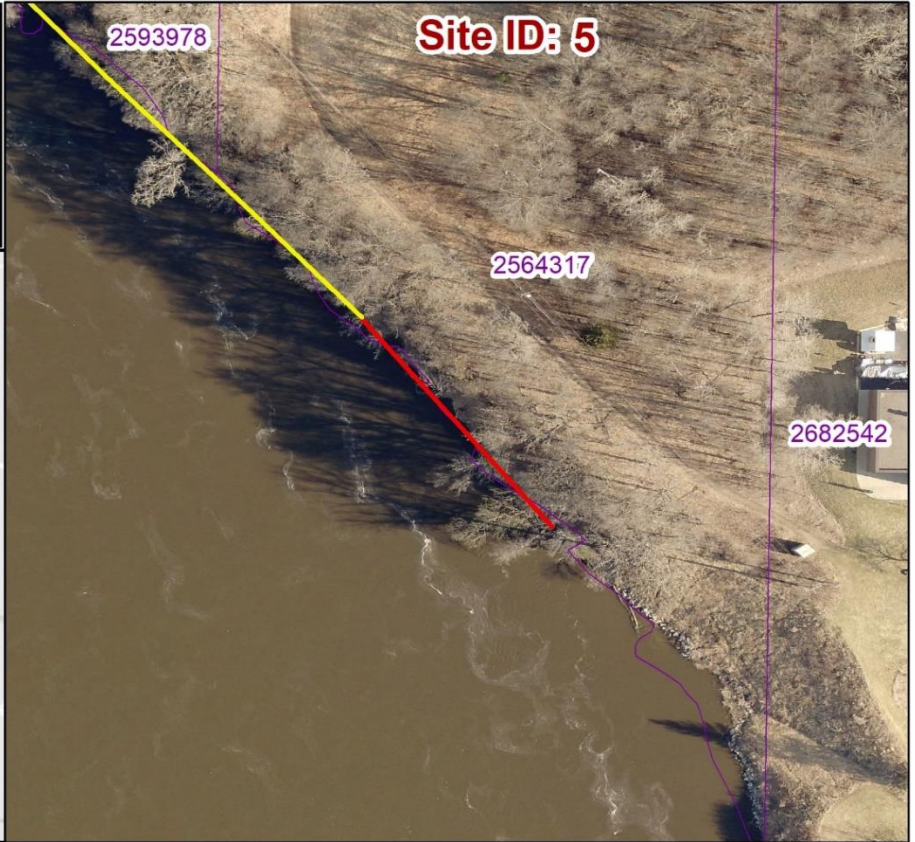
Length (ft)	154
Erosion Height (ft)	24
Bluff Height (ft)	24
Recession Rate (ft/yr)	0.5
Soil Loss (tons/yr)	157
Ownership	Private
Number of Owners	1
Stabilization Approach	Armor
Cost Estimate	171,627

Description: Very large bare cliff on Anoka Ramsey Community College Shoreline.

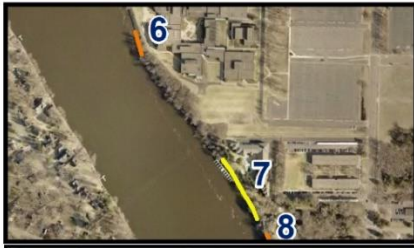
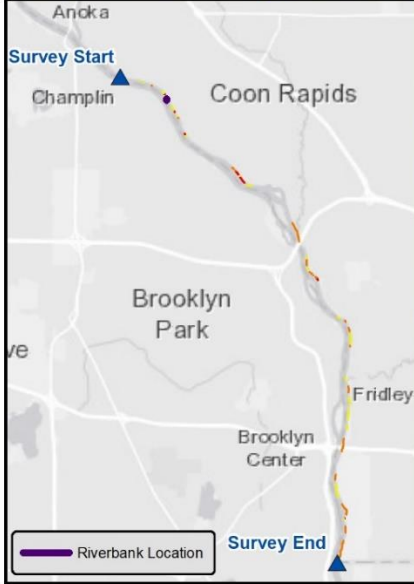
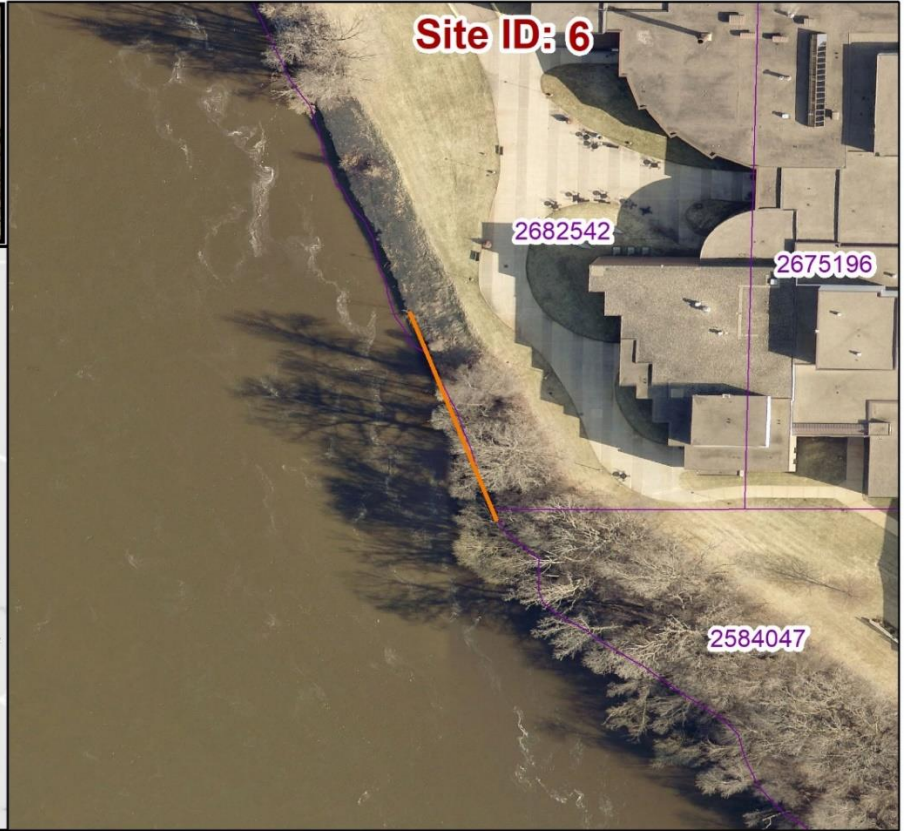
Length (ft)	148
Erosion Height (ft)	4
Bluff Height (ft)	18
Recession Rate (ft/yr)	0.3
Soil Loss (tons/yr)	24
Ownership	Private
Number of Owners	1
Stabilization Approach	Bio-eng.
Cost Estimate	85,435

Description: Eroding toe and some exposed roots/ leaning trees throughout.

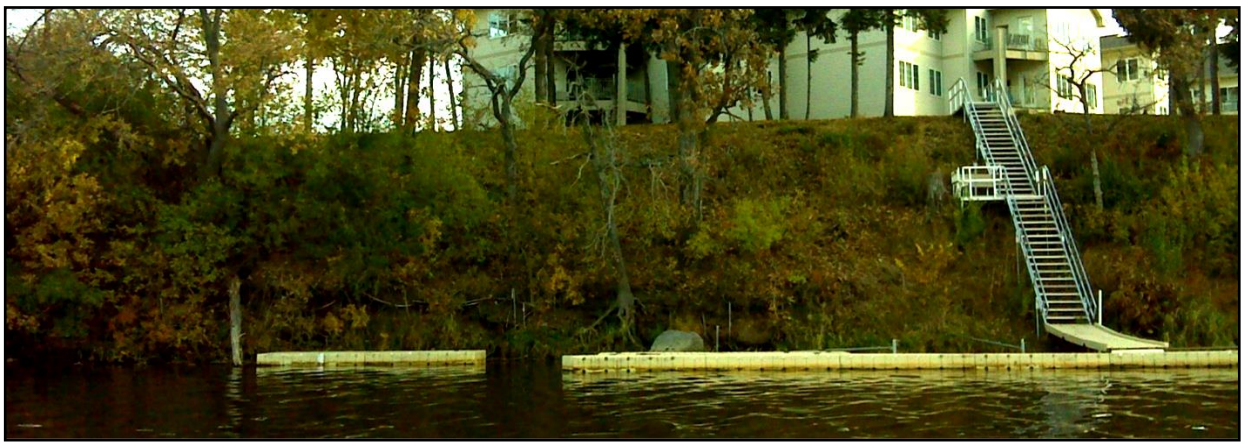
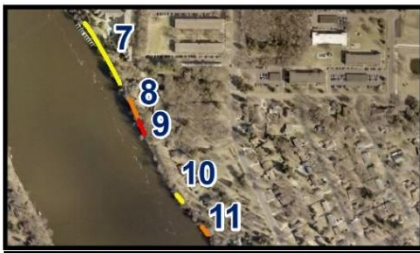
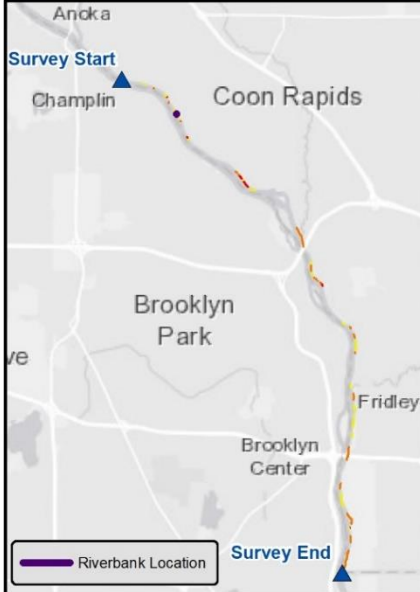
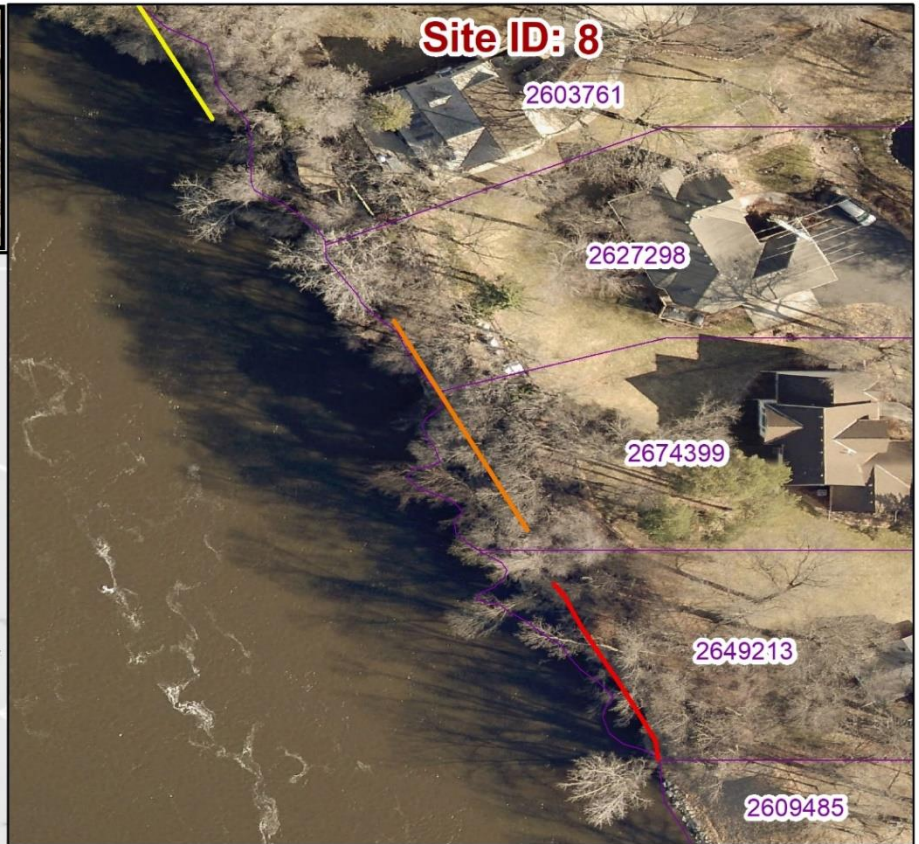
Description: Steep slope with some exposed root systems and soils on lowest 6 feet.

Length (ft)	109
Erosion Height (ft)	20
Bluff Height (ft)	20
Recession Rate (ft/yr)	0.3
Soil Loss (tons/yr)	66
Ownership	Private
Number of Owners	2
Stabilization Approach	Armor
Cost Estimate	116,123

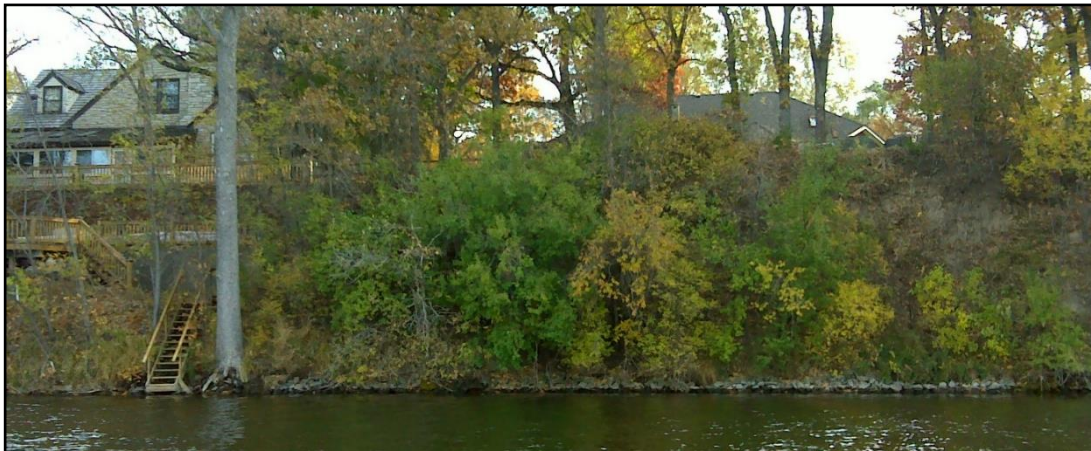
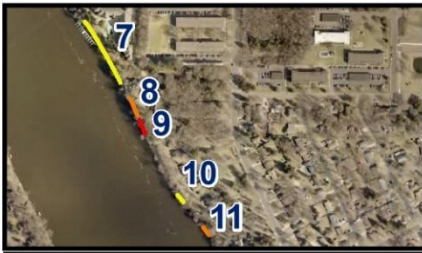
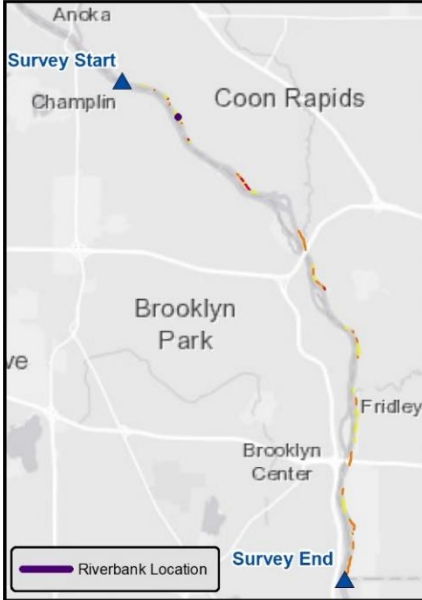
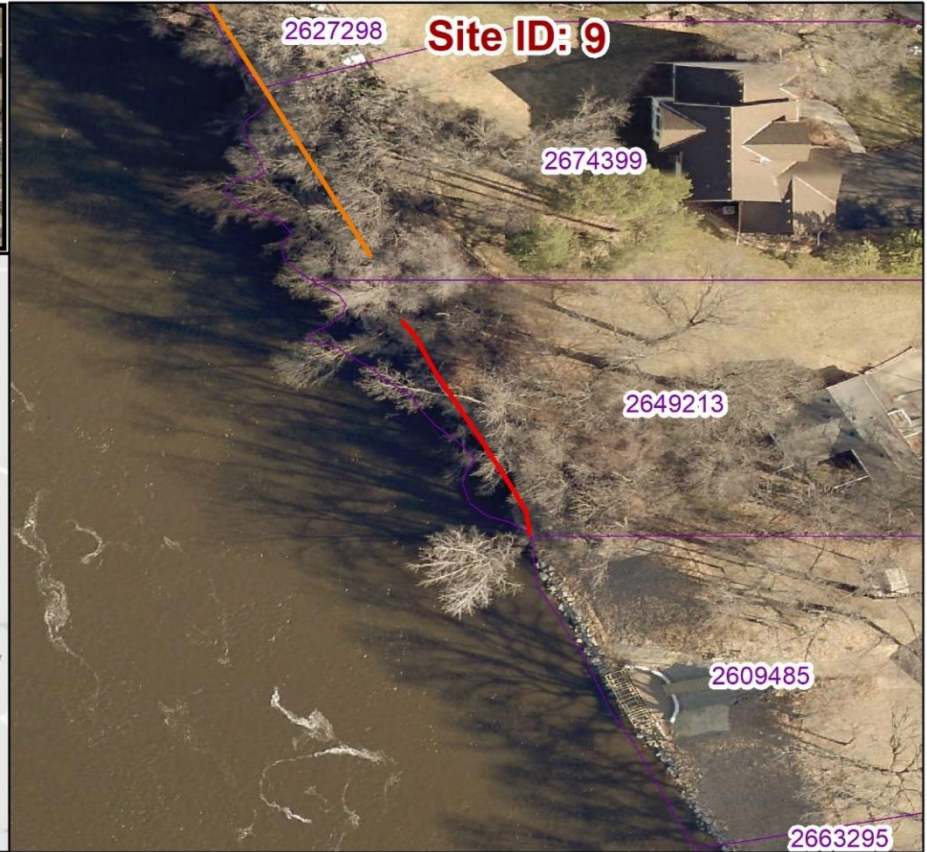
Description: Steep slope with erosion similar to upstream stretch but more severe.

Length (ft)	91
Erosion Height (ft)	26
Bluff Height (ft)	26
Recession Rate (ft/yr)	0.5
Soil Loss (tons/yr)	101
Ownership	Private
Number of Owners	1
Stabilization Approach	Armor
Cost Estimate	118,400

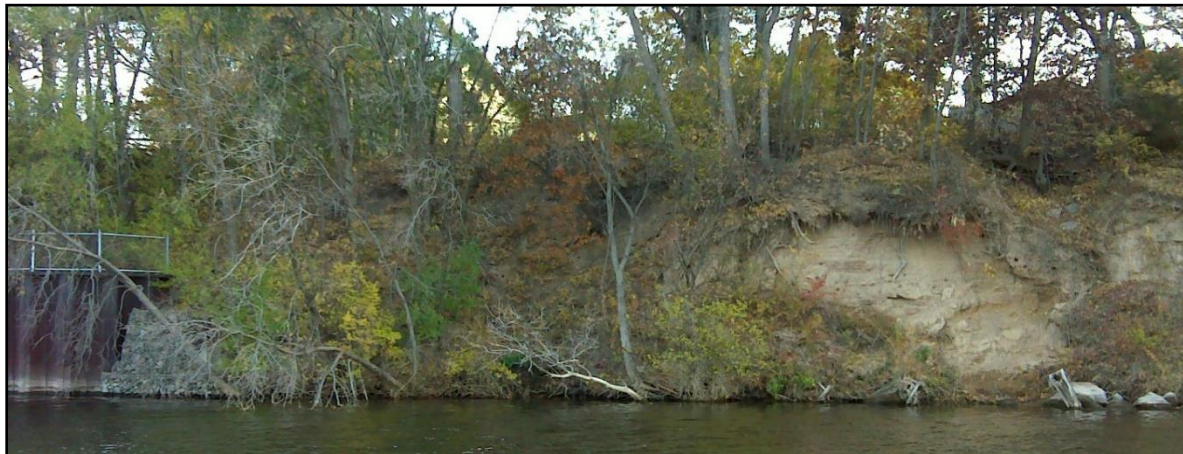
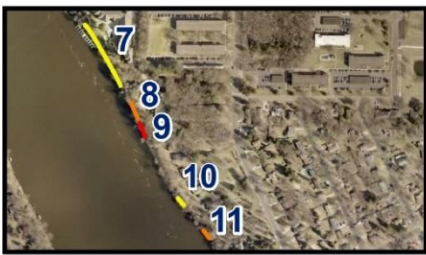
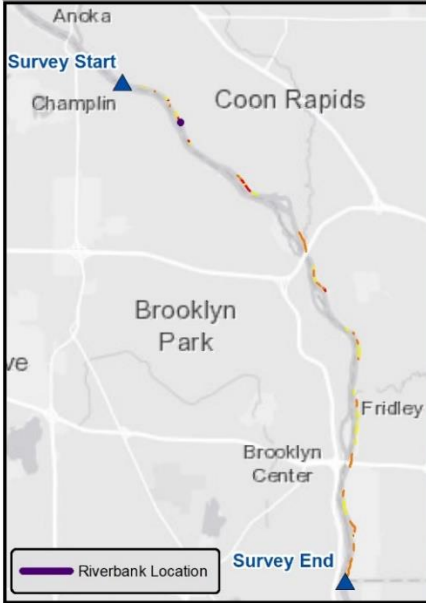
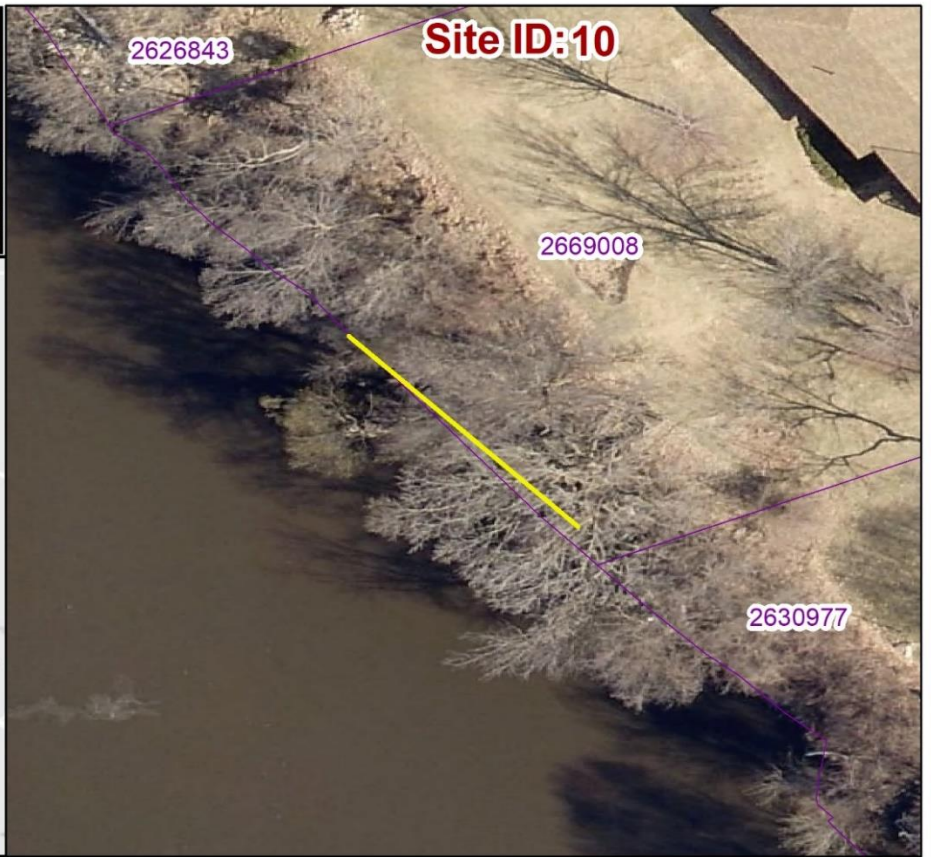
Description: Very steep eroding cliff north of recent "Stem" project.

Length (ft)	57
Erosion Height (ft)	4
Bluff Height (ft)	22
Recession Rate (ft/yr)	0.1
Soil Loss (tons/yr)	10
Ownership	Private
Number of Owners	1
Stabilization Approach	Bio-eng.
Cost Estimate	46,404

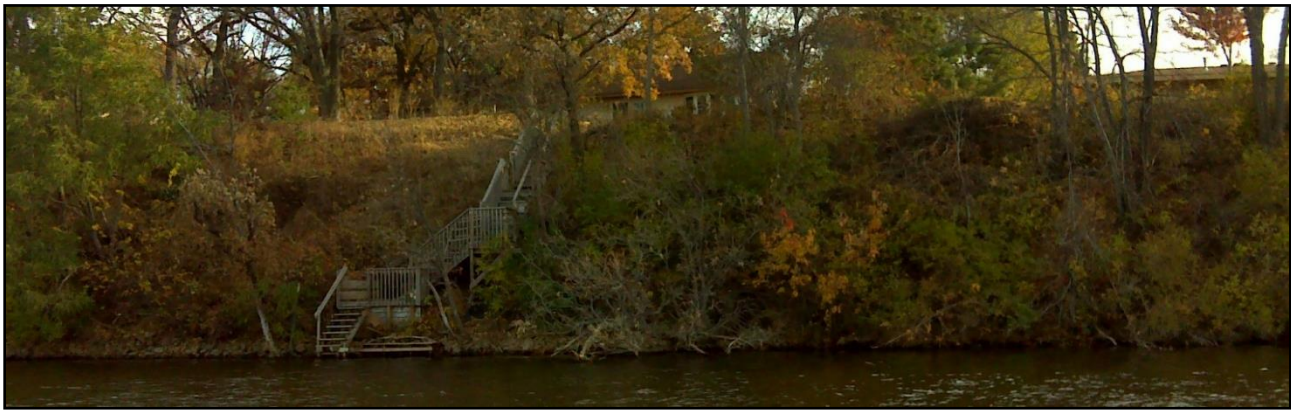
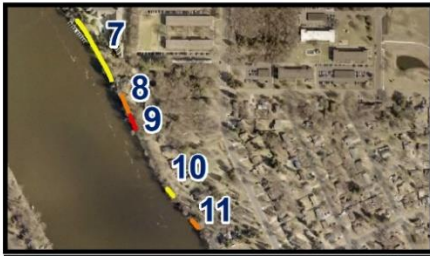
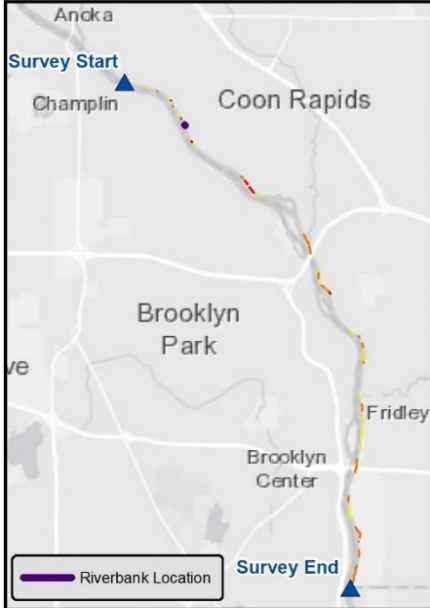
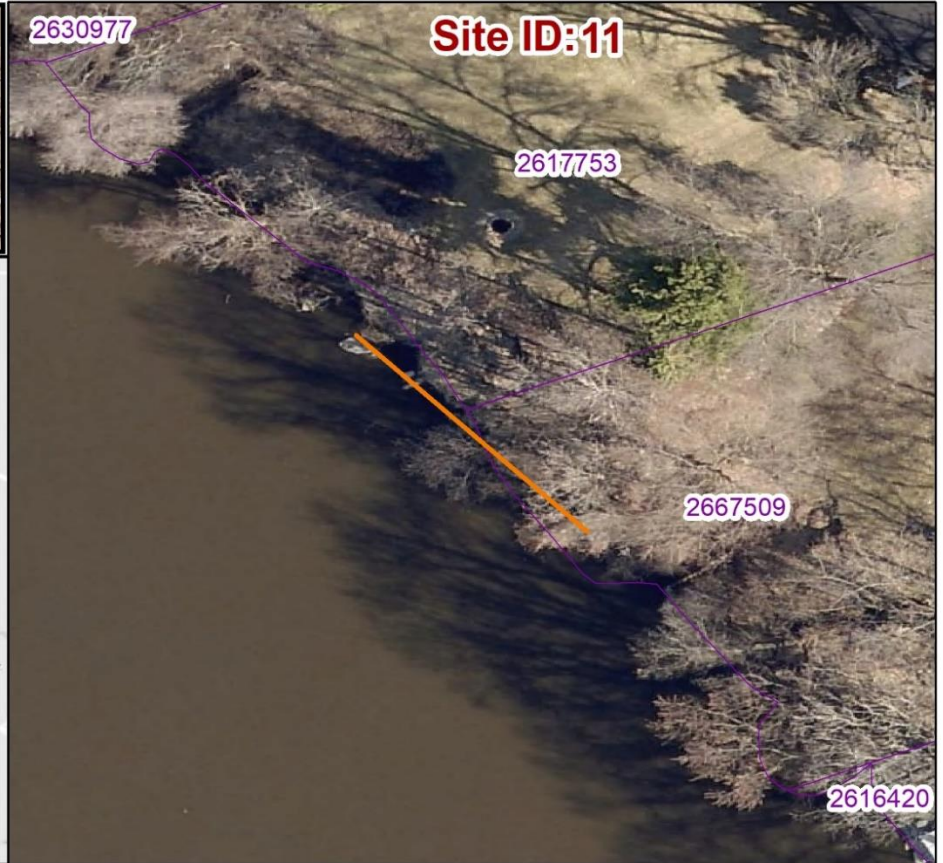
Description: Bank is difficult to see due to vegetation, but there are some leaning trees and an eroded toe.

Length (ft)	58
Erosion Height (ft)	18
Bluff Height (ft)	18
Recession Rate (ft/yr)	0.3
Soil Loss (tons/yr)	30
Ownership	Private
Number of Owners	2
Stabilization Approach	Armor
Cost Estimate	70,780

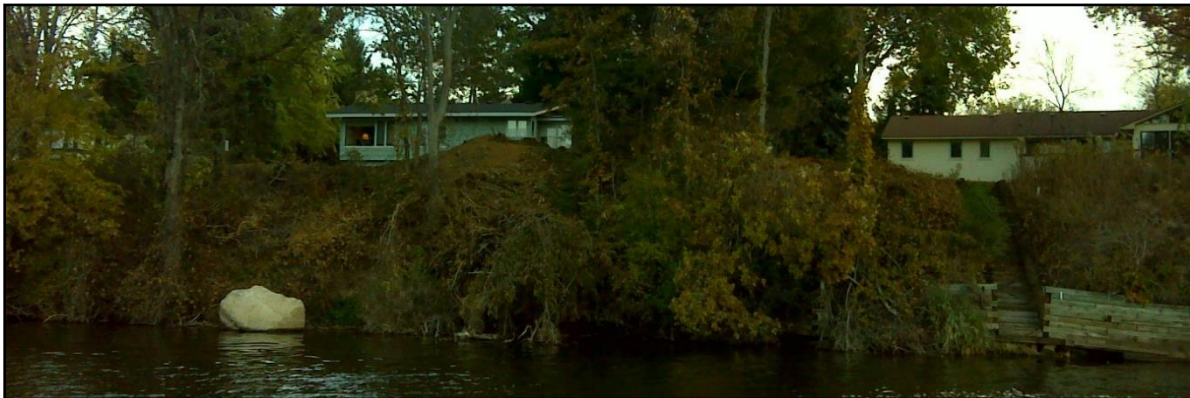
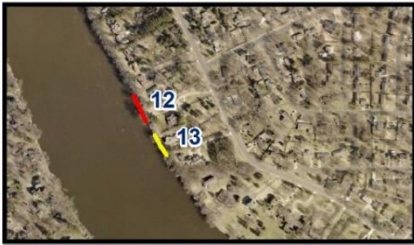
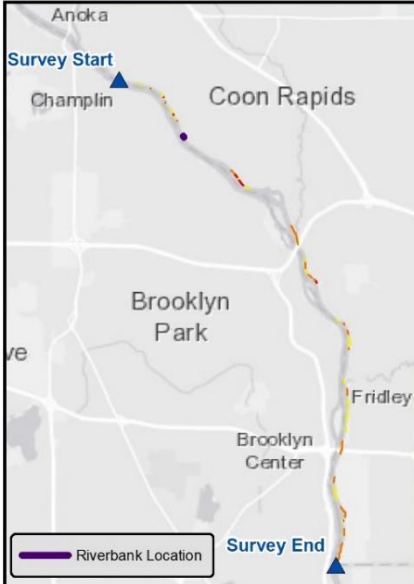
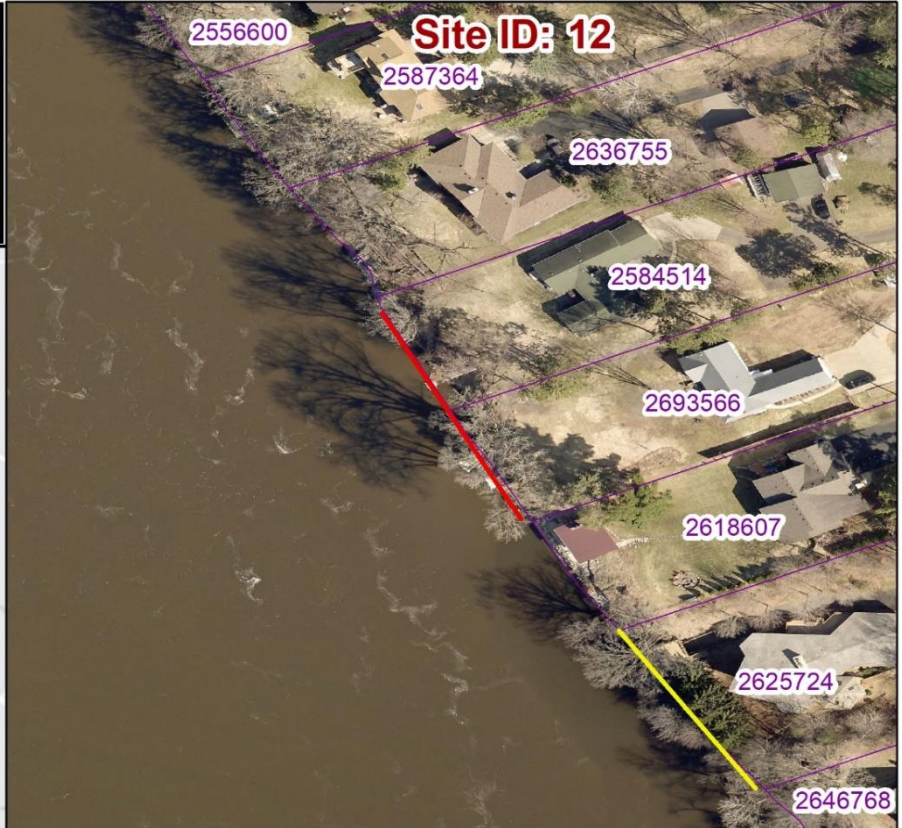
Description: Short stretch containing a severe gully that leads to slumping and a cliff near the bottom. May be influenced by overland flow, or large boulder creating concentrated flow.

Length (ft)	183
Erosion Height (ft)	24
Bluff Height (ft)	24
Recession Rate (ft/yr)	0.5
Soil Loss (tons/yr)	191
Ownership	Private
Number of Owners	2
Stabilization Approach	Armor
Cost Estimate	204,815

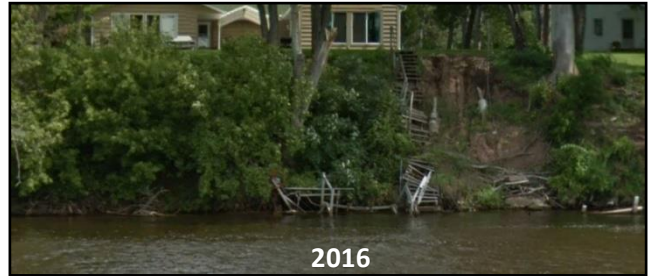
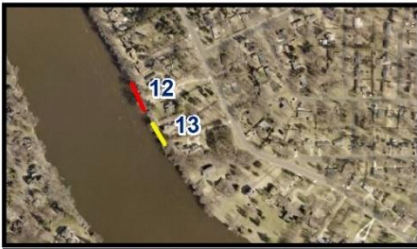
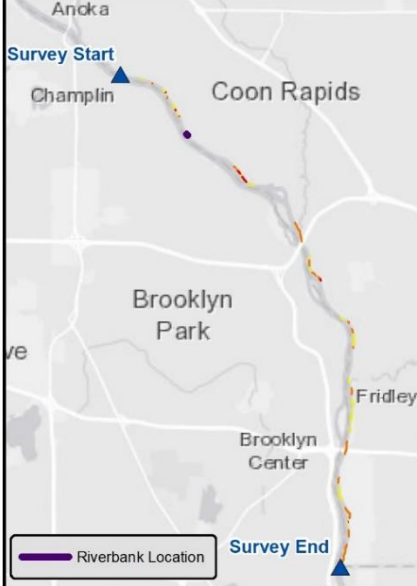
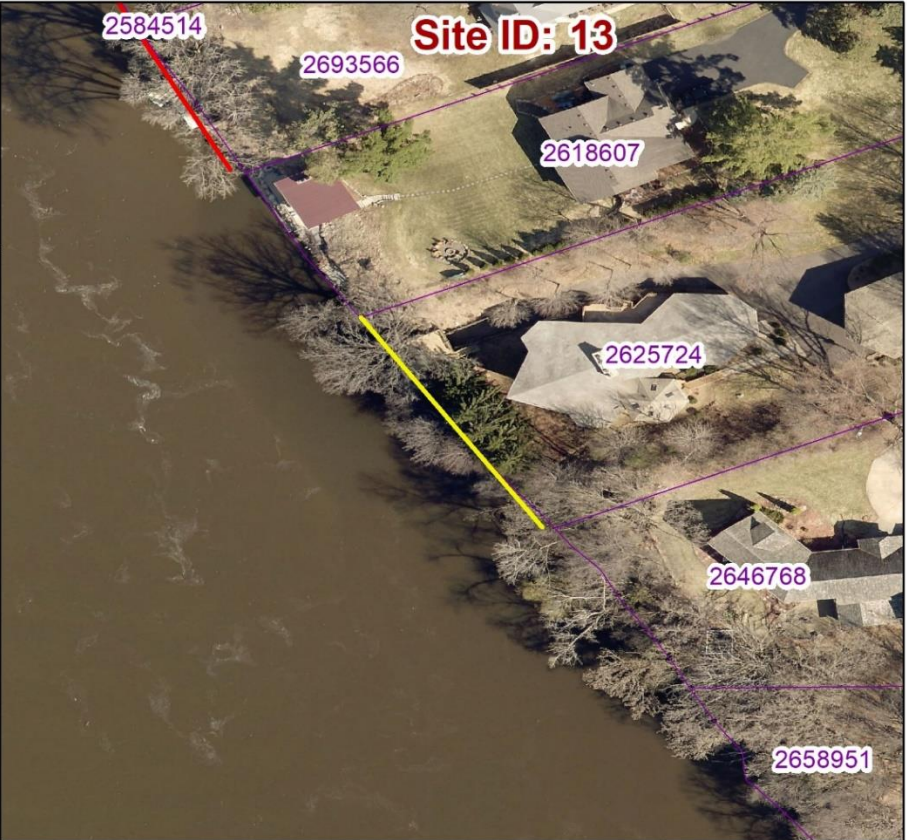
Description: Short but severe cliff that caused the collapse of a staircase leading to the river. Bank upstream of the cliff still contains vegetation but is equally steep and exhibits an eroded toe

Length (ft)	148
Erosion Height (ft)	10
Bluff Height (ft)	10
Recession Rate (ft/yr)	0.1
Soil Loss (tons/yr)	23
Ownership	Private
Number of Owners	1
Stabilization Approach	Bio-eng.
Cost Estimate	52,550

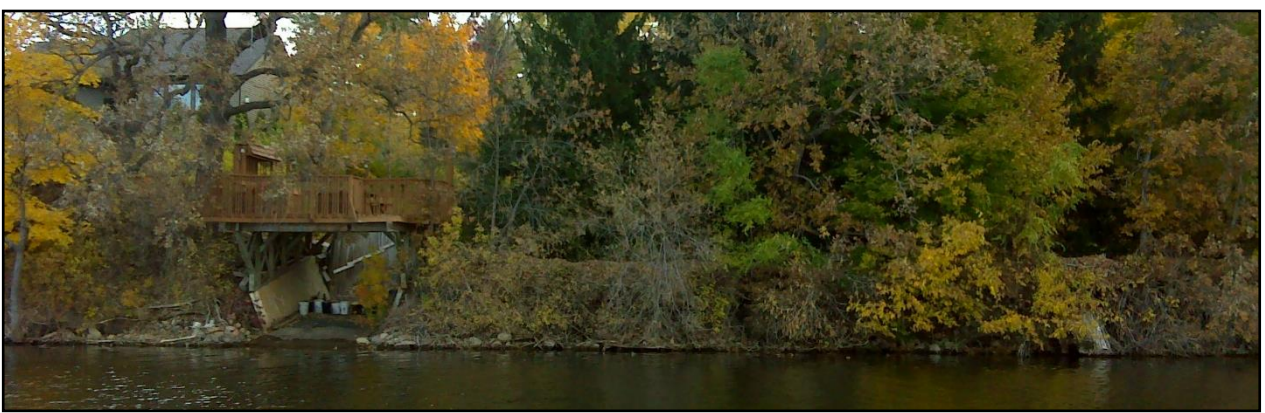
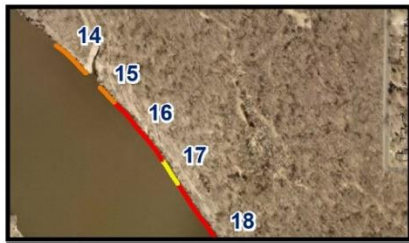
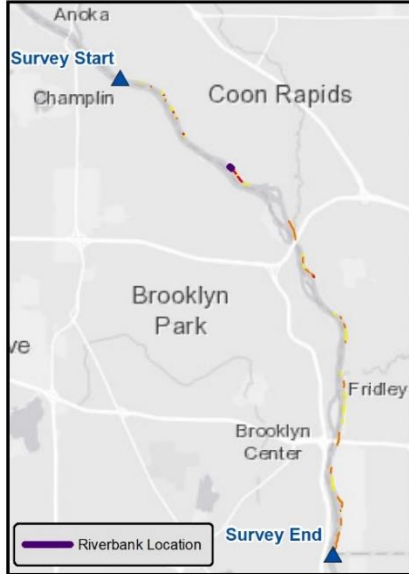
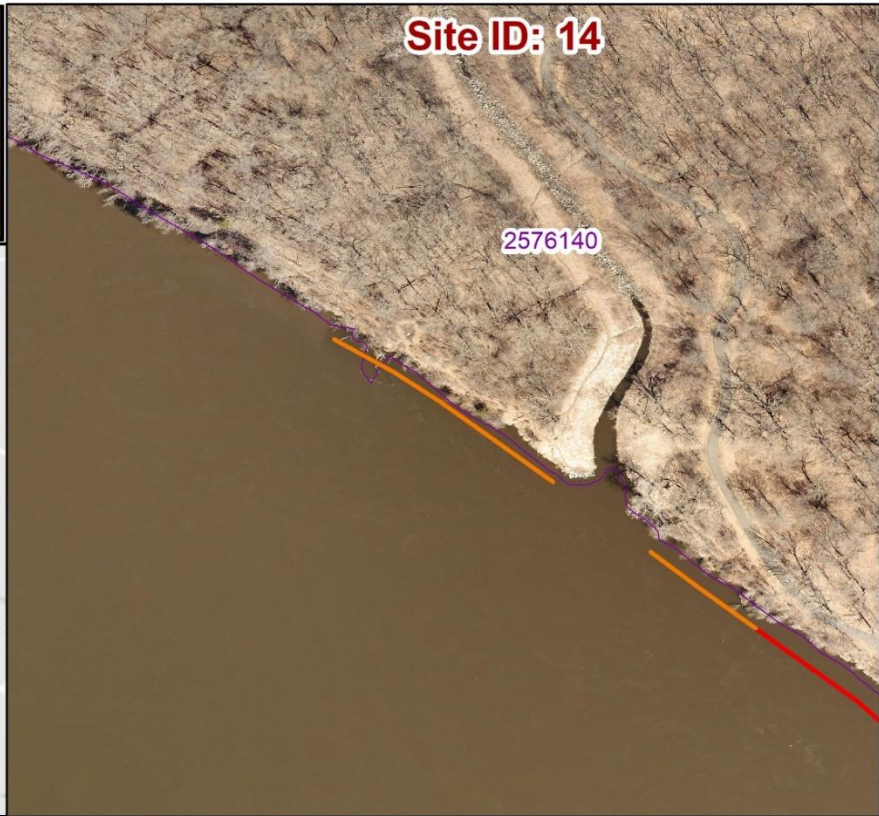
Description: Steep slope but well vegetated. Some moderate toe erosion has led to exposed roots.

Length (ft)	271
Erosion Height (ft)	16
Bluff Height (ft)	16
Recession Rate (ft/yr)	0.3
Soil Loss (tons/yr)	121
Ownership	Public
Number of Owners	1
Stabilization Approach	Armor
Cost Estimate	197,514

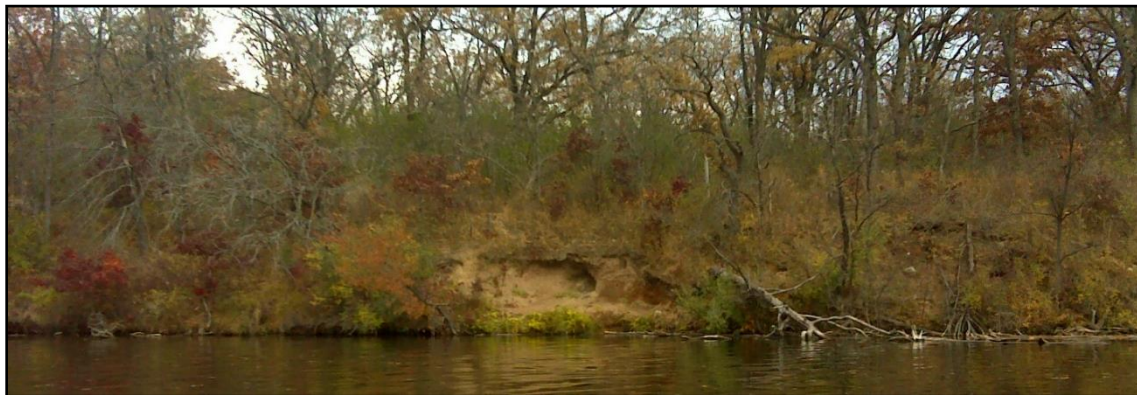
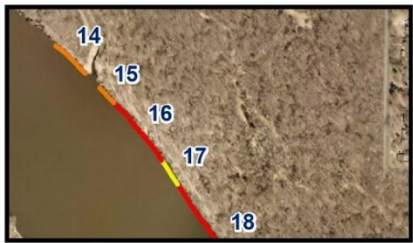
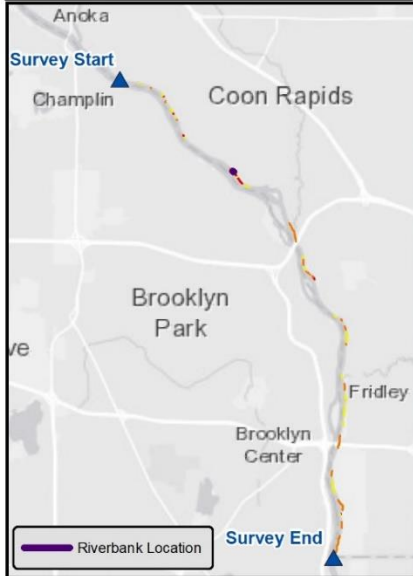
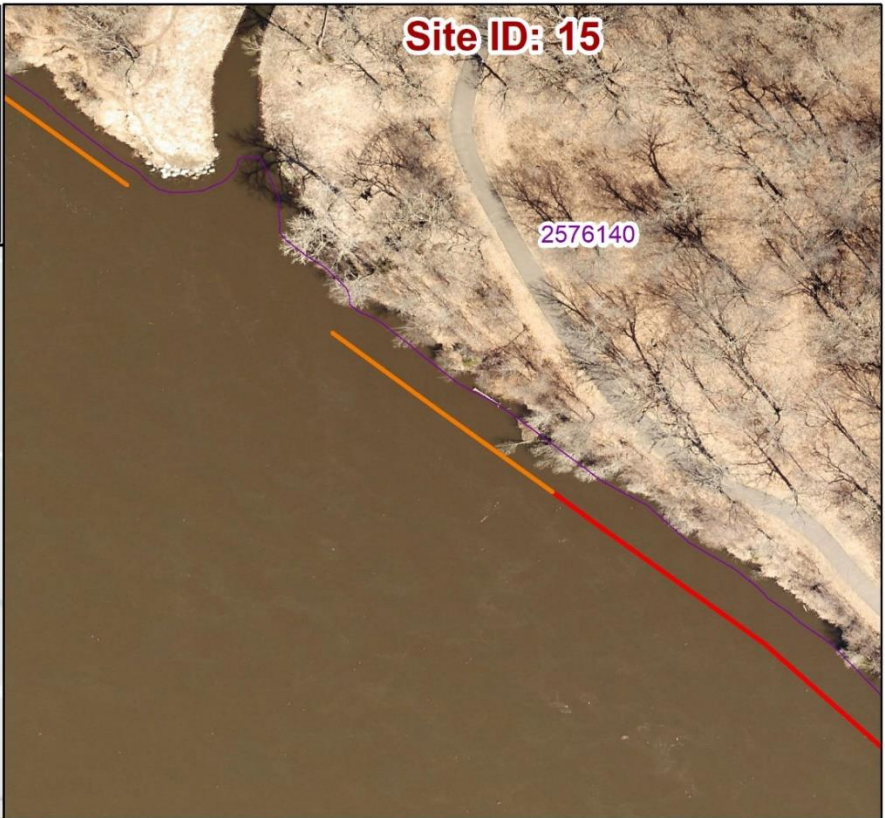
Description: Moderate severe erosion at the outlet of ditch system. Similar erosion is occurring on the other side of the ditch outlet. At Coon Rapids Dam park.

Length (ft)	137
Erosion Height (ft)	16
Bluff Height (ft)	16
Recession Rate (ft/yr)	0.3
Soil Loss (tons/yr)	63
Ownership	Public
Number of Owners	1
Stabilization Approach	Armor
Cost Estimate	111,631

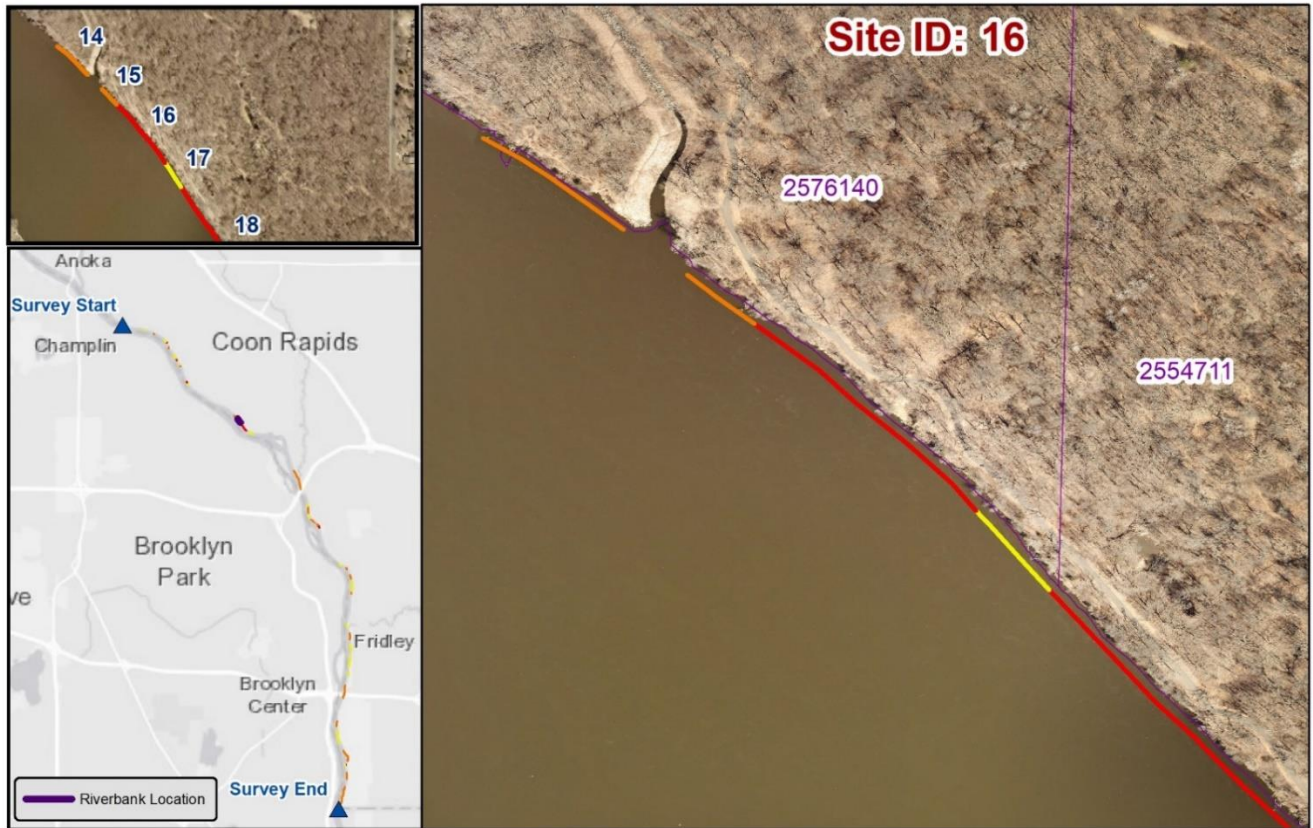
Description: Erosion has caused slumping, exposing soils and creating vegetative overhang. Located at Coon Rapids Dam park.

Length (ft)	488
Erosion Height (ft)	14
Bluff Height (ft)	14
Recession Rate (ft/yr)	0.5
Soil Loss (tons/yr)	393
Ownership	Public
Number of Owners	1
Stabilization Approach	Armor
Cost Estimate	297,377
