Mississippi Riverbank Erosion Inventory: Coon Rapids to Fridley

November 2021

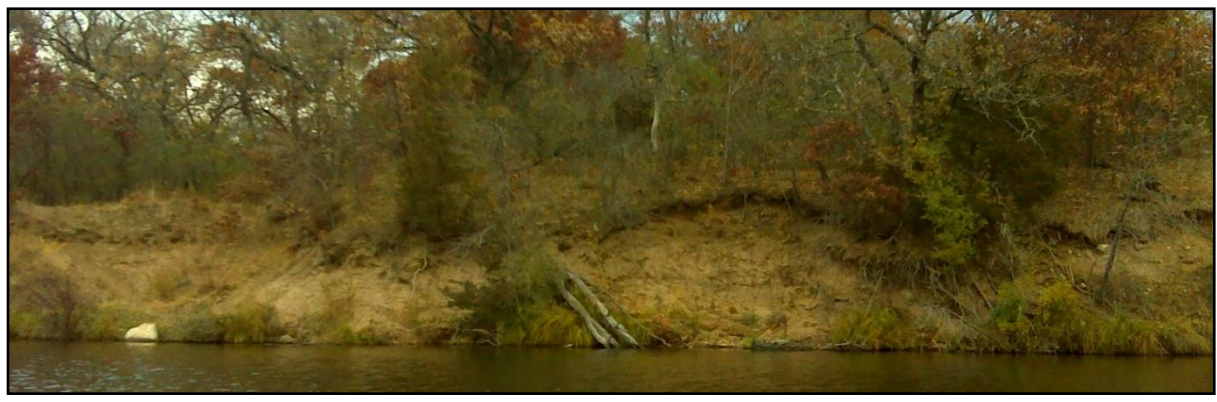
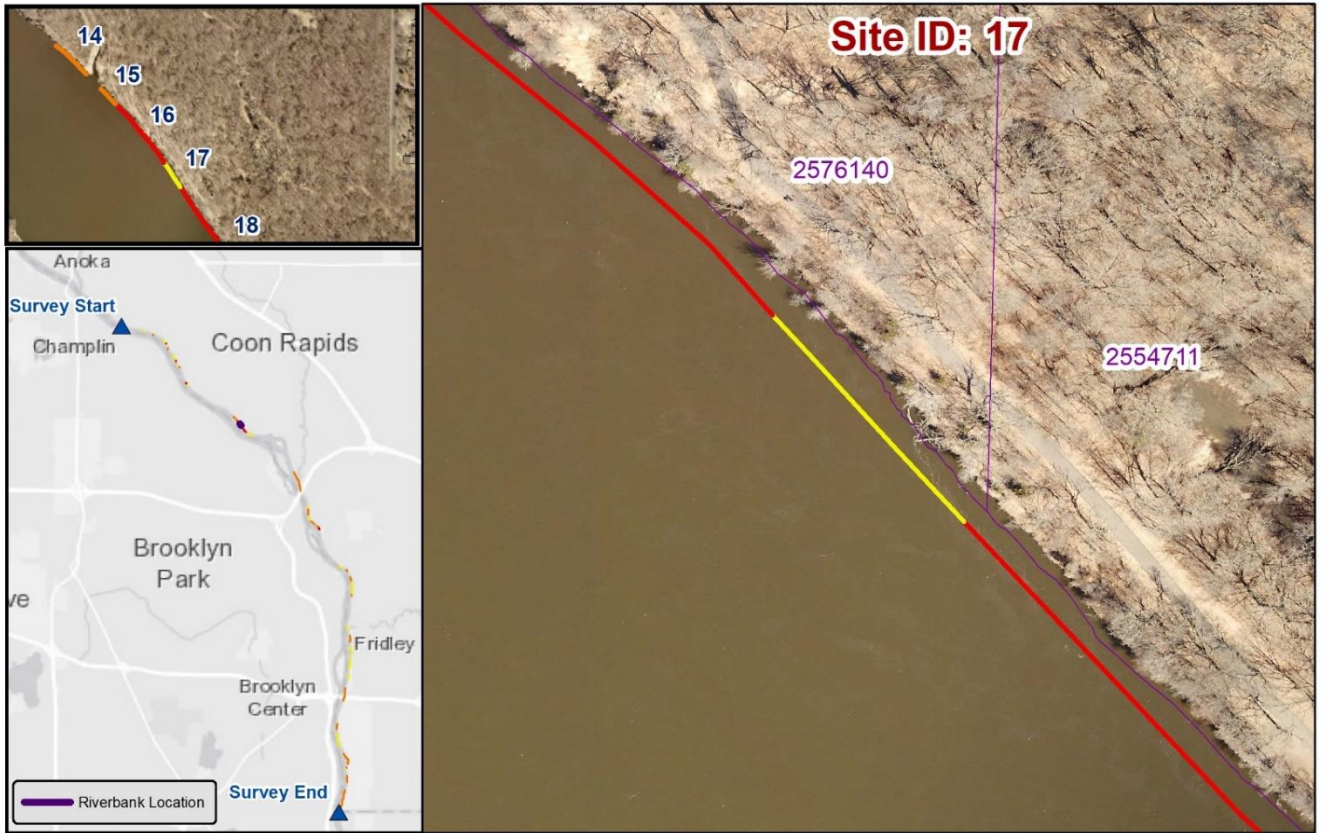
Description: Severe erosion has created cliffs along this stretch in Coon Rapids Dam regional park. Many fallen trees and exposed roots are present.

Length (ft)	190
Erosion Height (ft)	18
Bluff Height (ft)	18
Recession Rate (ft/yr)	0.1
Soil Loss (tons/yr)	33
Ownership	Public
Number of Owners	1
Stabilization Approach	Armor
Cost Estimate	160,609

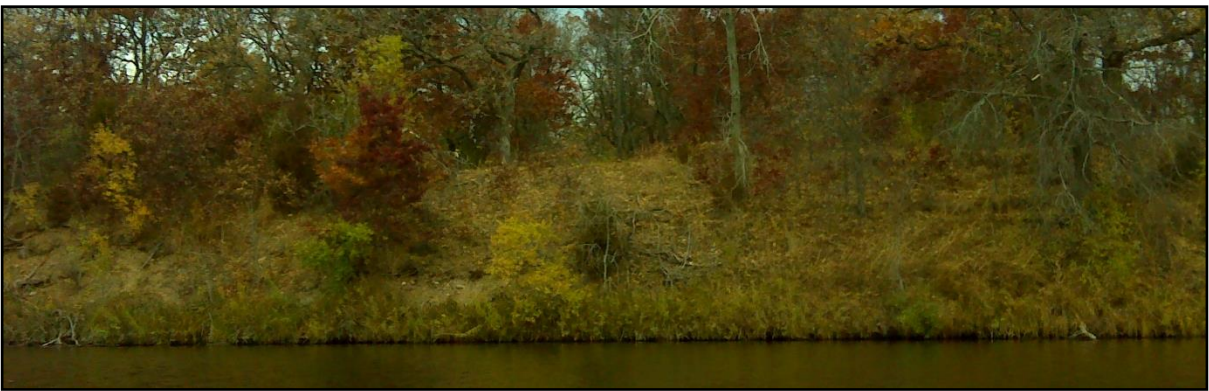
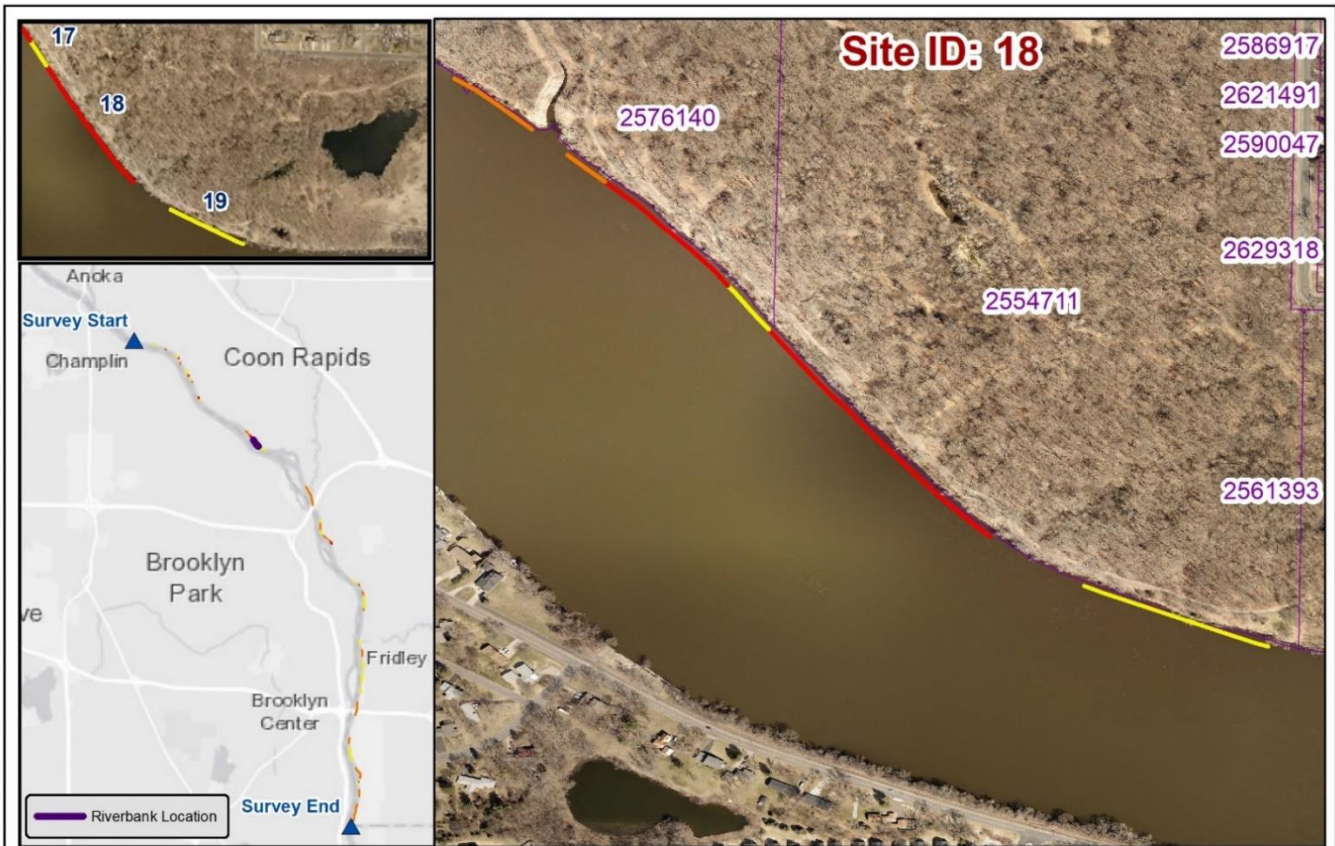
Description: Bank in early stages of erosion with some exposed soils; will likely erode to the severity of the banks up/ down stream of it over time. Located at Coon Rapids Dam Regional Park.

Length (ft)	935
Erosion Height (ft)	16
Bluff Height (ft)	16
Recession Rate (ft/yr)	0.5
Soil Loss (tons/yr)	694
Ownership	Public
Number of Owners	1
Stabilization Approach	Armor
Cost Estimate	622,574

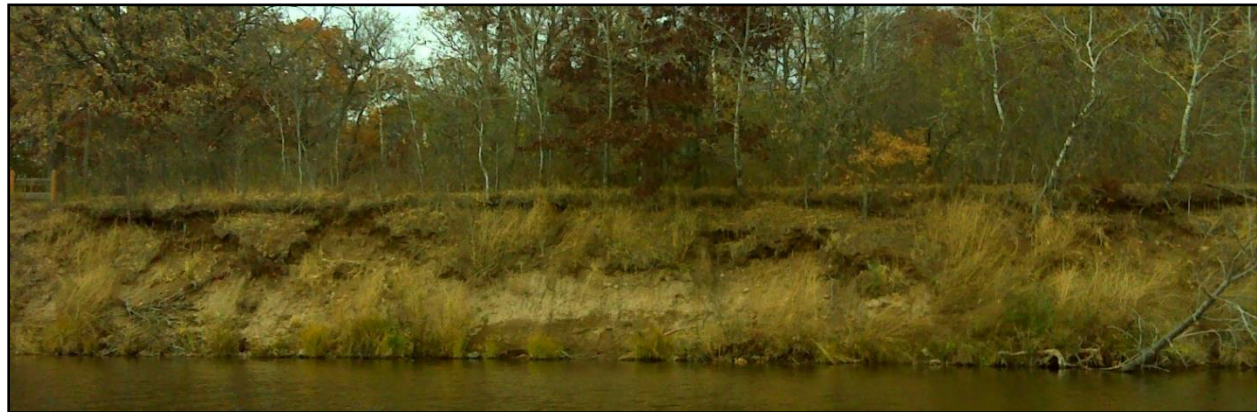
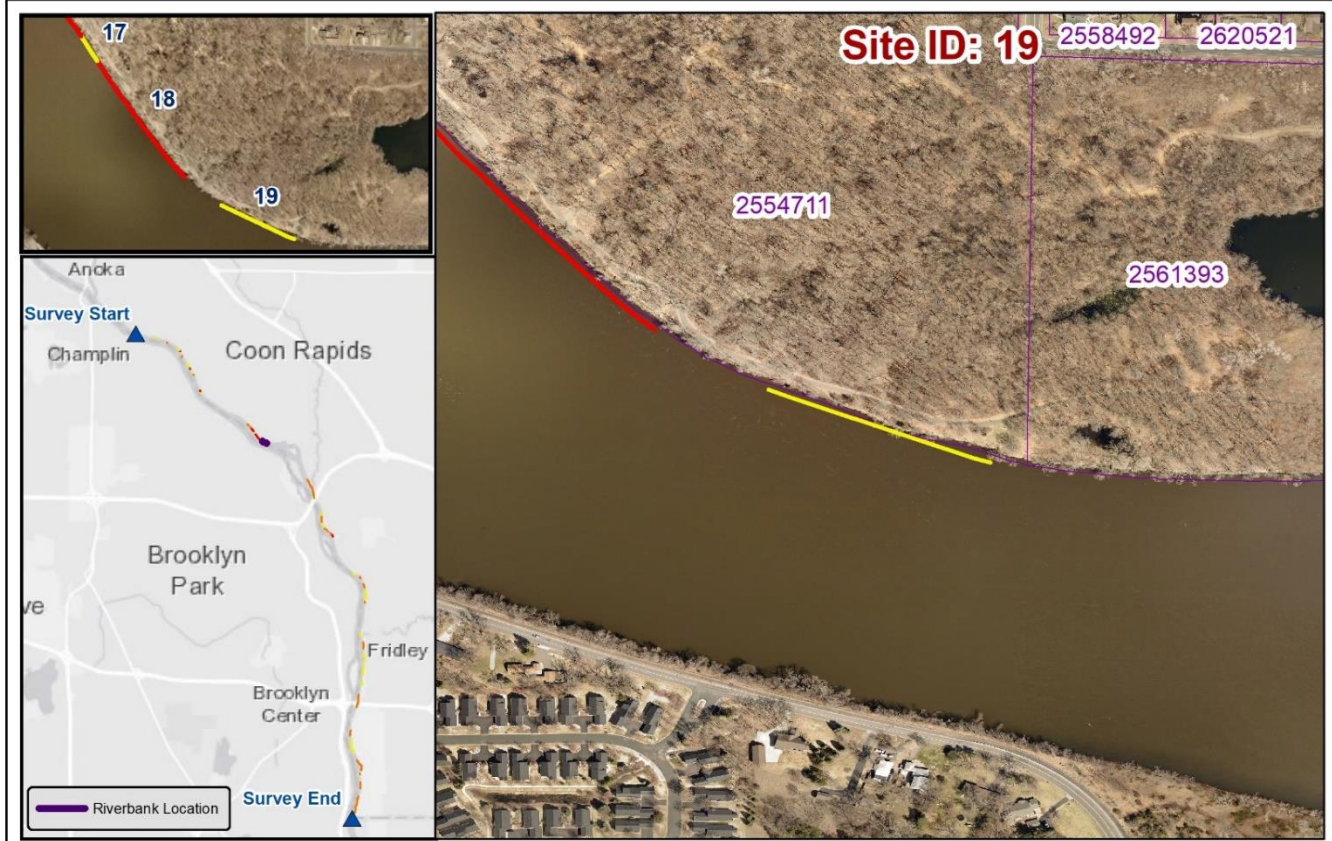
Description: Very severe erosion resulting in cliffs and fallen trees along the entire stretch. Encompasses nearly the entire upstream portion of the Coon Rapids Dam park.

Length (ft)	517
Erosion Height (ft)	4
Bluff Height (ft)	10
Recession Rate (ft/yr)	0.1
Soil Loss (tons/yr)	35
Ownership	Public
Number of Owners	1
Stabilization Approach	Bio-eng.
Cost Estimate	155,877

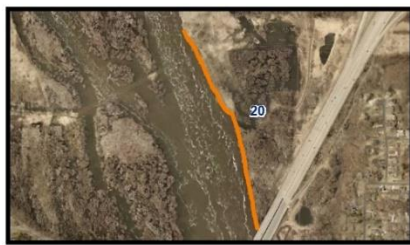
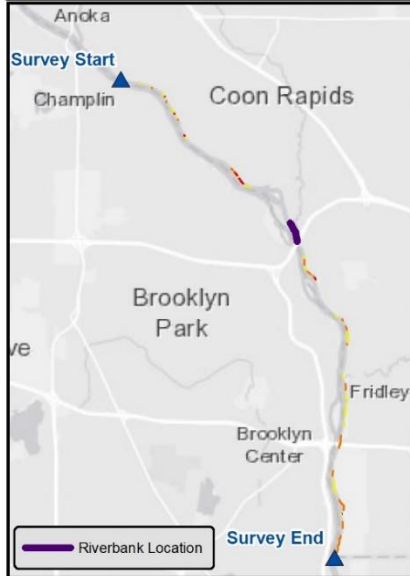
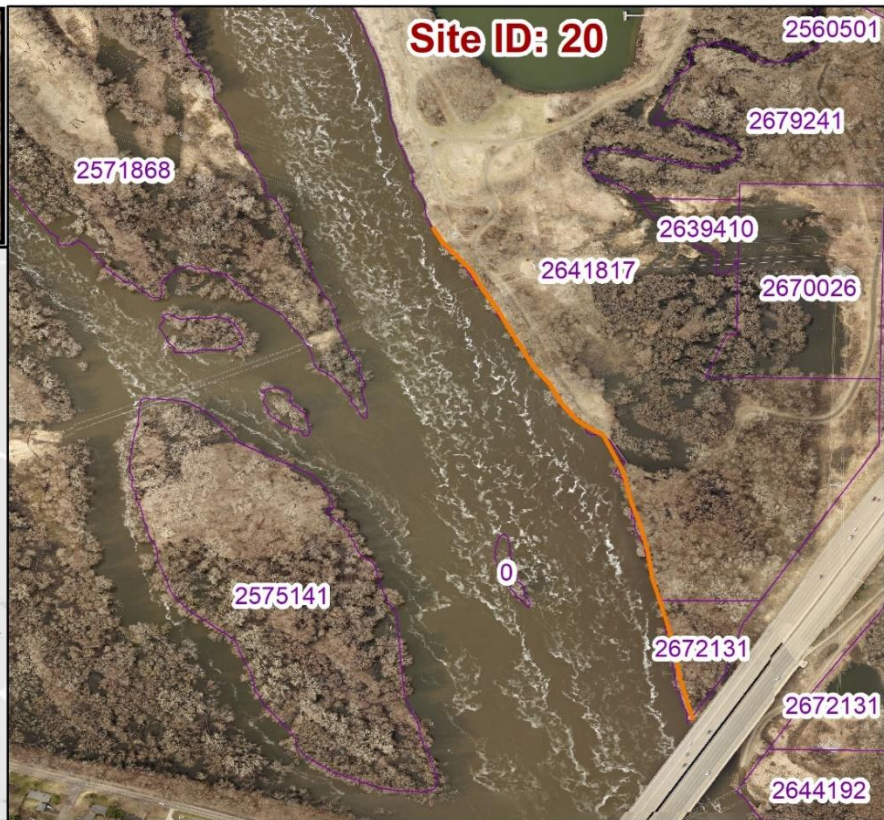
Length (ft)	2229
Erosion Height (ft)	10
Bluff Height (ft)	12
Recession Rate (ft/yr)	0.3
Soil Loss (tons/yr)	748
Ownership	Public
Number of Owners	1
Stabilization Approach	Bio-eng.
Cost Estimate	759,996

Description: Located at the Coon Rapids Dam Regional Park. Bank is highly eroded with visible soil and a vertical bank on the upstream stretch; exposed roots/ fallen trees on the downstream stretch.

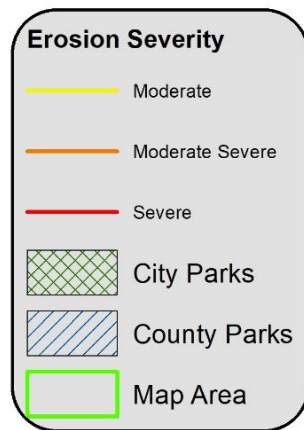
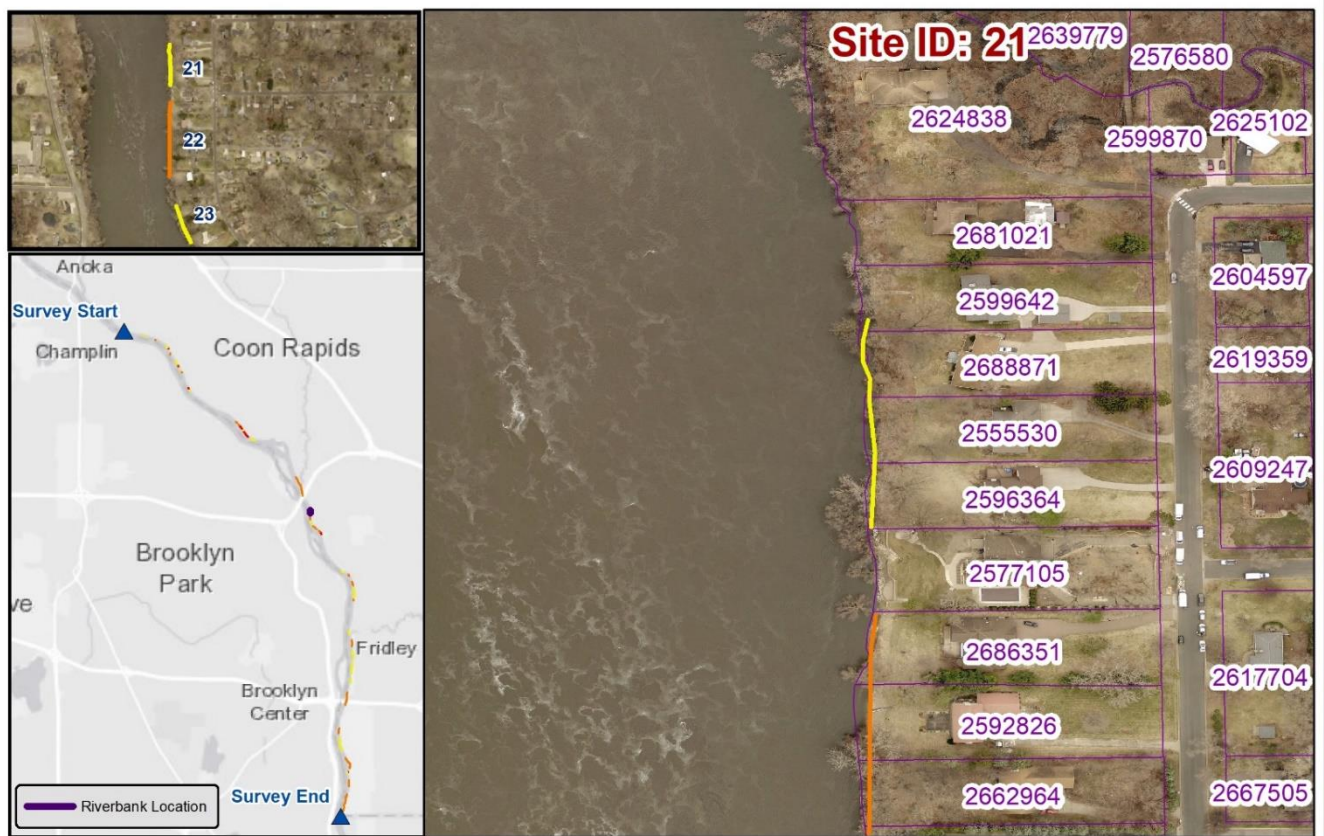
Length (ft)	315
Erosion Height (ft)	12
Bluff Height (ft)	20
Recession Rate (ft/yr)	0.1
Soil Loss (tons/yr)	63
Ownership	Private
Number of Owners	4
Stabilization Approach	Bio-eng.
Cost Estimate	194,980

Description: Slope is maintaining some vegetation but contains several fallen trees, exposed roots, and some minor slumps forming near the trunk bases.

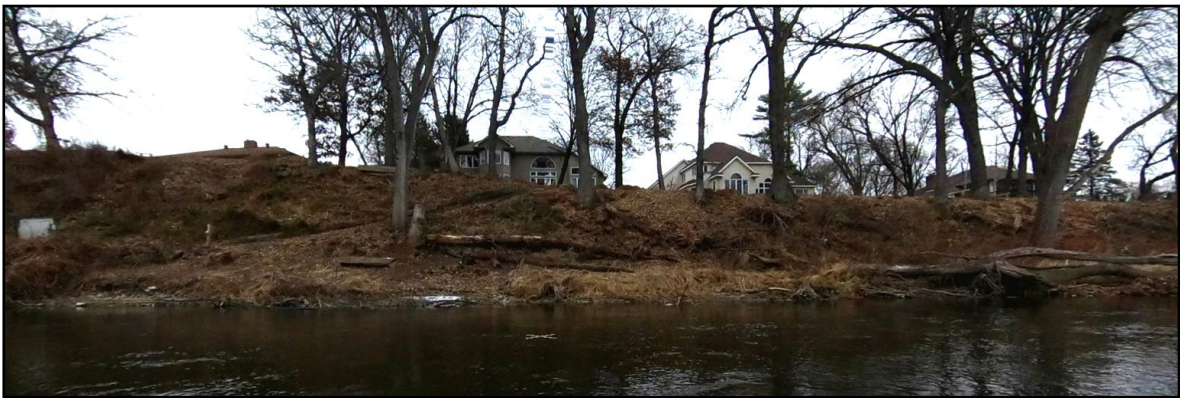
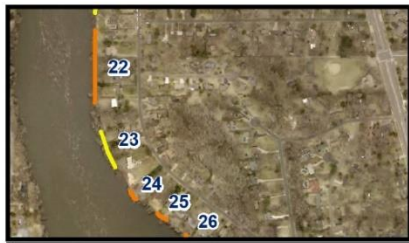
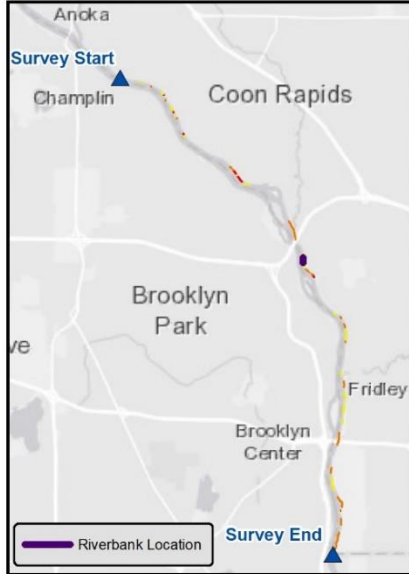
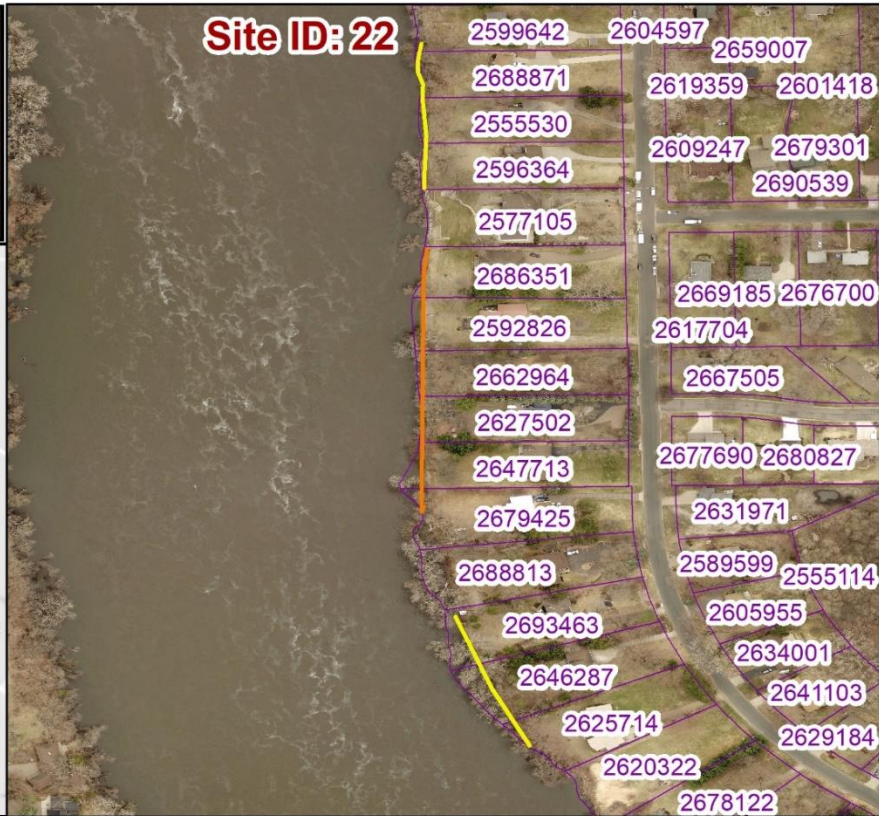
Length (ft)	581
Erosion Height (ft)	4
Bluff Height (ft)	16
Recession Rate (ft/yr)	0.3
Soil Loss (tons/yr)	110
Ownership	Private
Number of Owners	6
Stabilization Approach	Bio-eng.
Cost Estimate	283,815

Description: Exposed edge with visible roots, vegetative overhang, and an undercut forming at the toe.

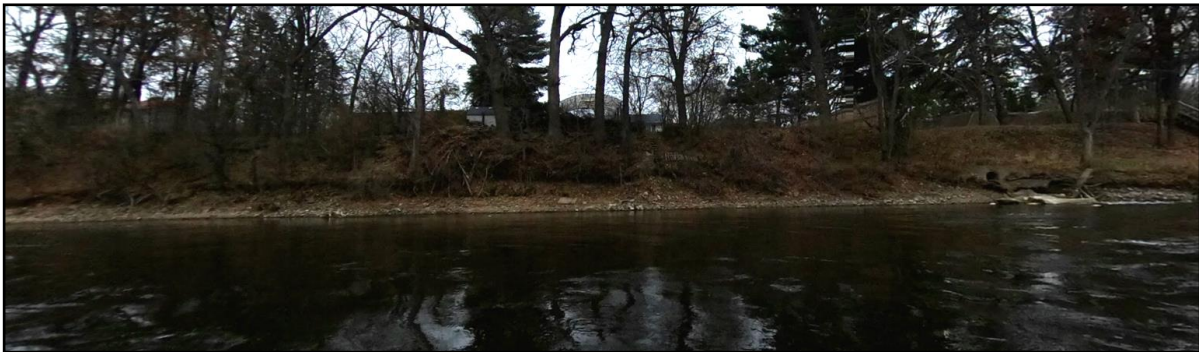
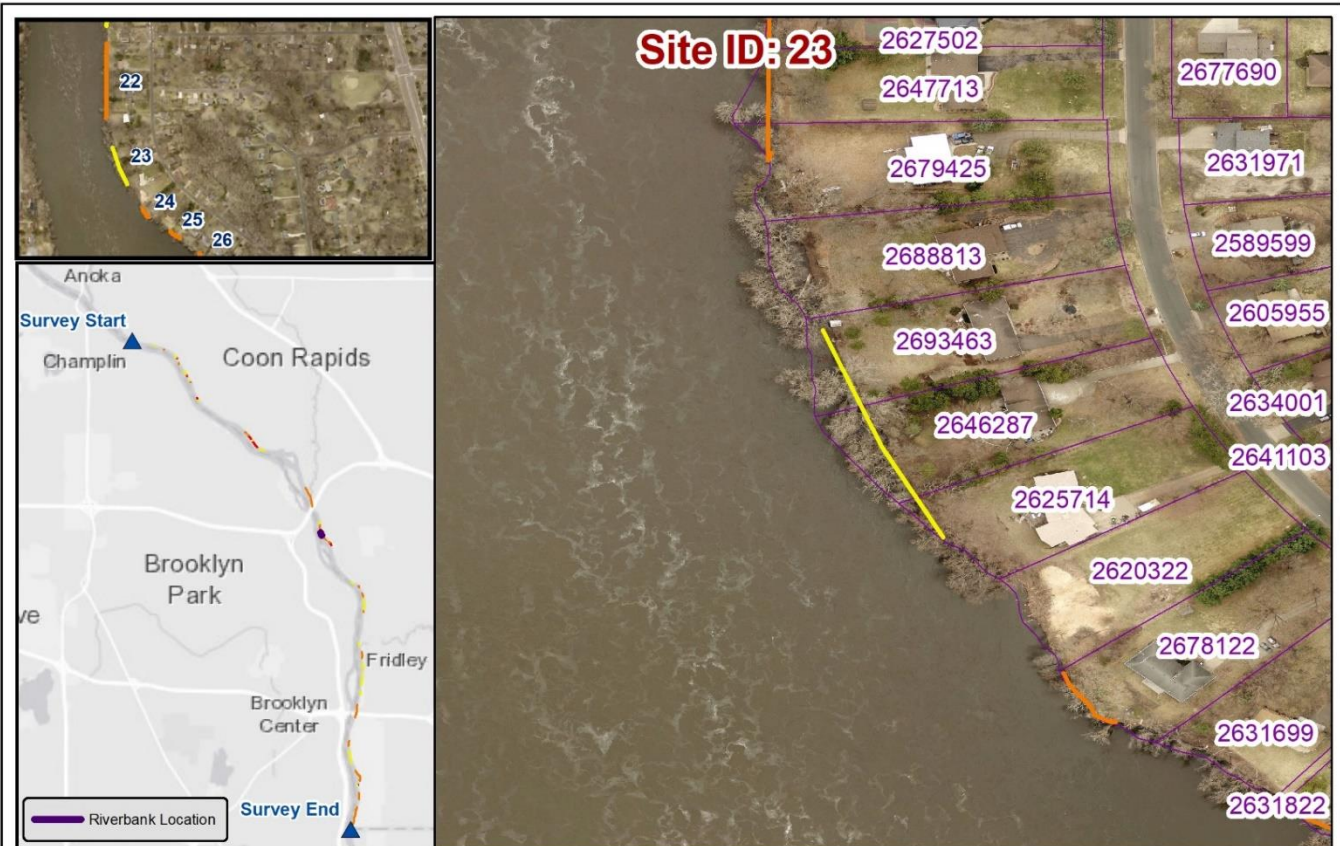
Length (ft)	303
Erosion Height (ft)	4
Bluff Height (ft)	12
Recession Rate (ft/yr)	0.1
Soil Loss (tons/yr)	16
Ownership	Private
Number of Owners	3
Stabilization Approach	Bio-eng.
Cost Estimate	112,695

Description: Shoreline is relatively low-lying and the bank contains a slight undercut, exposed roots, and vegetative overhang. Erosion is most distinct on the lowest section of the bank.

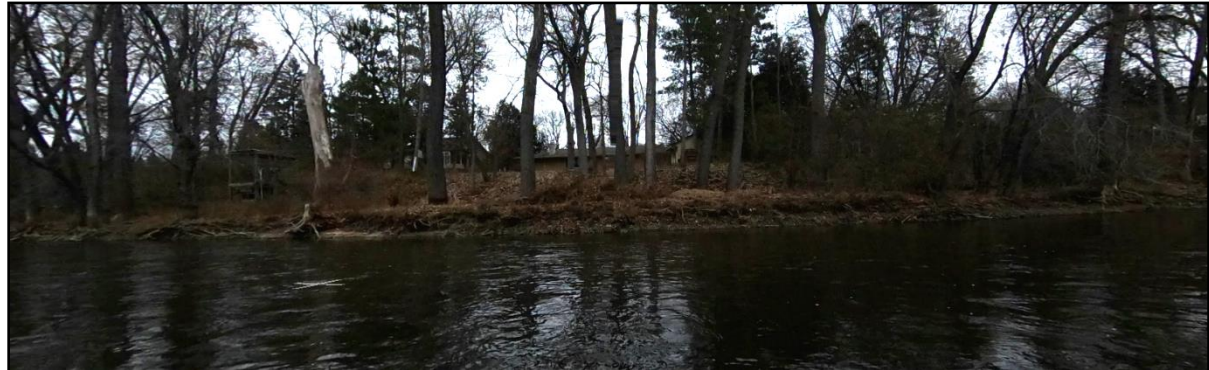
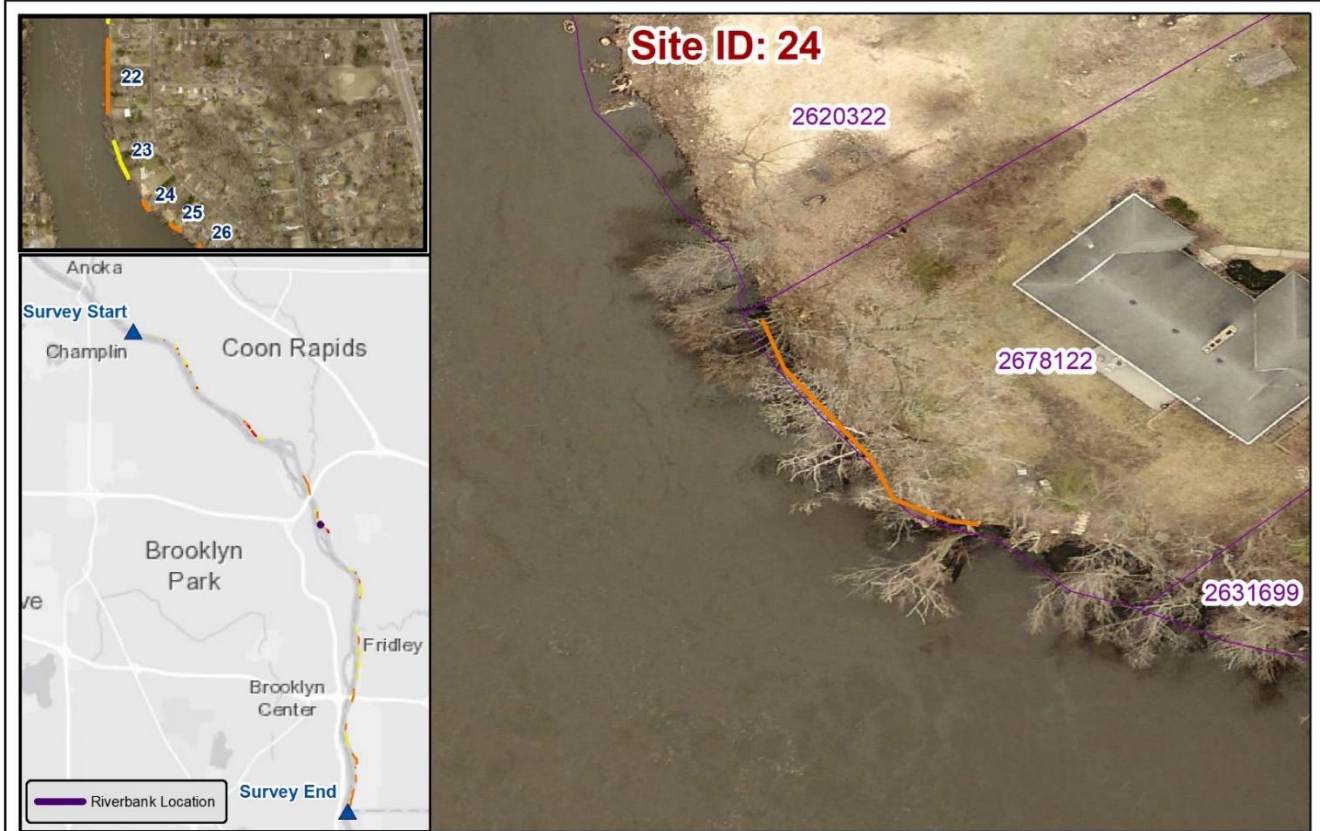
Length (ft)	88
Erosion Height (ft)	12
Bluff Height (ft)	12
Recession Rate (ft/yr)	0.3
Soil Loss (tons/yr)	41
Ownership	Private
Number of Owners	1
Stabilization Approach	Bio-eng.
Cost Estimate	40,431

Description: Vegetation is present, but several fallen trees and exposed root systems are visible. Some undercuts and slumps have formed on the outer curve.

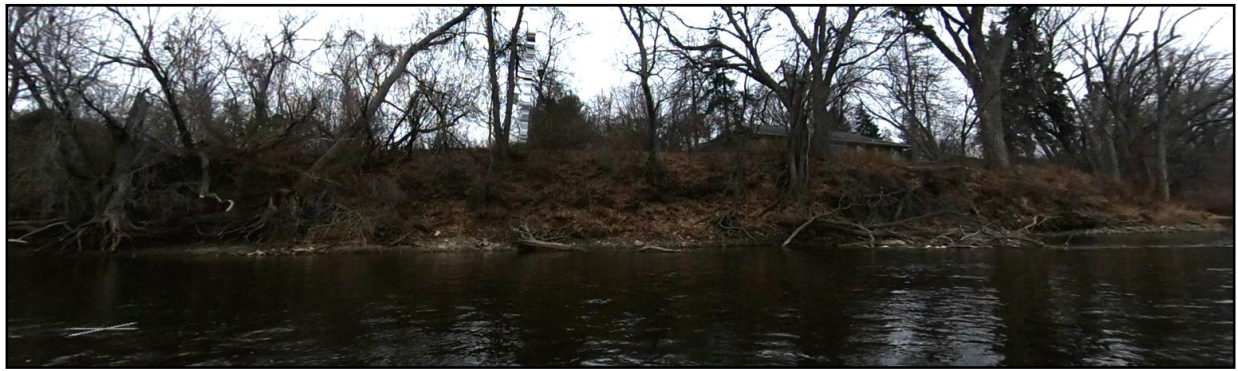
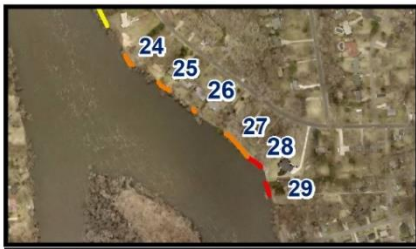
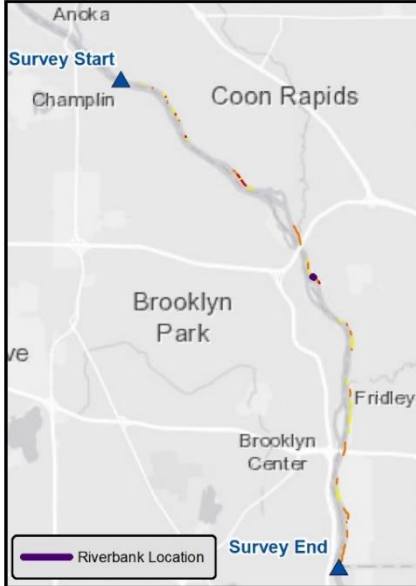
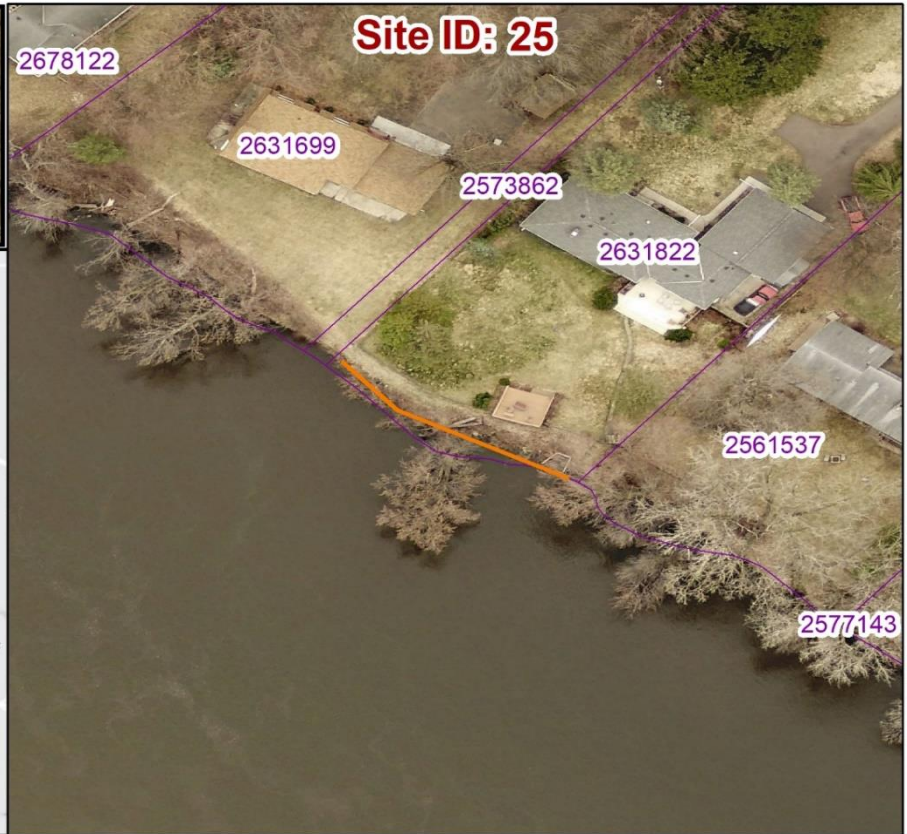
Length (ft)	94
Erosion Height (ft)	12
Bluff Height (ft)	12
Recession Rate (ft/yr)	0.3
Soil Loss (tons/yr)	33
Ownership	Private
Number of Owners	1
Stabilization Approach	Bio-eng.
Cost Estimate	42,522

Description: There are no remaining trees on the steepest section, and those on the outer edges are leaning. Root systems are exposed and a large slump is present.

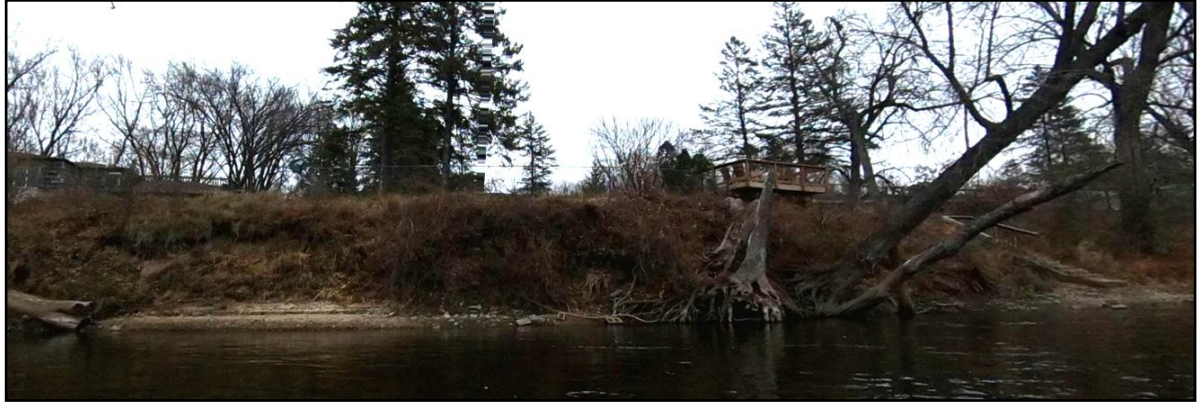
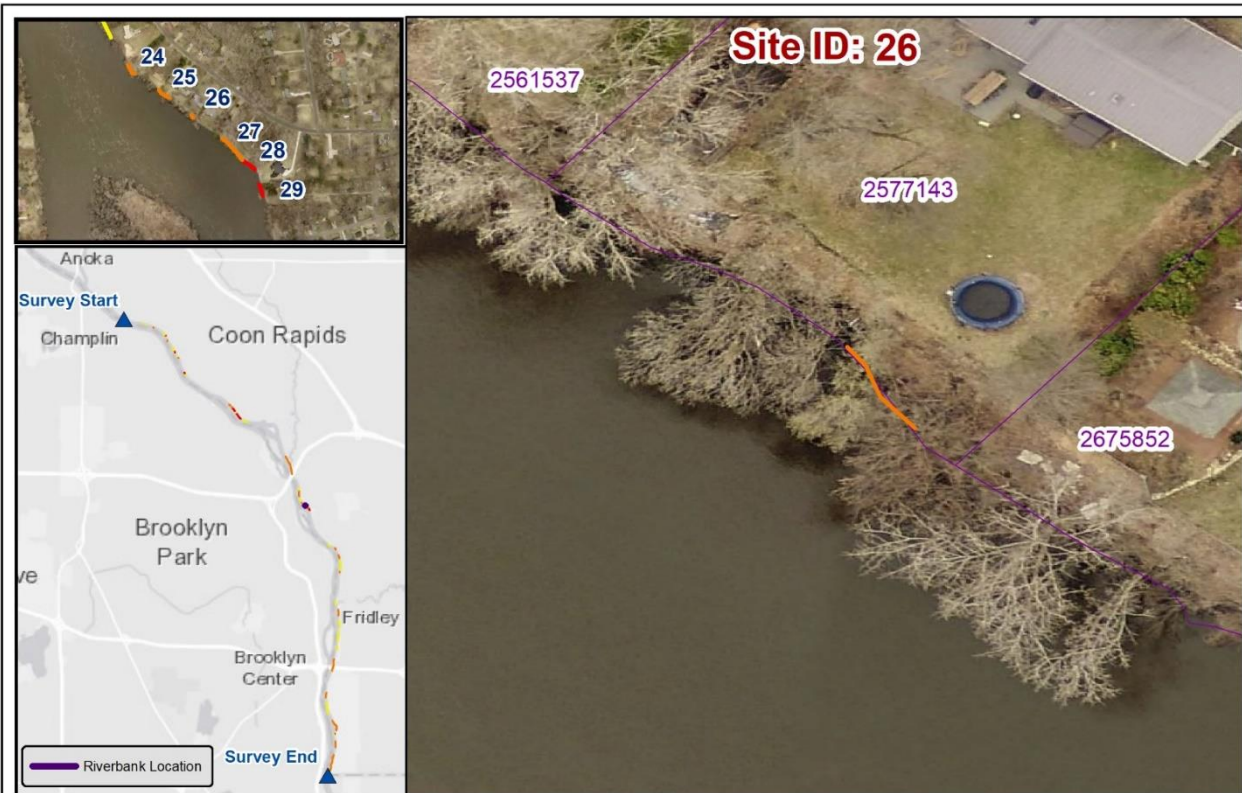
Length (ft)	26
Erosion Height (ft)	12
Bluff Height (ft)	12
Recession Rate (ft/yr)	0.3
Soil Loss (tons/yr)	8
Ownership	Private
Number of Owners	1
Stabilization Approach	Bio-eng.
Cost Estimate	19,768

Description: Short stretch of steep slope with exposed roots and leaning trees. An undercut is forming at the toe. There is a pipe extending out of the bank.

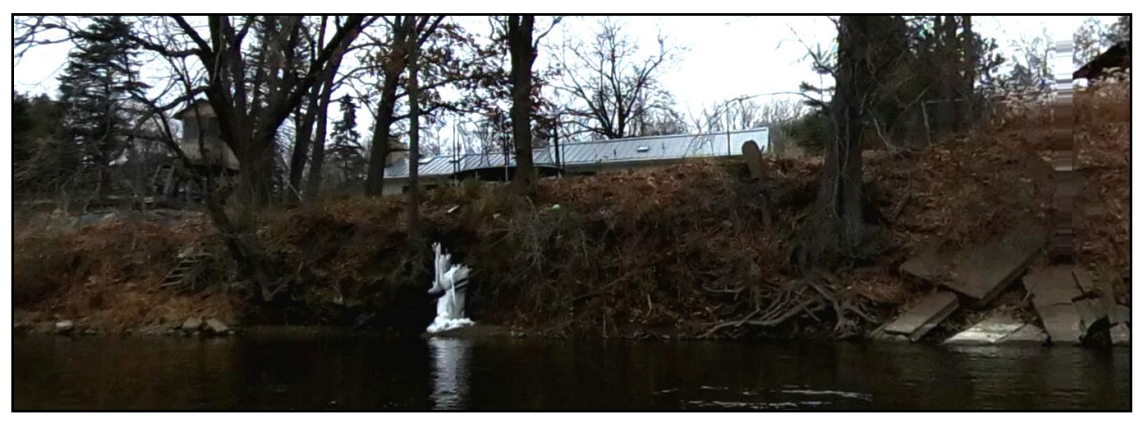
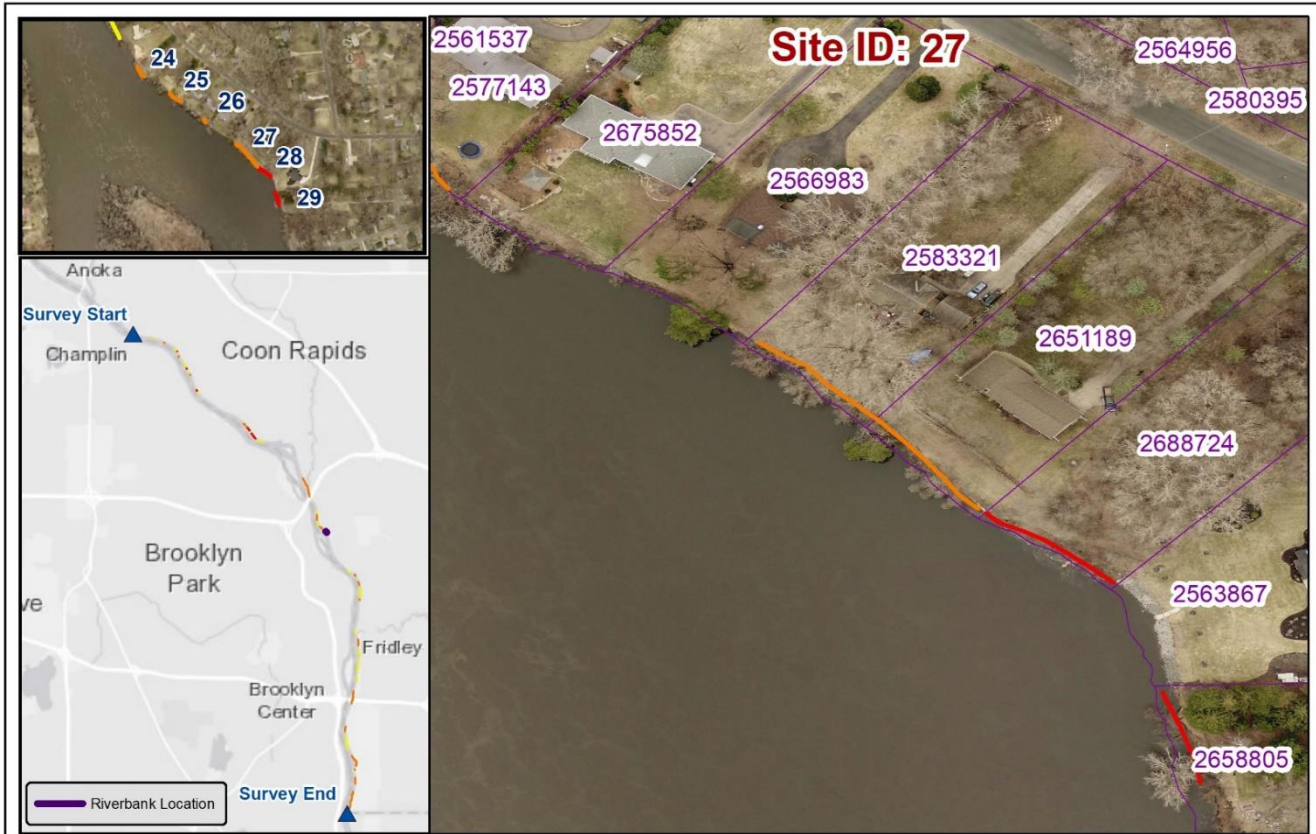
Length (ft)	206
Erosion Height (ft)	14
Bluff Height (ft)	14
Recession Rate (ft/yr)	0.3
Soil Loss (tons/yr)	66
Ownership	Private
Number of Owners	2
Stabilization Approach	Bio-eng.
Cost Estimate	94,070

Description: Erosion has caused a slump on the upstream part of this shoreline and an undercut toe on the downstream portion. This transitions into severe erosion on the next stretch of shoreline.

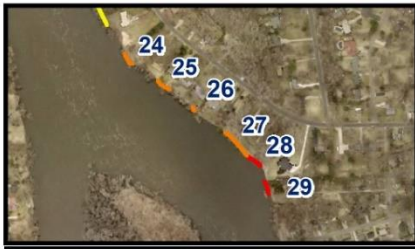
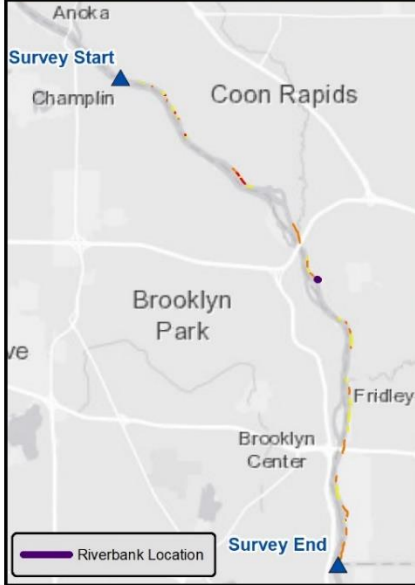
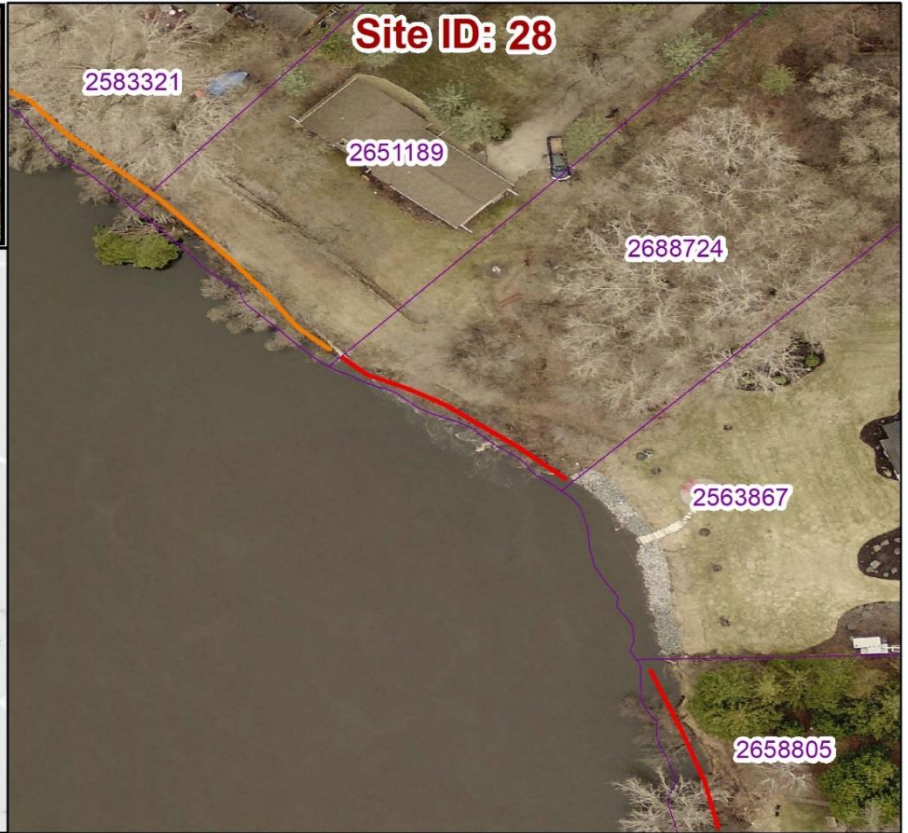
Length (ft)	102
Erosion Height (ft)	12
Bluff Height (ft)	12
Recession Rate (ft/yr)	0.5
Soil Loss (tons/yr)	55
Ownership	Private
Number of Owners	1
Stabilization Approach	Armor
Cost Estimate	73,099

Description: Highly eroded steep slope with slumps, exposed roots, and fallen woody debris.

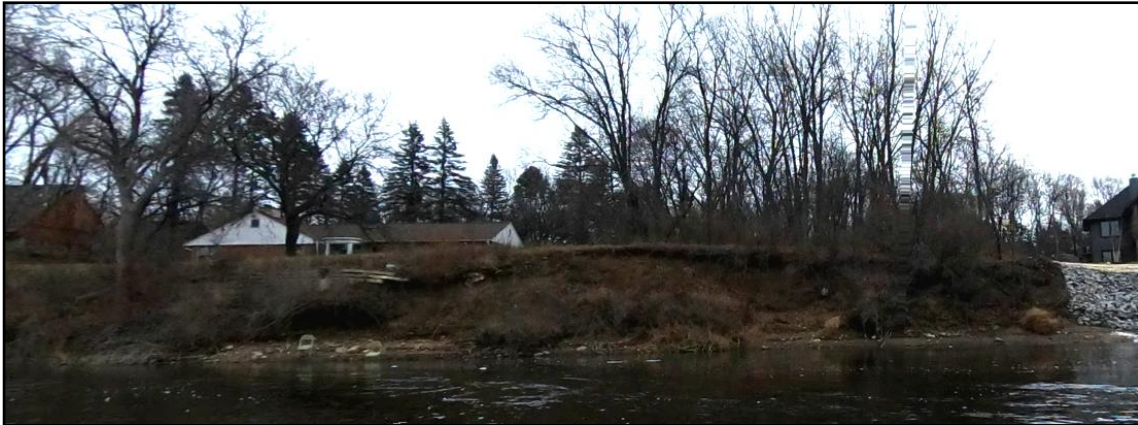
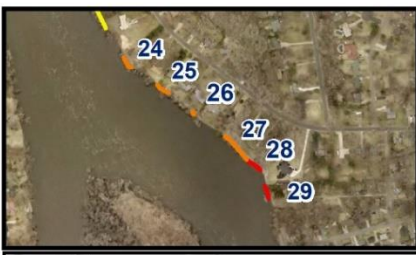
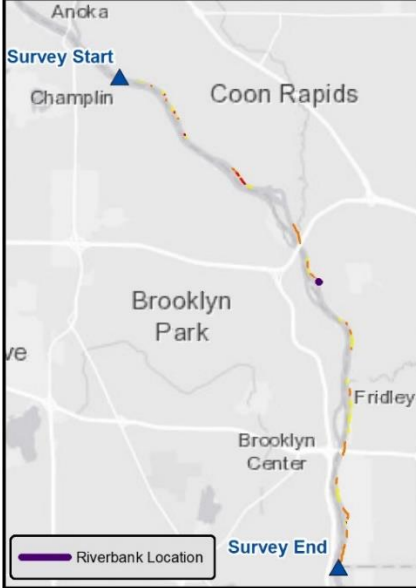
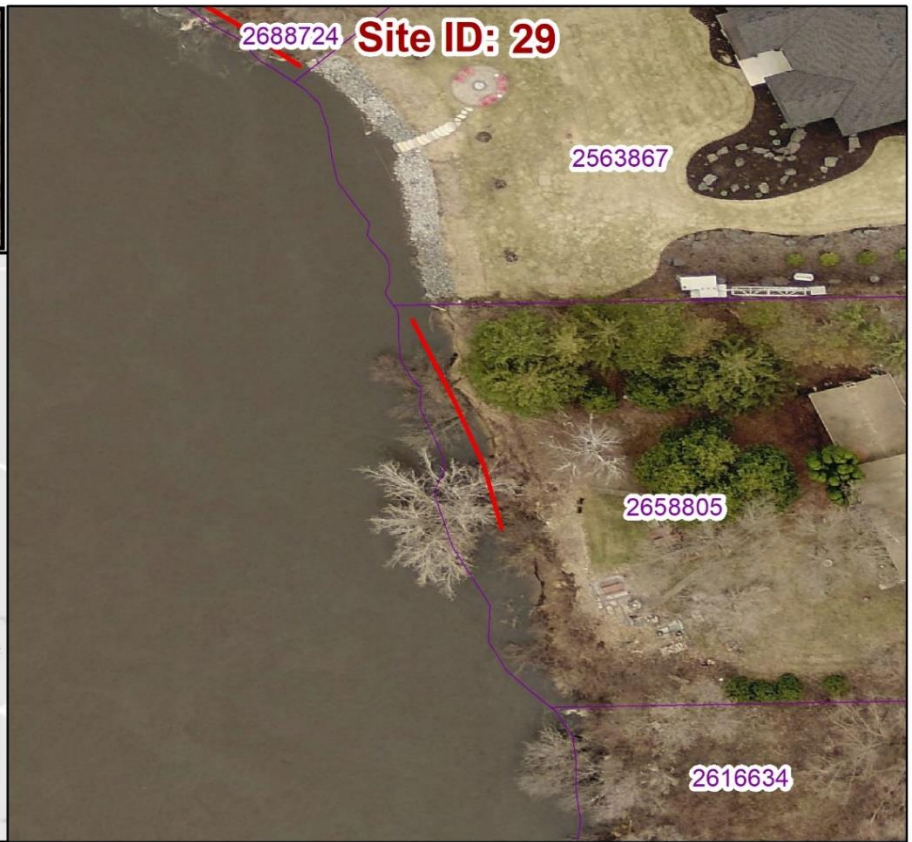
Length (ft)	84
Erosion Height (ft)	12
Bluff Height (ft)	12
Recession Rate (ft/yr)	0.5
Soil Loss (tons/yr)	45
Ownership	Private
Number of Owners	1
Stabilization Approach	Armor
Cost Estimate	64,331

Description: Highly eroded steep slope with slumps, vegetative overhang, exposed roots, and leaning trees.

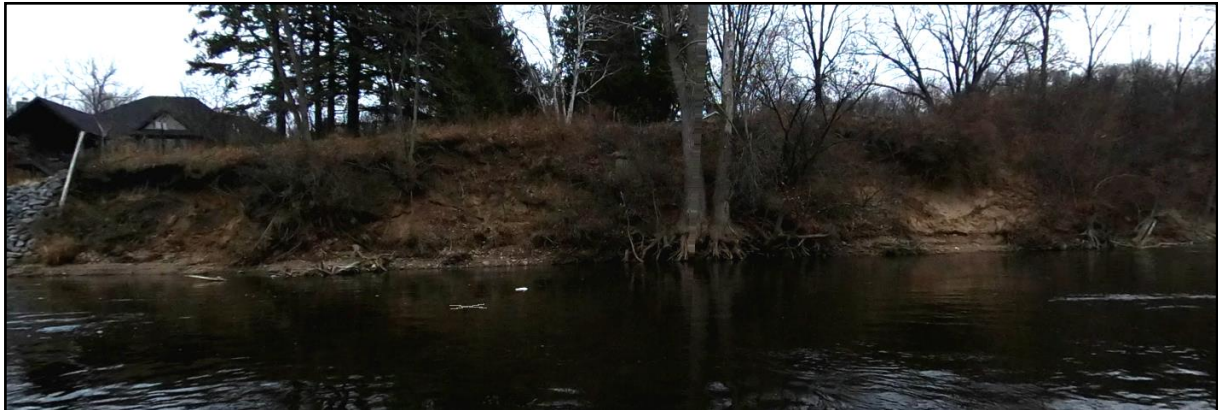
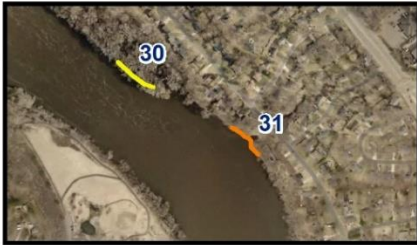
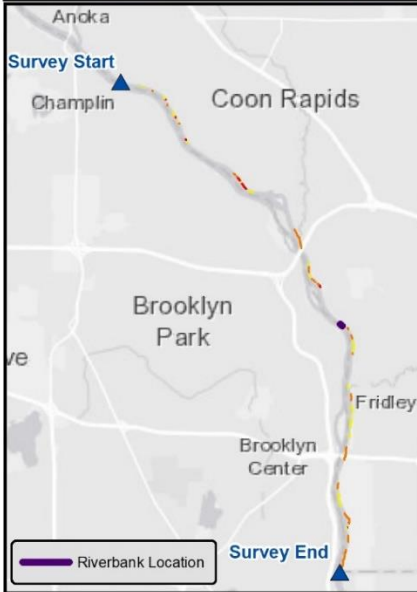
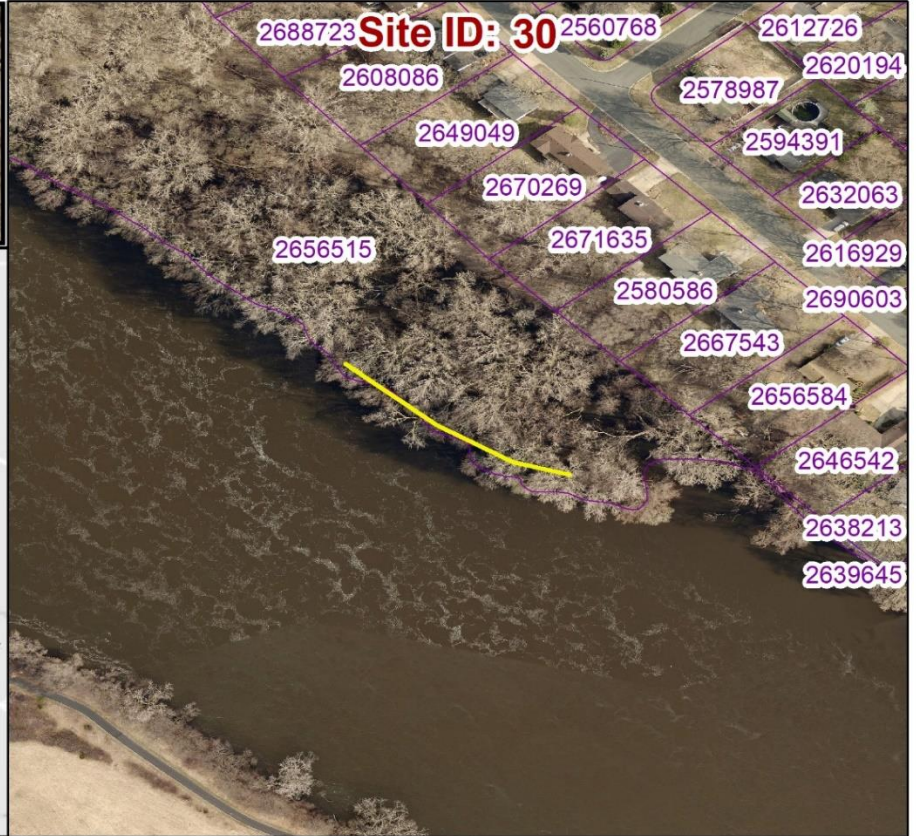
Length (ft)	280
Erosion Height (ft)	4
Bluff Height (ft)	4
Recession Rate (ft/yr)	0.1
Soil Loss (tons/yr)	22
Ownership	Fridley
Number of Owners	1
Stabilization Approach	Bio-eng.
Cost Estimate	42,404

Description: Moderate erosion of the toe is causing an undercut and exposed roots. There is little to no slope on the visible shoreline because this is a floodplain area.

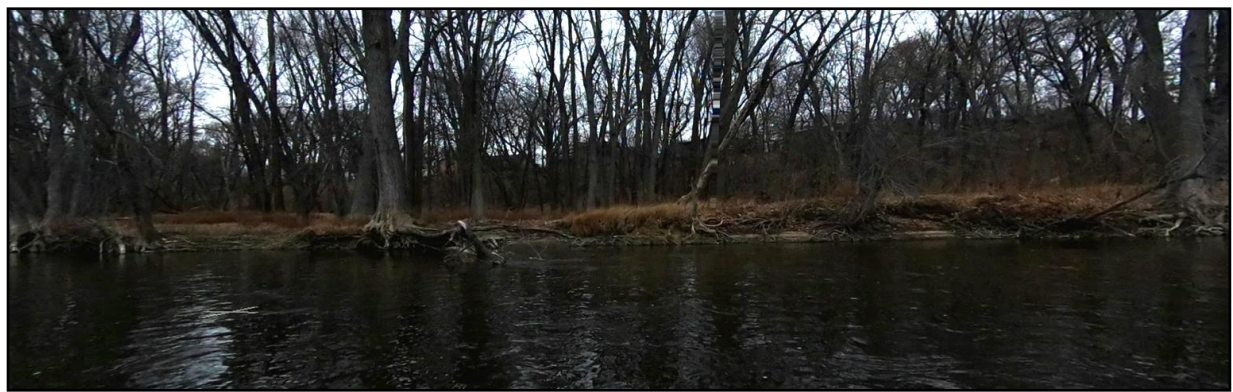
Length (ft)	259
Erosion Height (ft)	10
Bluff Height (ft)	28
Recession Rate (ft/yr)	0.3
Soil Loss (tons/yr)	94
Ownership	Private
Number of Owners	2
Stabilization Approach	Armor
Cost Estimate	319,314
