Mississippi Riverbank Erosion Inventory: Coon Rapids to Fridley

November 2021

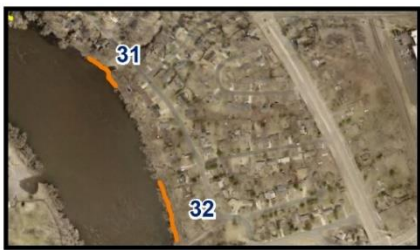
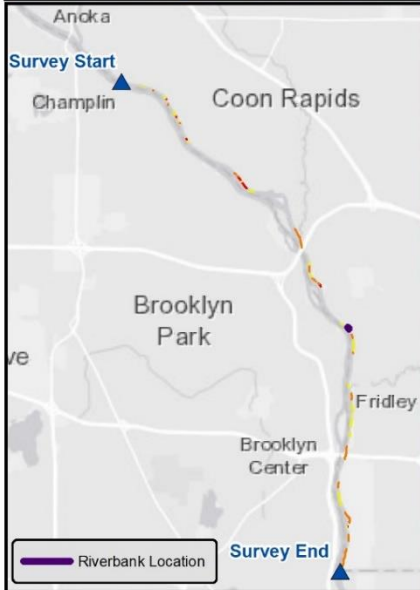
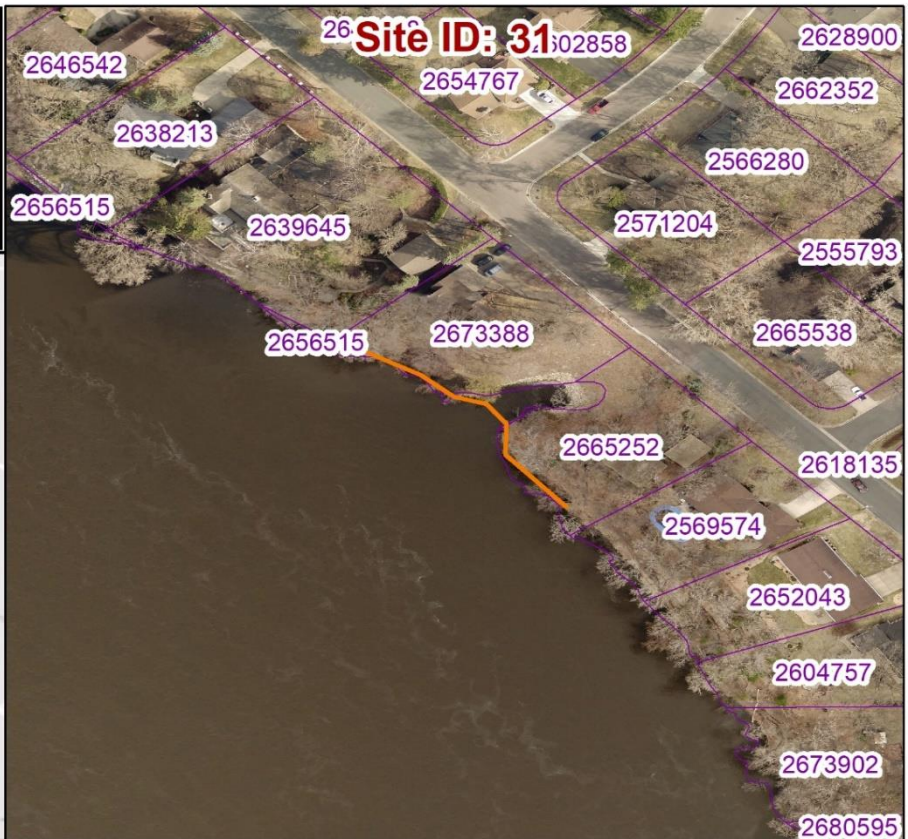
Description: Slumps, exposed roots, and an undercut toe are present along this stretch. The slope above the slumps is still well-vegetated but compromised by the erosion below.

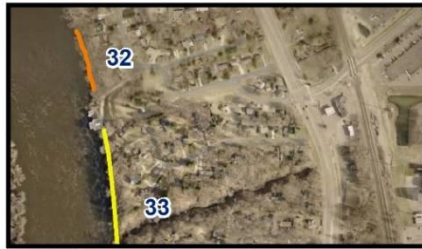
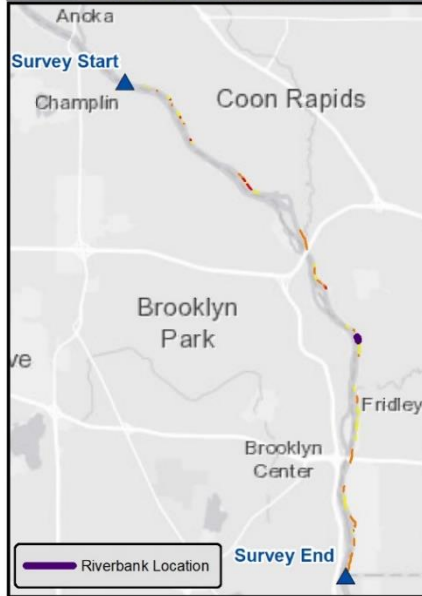
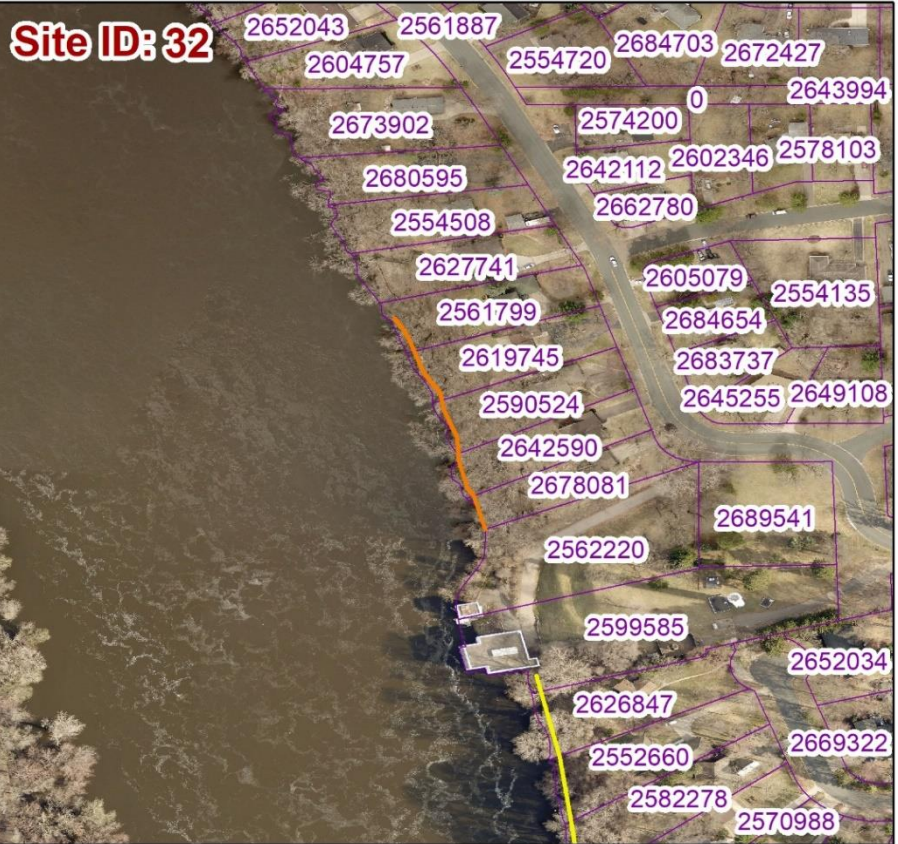
Description: An undercut toe is present along the entire stretch, resulting in exposed root systems, overhanging vegetation, and leaning trees near the edge. Some minor slumps have occurred near the bottom. Remainder of slope is steep but well vegetated.

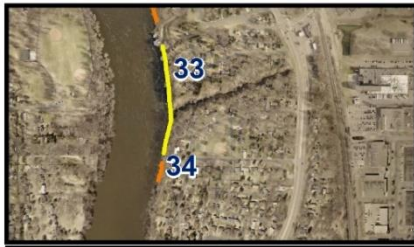
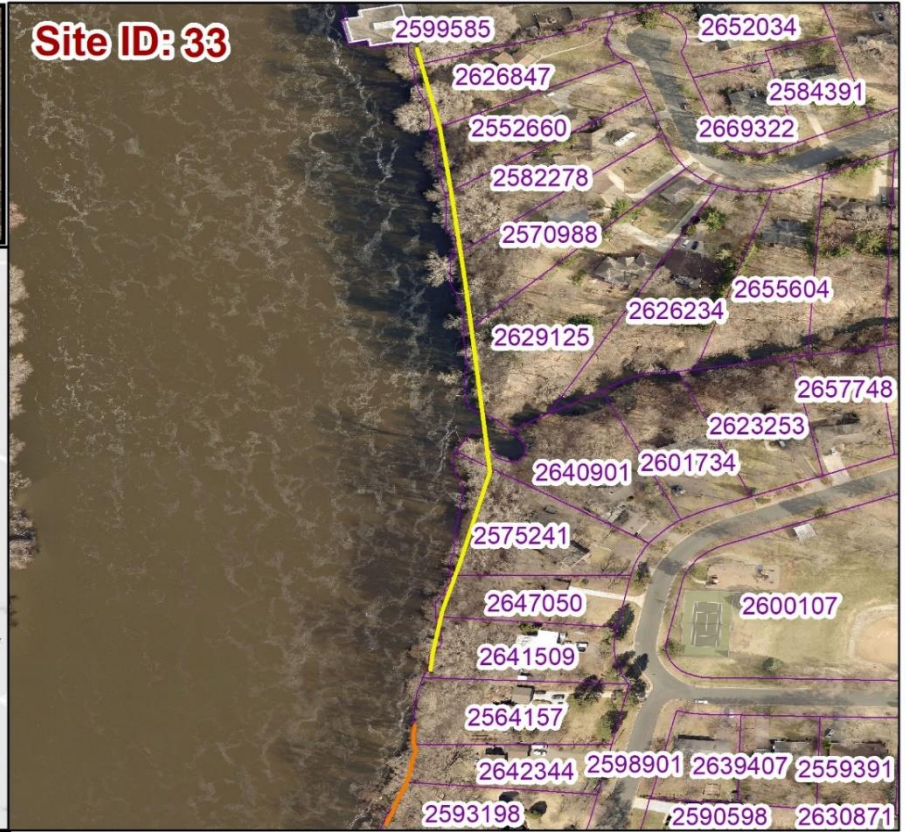
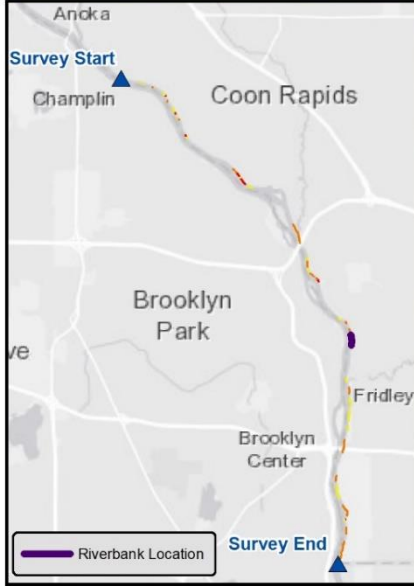
Site ID: 33

Description: An undercut has formed at the toe, exposing some root systems. The remainder of the slope is steep but currently well-vegetated.

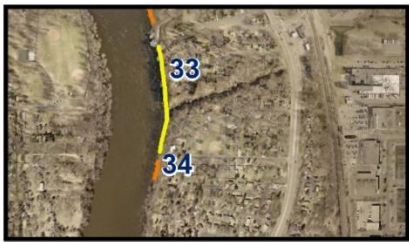
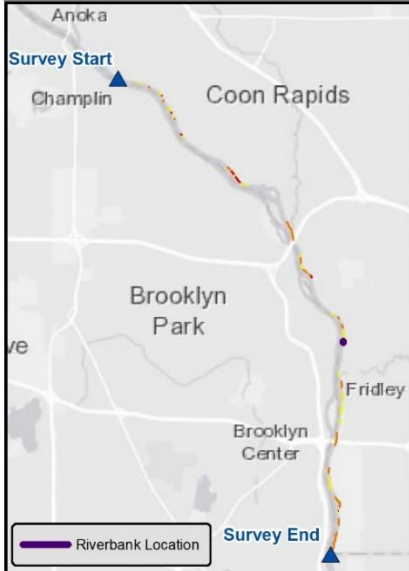
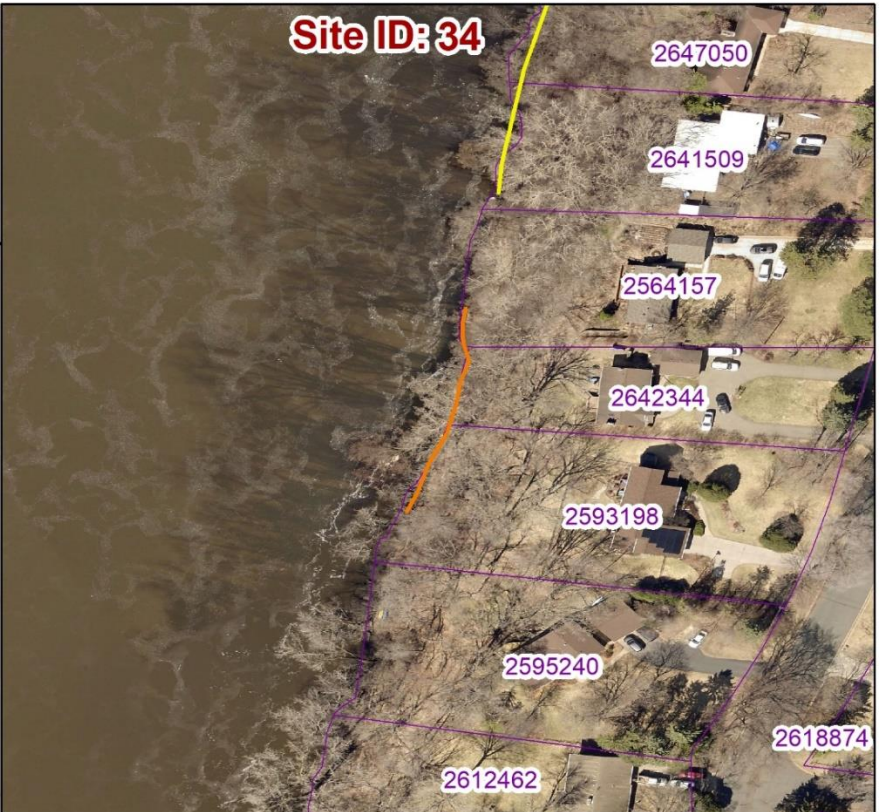
Description: On the northern and southern stretch, an undercut has formed. In the center, a slump is present, exposing tree roots and creating a vertical face.

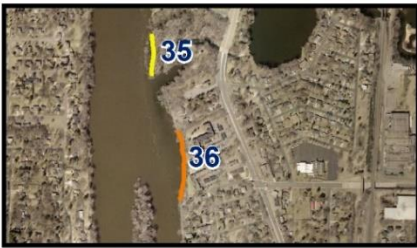
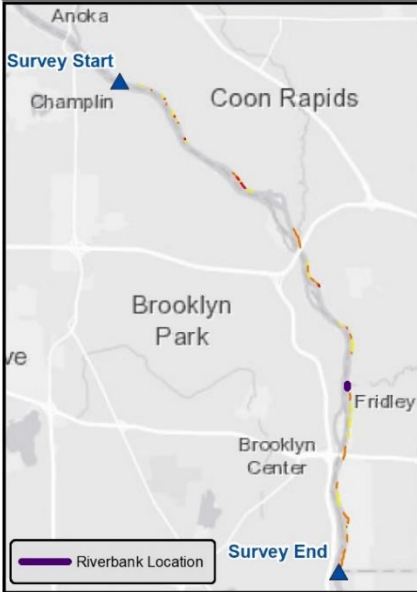
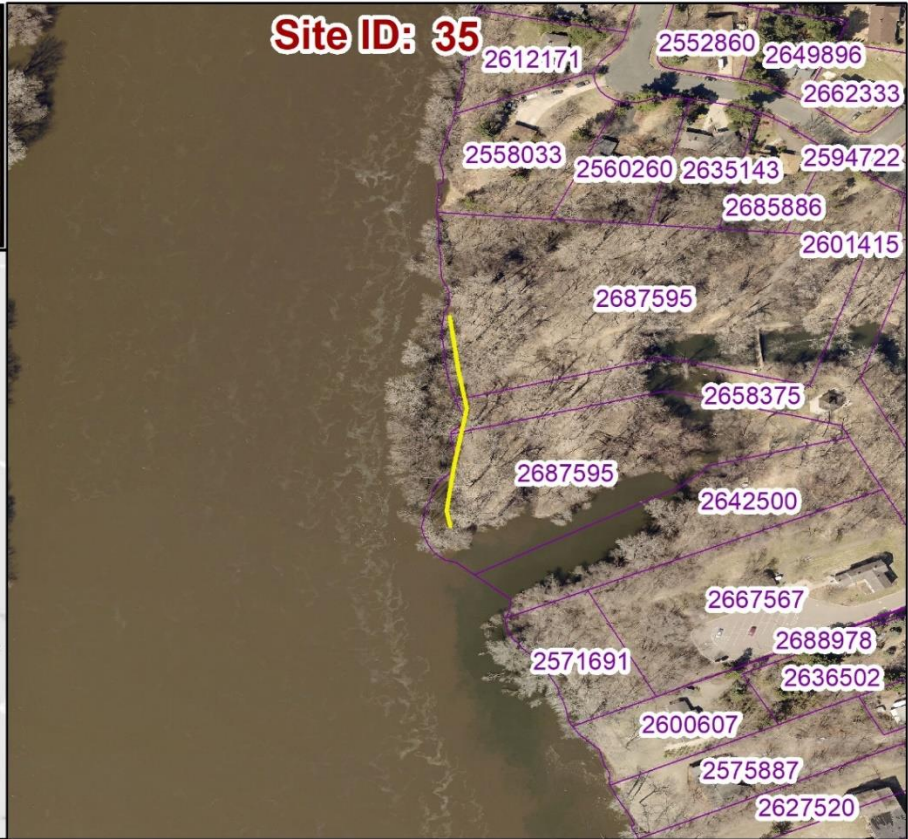
Description: This is a floodplain area with minimal slope, but the bank is vertical and several trees have fallen into the river. This is a Fridley park owned by Anoka County.

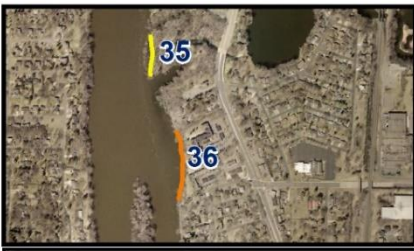
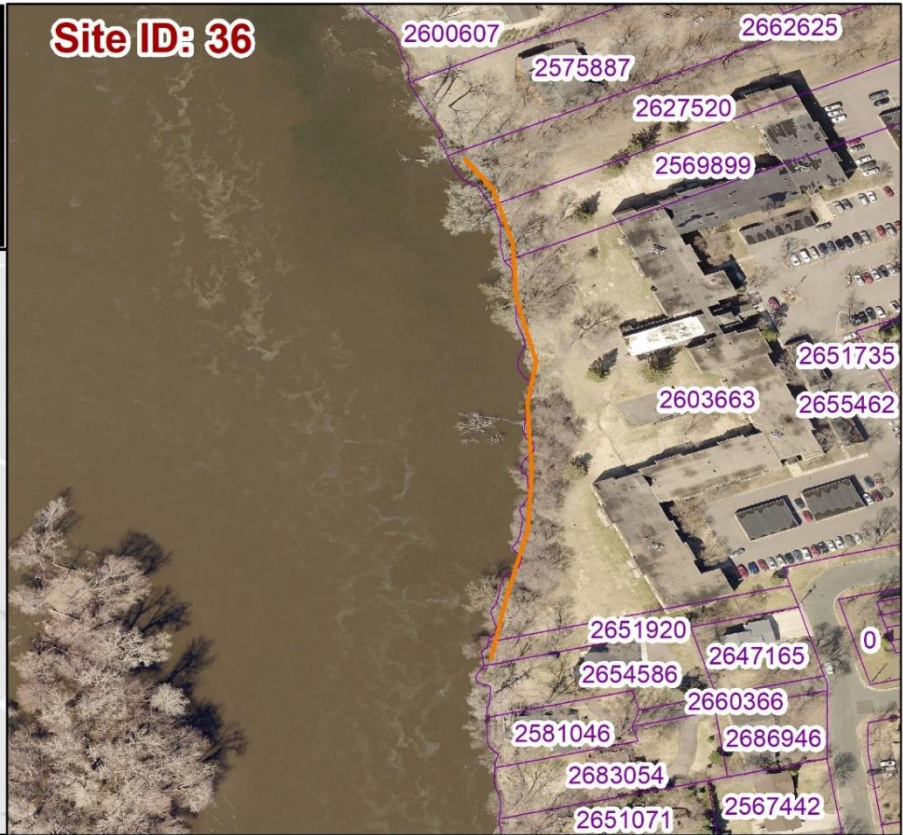
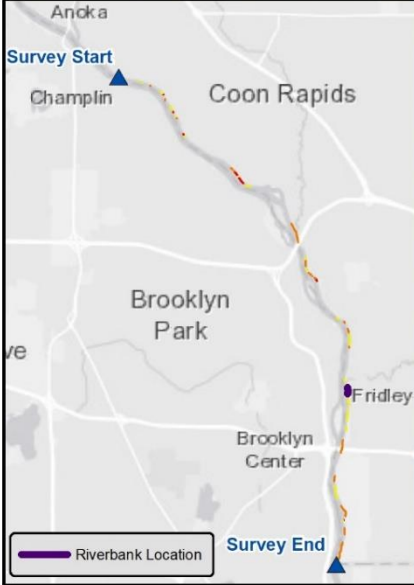
Site ID: 36

Description: Slope is very eroded but maintaining some vegetation. Several trees have fallen into the river and many root systems are exposed. 18' slumps are present throughout the stretch.

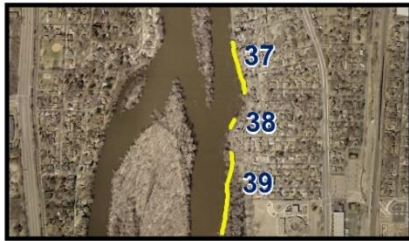
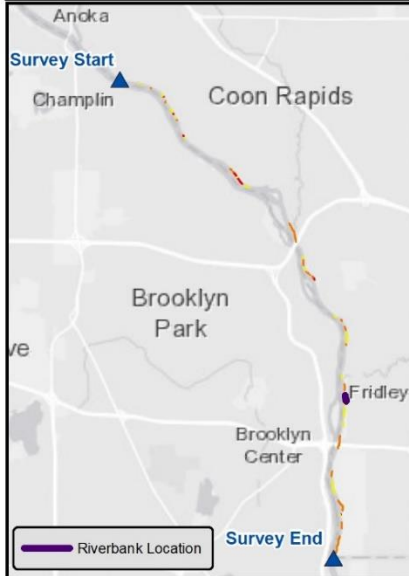
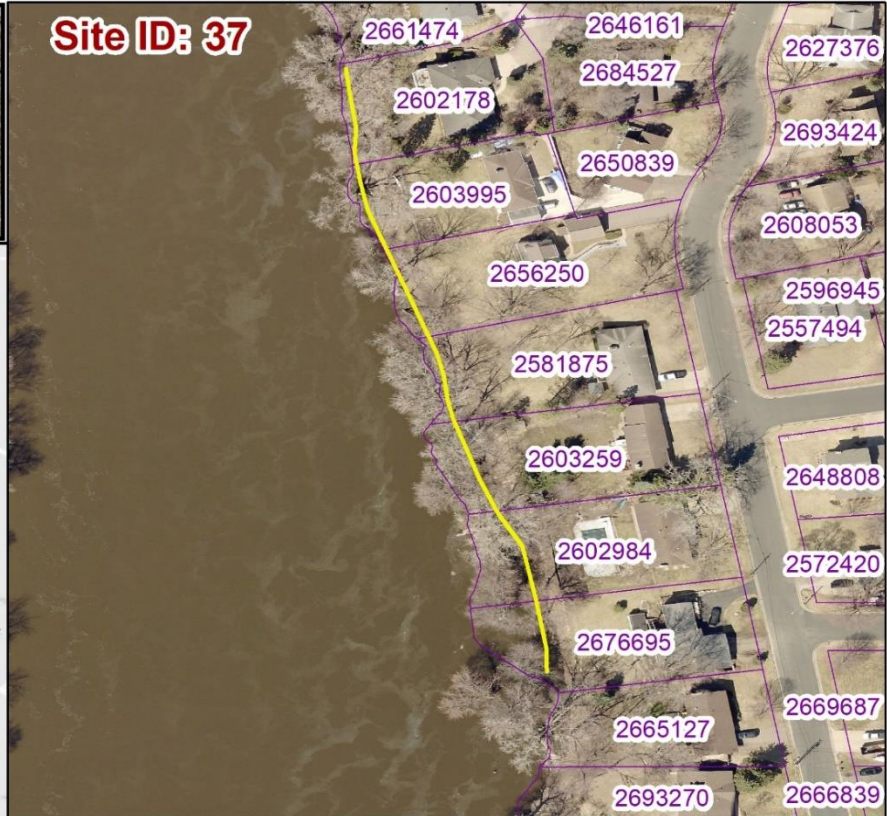
Site ID: 37

Description: Erosion has caused the toe to recede and the bank to become vertical with some exposed root systems. The most visible erosion is occurring only on the bottom section of the shoreline.

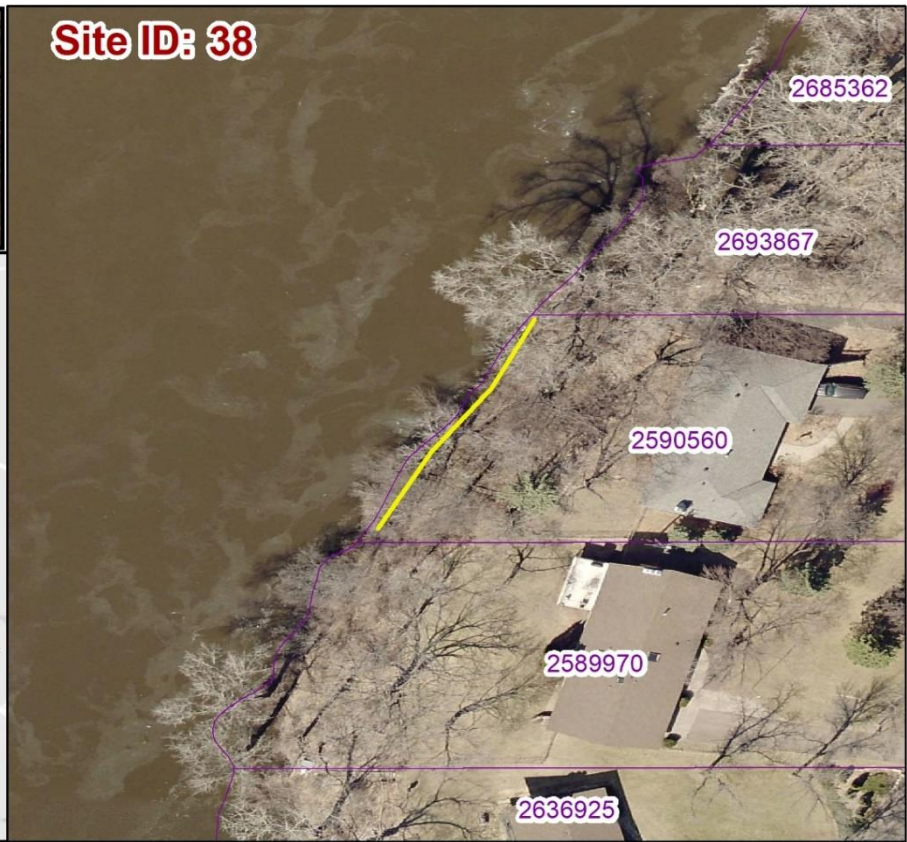
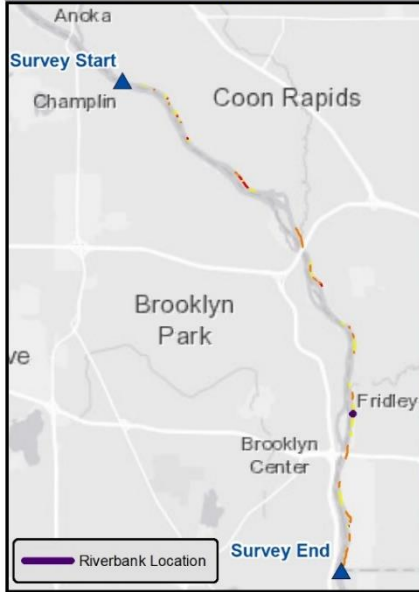
Site ID: 38

Description: Moderately eroded toe and slight 4' slump which has exposed root systems.

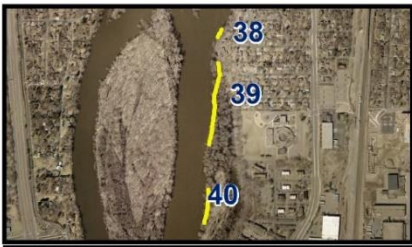
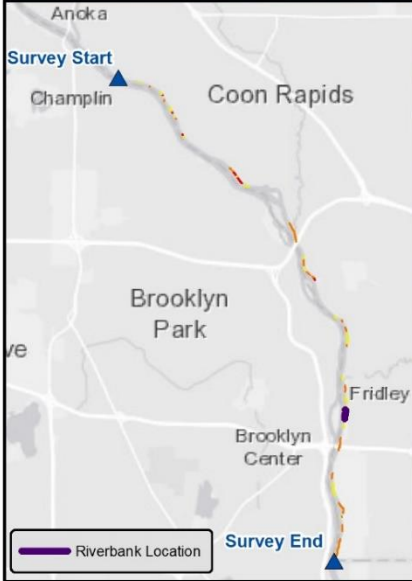
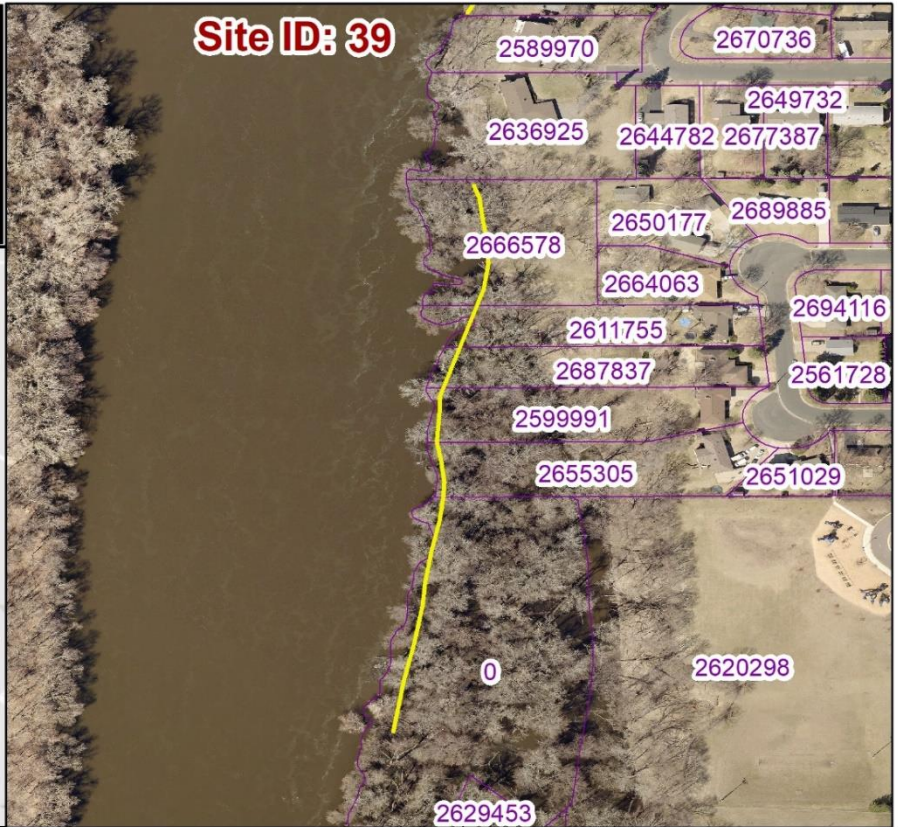
Description: Low-lying piece of land adjacent to more steeply sloped shoreline with moderate erosion creating a short vertical slope and exposed roots.

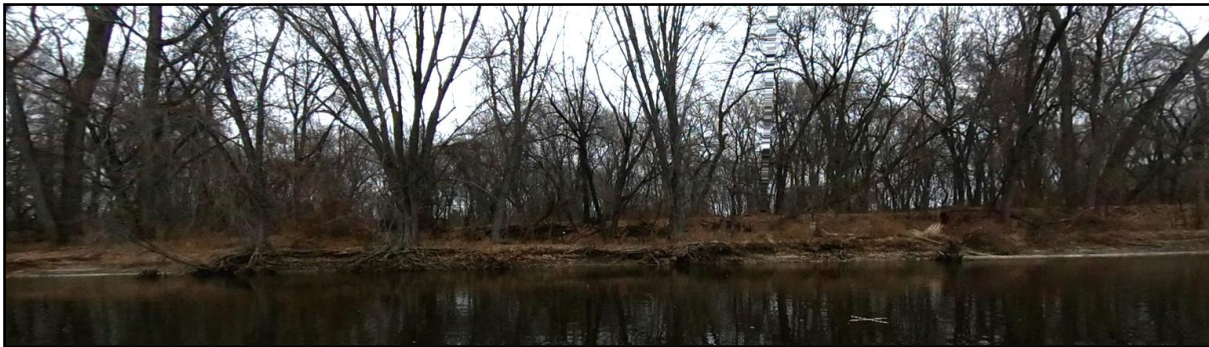
Description: Western shoreline of an island. There is little to no slope, but moderate erosion is causing a vertical edge and exposed roots/leaning trees.

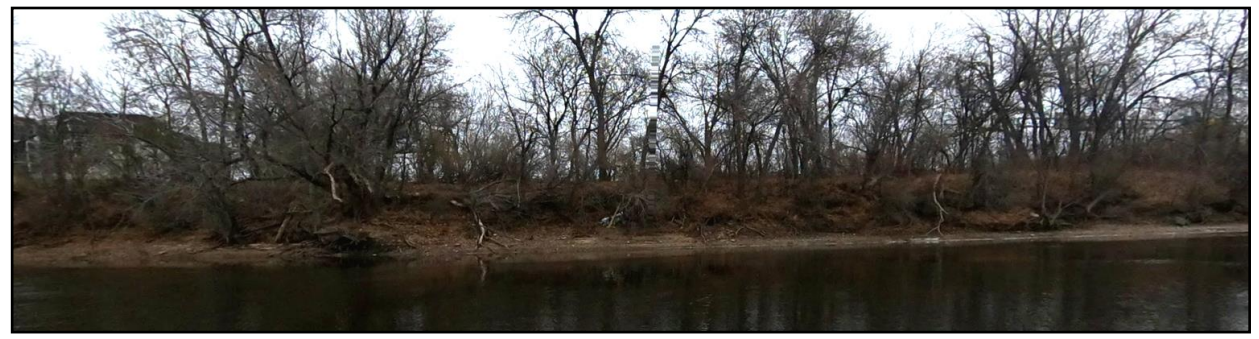
Description: The upstream portion contains an undercut toe that leads to an eroded slope with a slump and slight undercut. The remainder of the bank above the eroded portion contains intact vegetation.

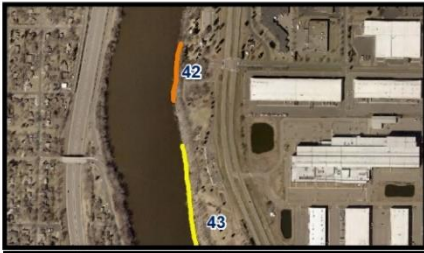
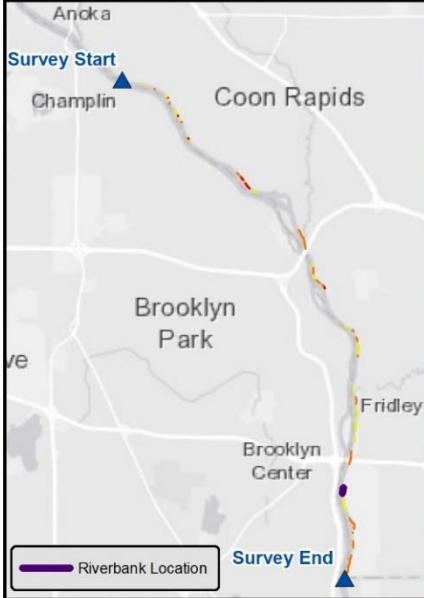
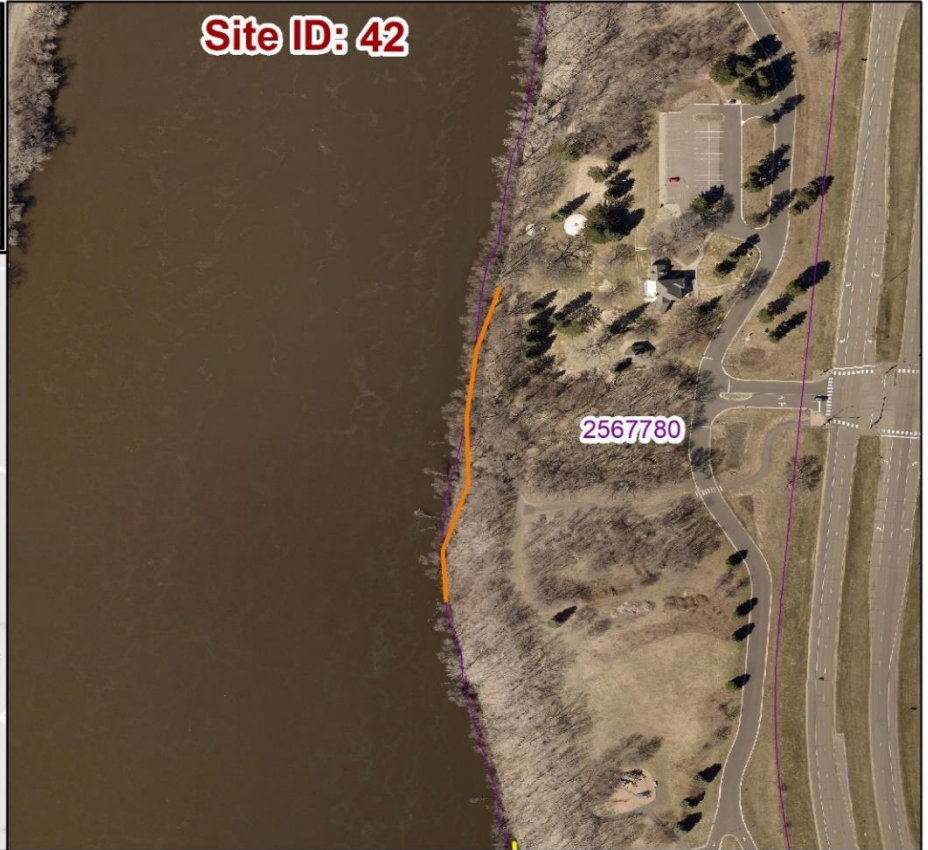
Site ID: 42

Description: Relatively short erosion height on a larger slope, but it has caused an undercut, exposed roots/leaning trees, and some moderate slumps.

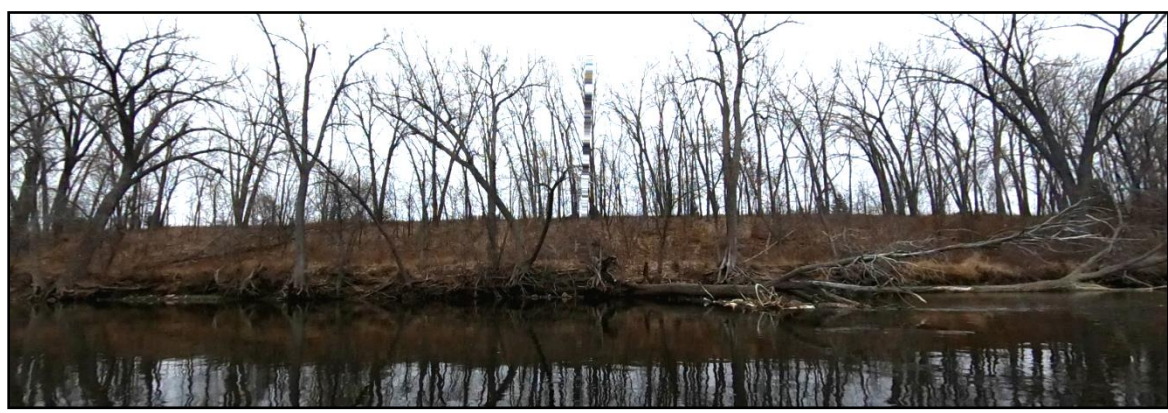
Description: Moderate erosion is causing some undercuts and minor slumps with overhanging trees and exposed roots.

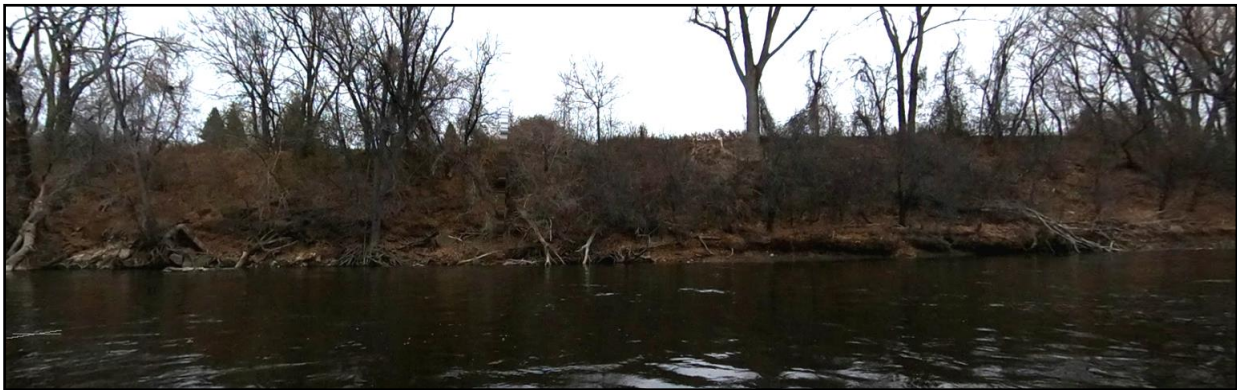
Description: Steep slope with bare soils, several fallen trees and intermittent slumps. Occasional undercuts have also formed throughout the stretch, exposing root systems.

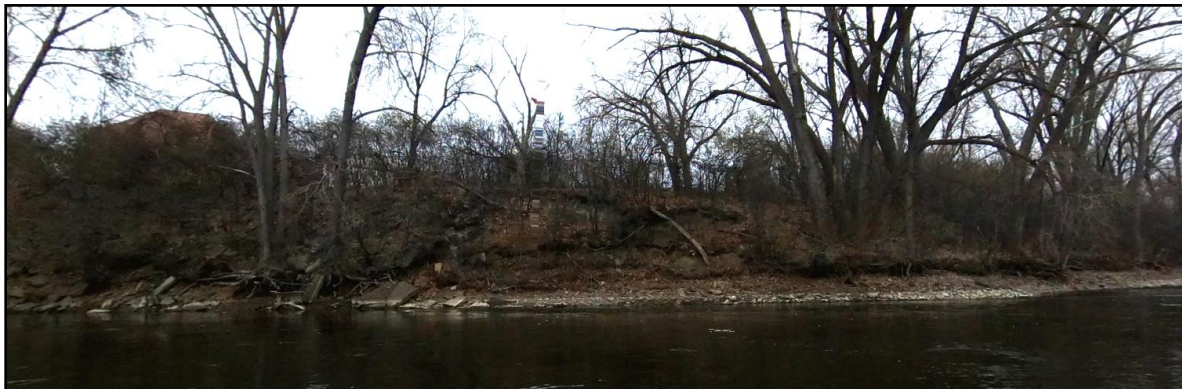
Site ID: 45

Description: Severe erosion is causing a vertical cliff. The adjacent stretch upstream is covered with concrete chunks stabilizing the bank.

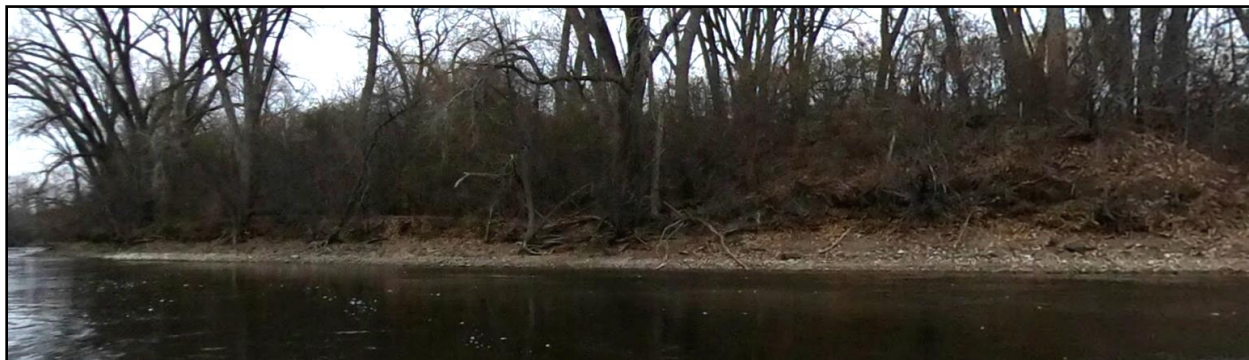
Site ID: 46

Description: An undercut at the toe is causing some vegetative overhang and exposed roots. Located along city of Minneapolis' water treatment facility.

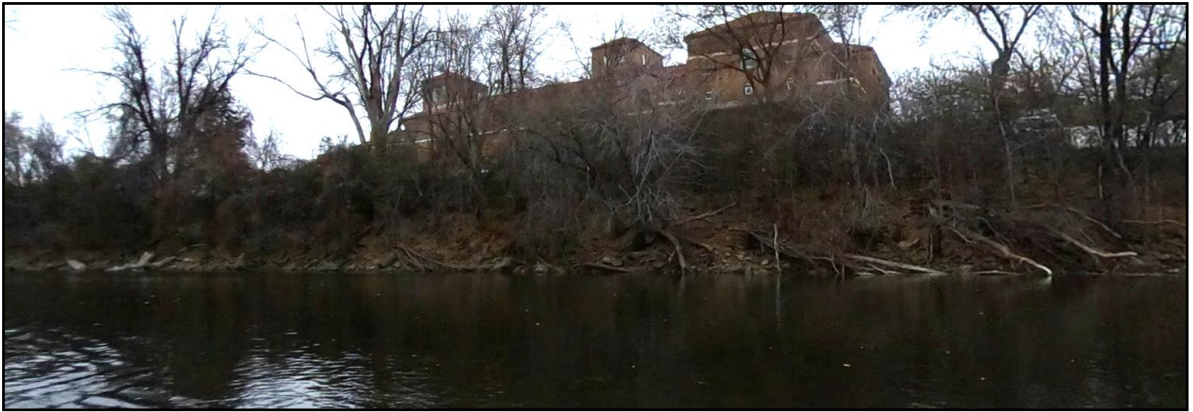
Description: The slope is mostly bare with several trees that have fallen over along the slumped zone. Adjacent to City of Minneapolis' water treatment facility.

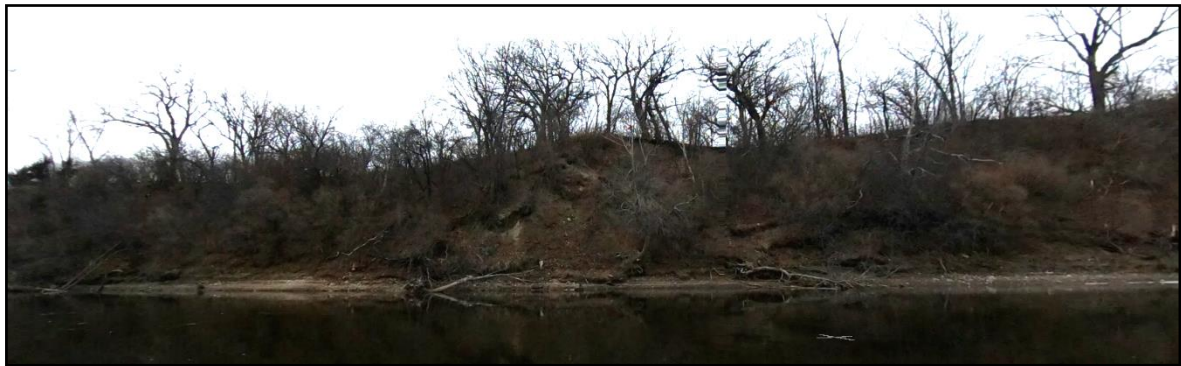
Description: Very steep slope ranging from 20' - 30' maintaining some vegetation but otherwise abundant in fallen trees and severely exposed roots from slumps/slips. An undercut toe is present in some portions. Adjacent to Minn. water treatment facility.
