# Rum River Field Assessment throughout the Upper Rum River WMO Area

*Upper Rum River Watershed Management Organization*

## Rum River Field Assessment

15 April 2010

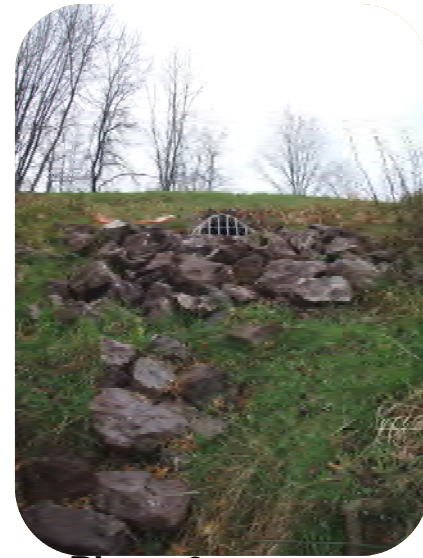
**Photo 6** – Stormwater outfall. 20" dia FES

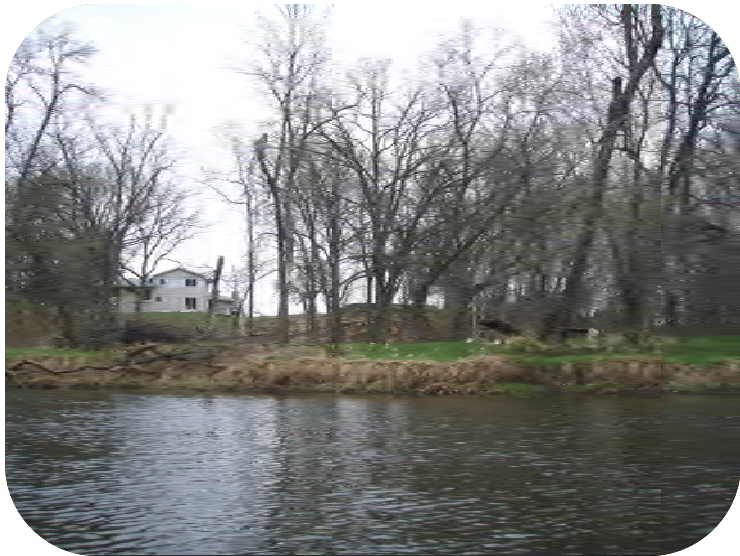
**Photo 9** – Earthwork and nearly bare soil (sparse straw cover) associated with home or septic construction.

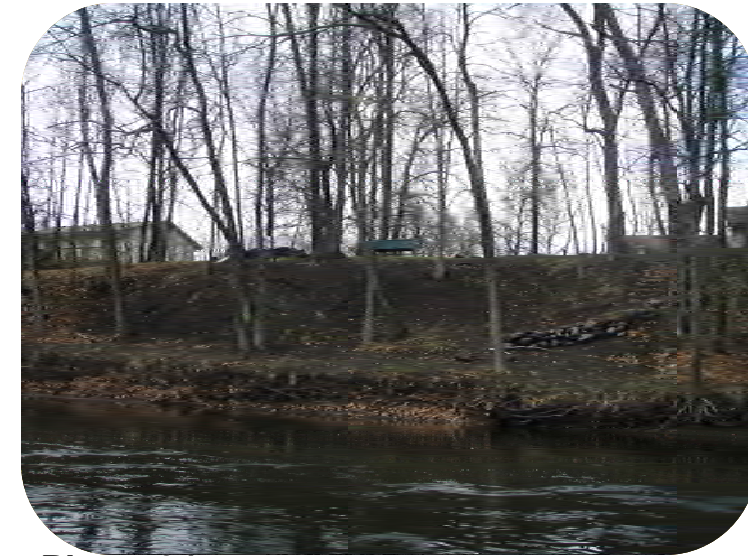
**Photo 24** – Removed all ground and leaf cover across slope. No apparent erosion, but a poor practice.

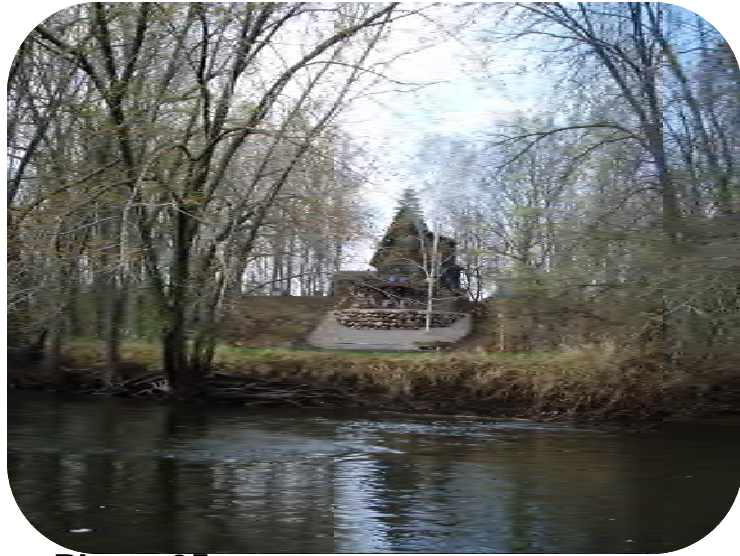
**Photo 25** – A-frame house on bluff. Rock work to stabilize toe of slope. Also see Photos 26, 27.

**Photo 26** – See Photo 25 description.

**Photo 27** – See Photo 25 description.

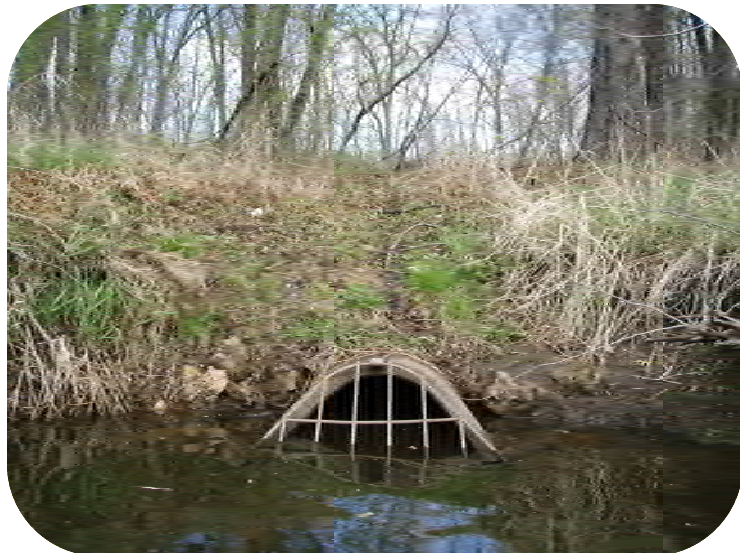
**Photo 29** – 36 in. wide, 20 in. tall FES, with trash rack, outlets at water level.

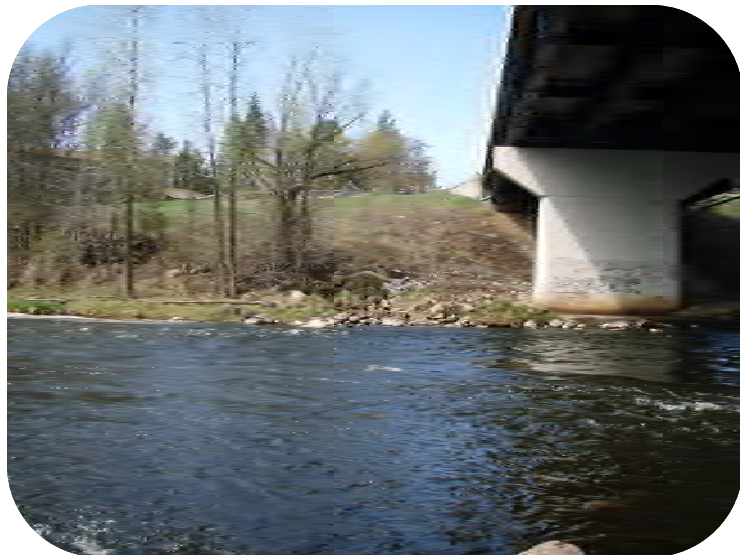
**Photo 31** – Outfall with concrete water break and rock apron. Also see Photo 32.

**Photo 32** – See Photo 31 description.

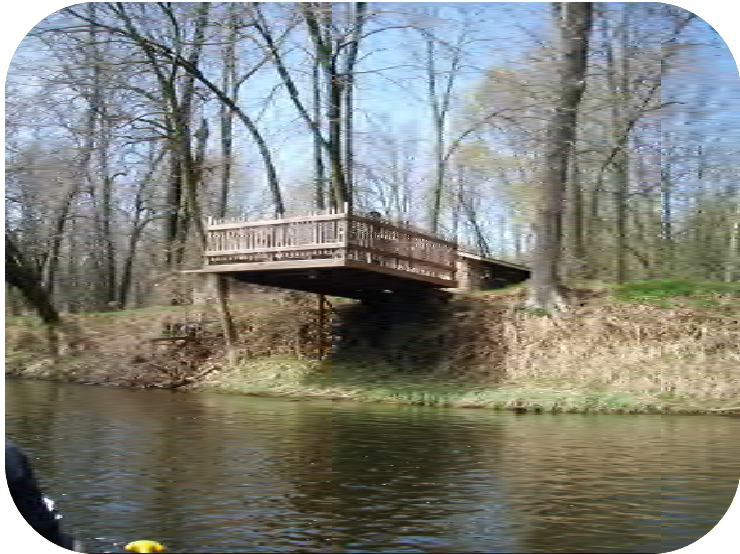
**Photo 33** – Approx. 10 ft. by 10 ft. deck cantilevered over water's edge. No apparent erosion.

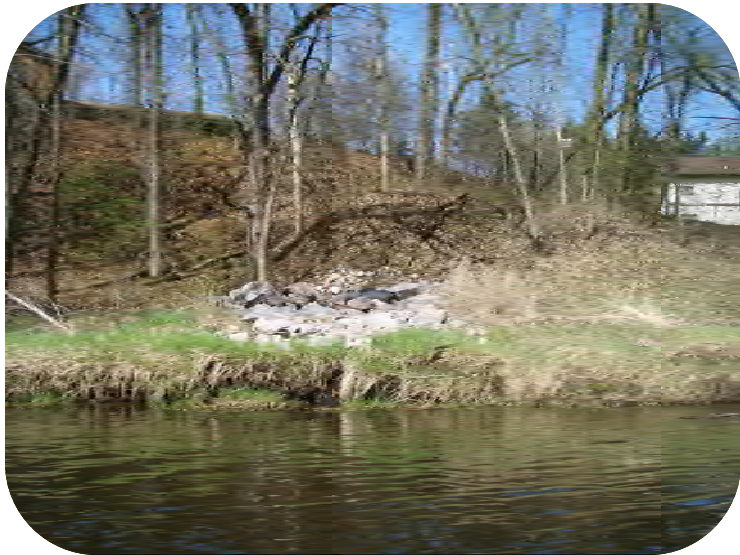
**Photo 35** – Outlet 18-24 in diam. with flow separator. Large rock below, no apparent erosion. Also see Photo 36.

**Photo 36** – See Photo 35 description.

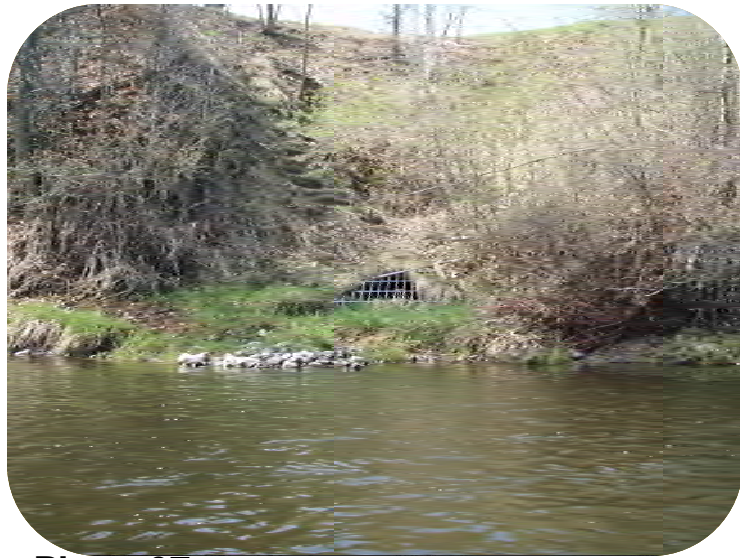
**Photo 37** – Outlet with flared end section 66 in. wide, 32 in. tall with trash rack.

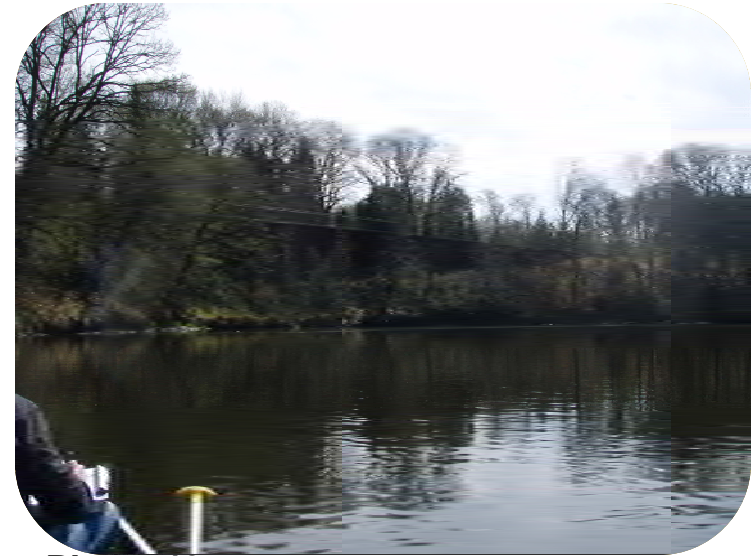
**Photo 38** – 12" pipe at toe of bank. Moderate erosion with homeowner-attempted repair. Also see Photo 39.

**Photo 39** – See Photo 38 description.

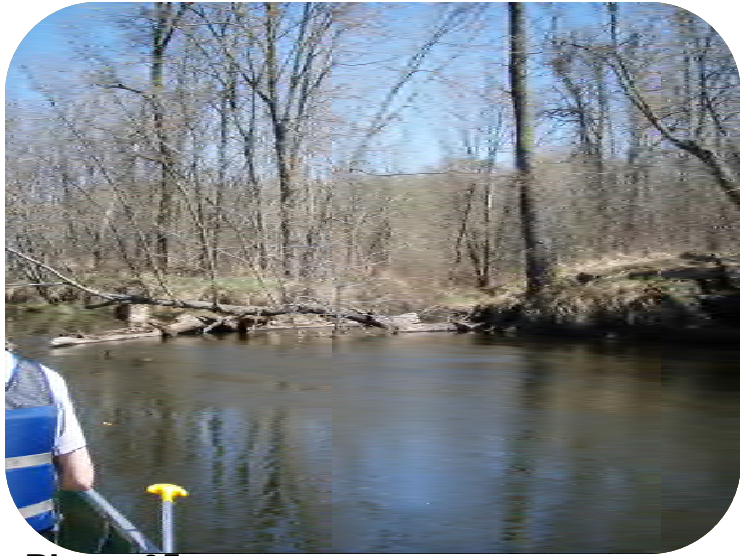
**Photo 63** – Sunken boat pulled onto bank. Also see Photo 64.

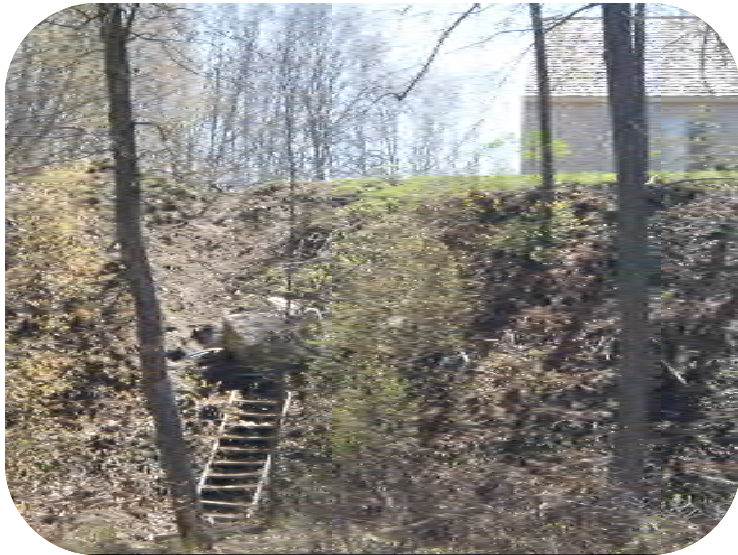
**Photo 70** – High bank with good tree cover. No recommended action. Also see Photos 71, 72, 73, and 74.

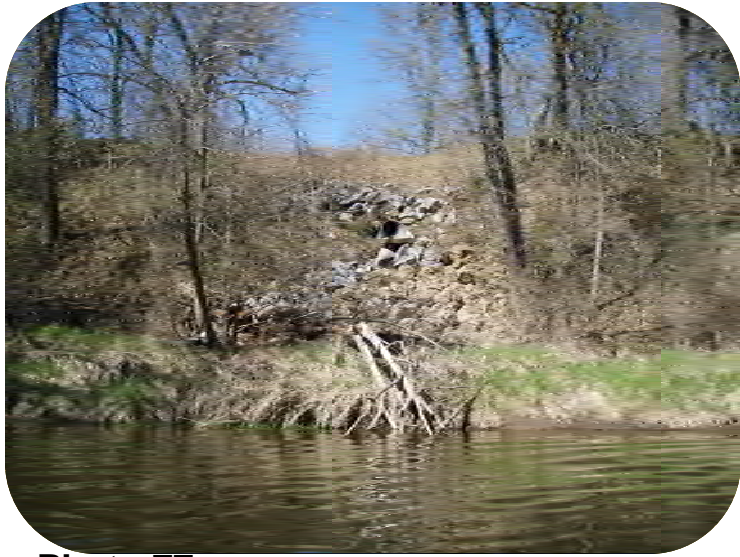
**Photo 76** – Approx. 3 in. diam. PVC outlet near toe of slope with high flow and erosion.

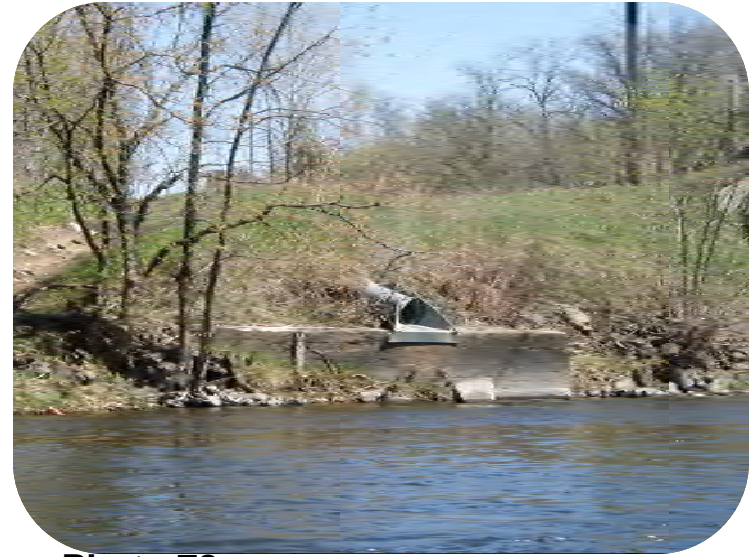
**Photo 77** – Approx. 18 in. outlet at midpoint of slope with flowing water, rock above and below, and no erosion.

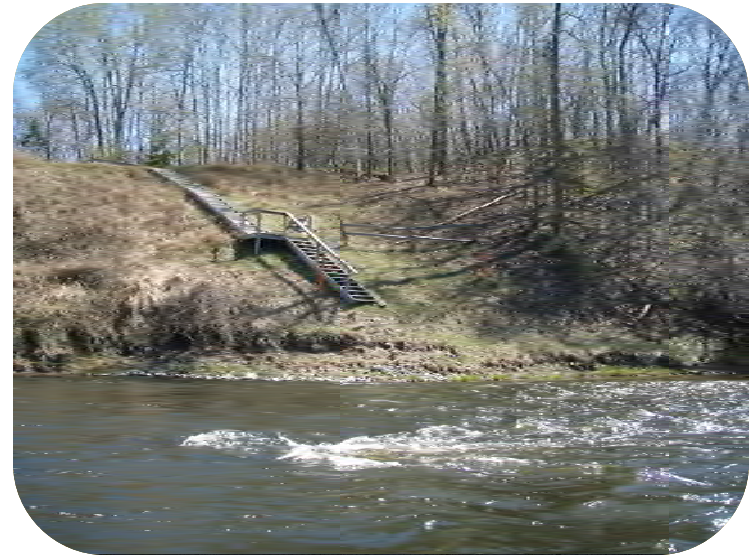
**Photo 84** – Gas pipeline crossing. Also see Photo 85.

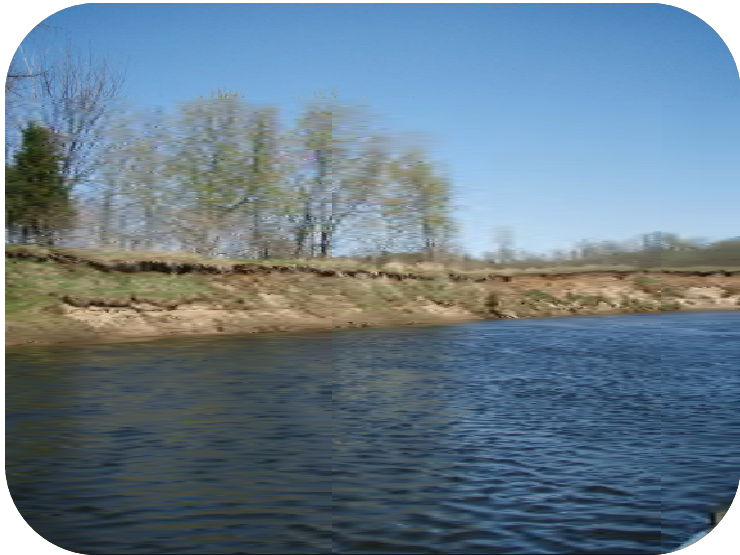
**Photo 91** – Severe erosion, 20 ft. back with fence over water. Also see Photos 92, 93, 94, 95, and 96.

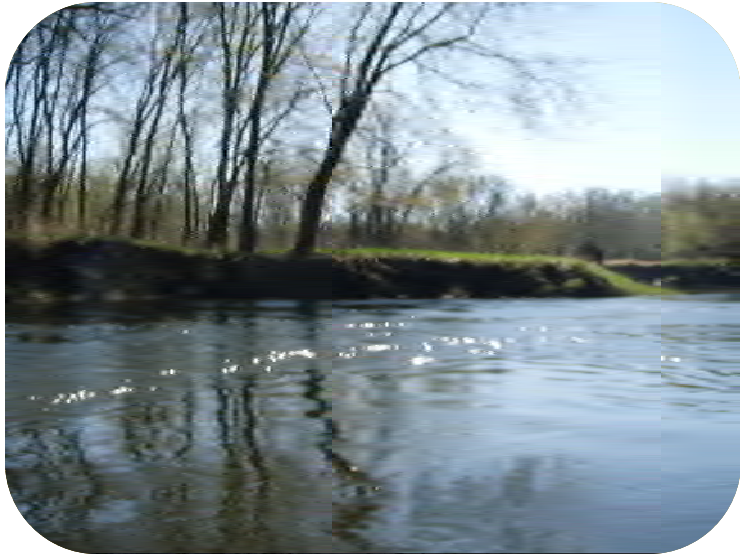
**Photo 97** – Mild erosion. Also see Photo 98.

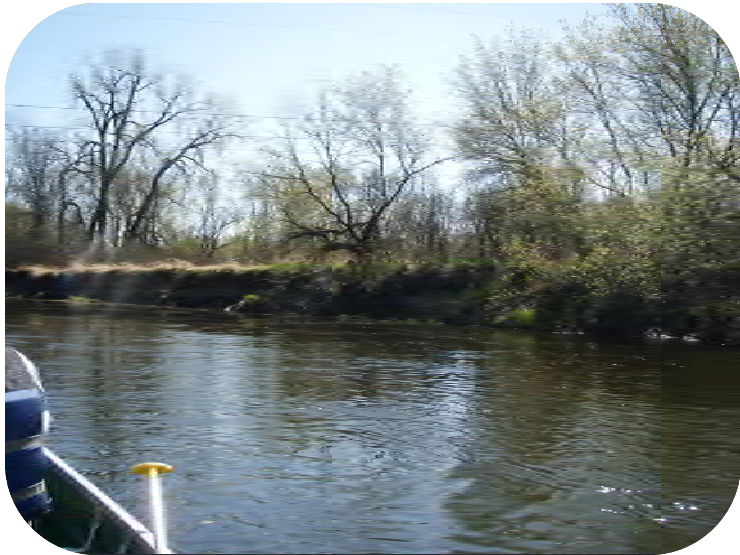
**Photo 99** – Moderate erosion. Also see Photos 100, 101, and 102.

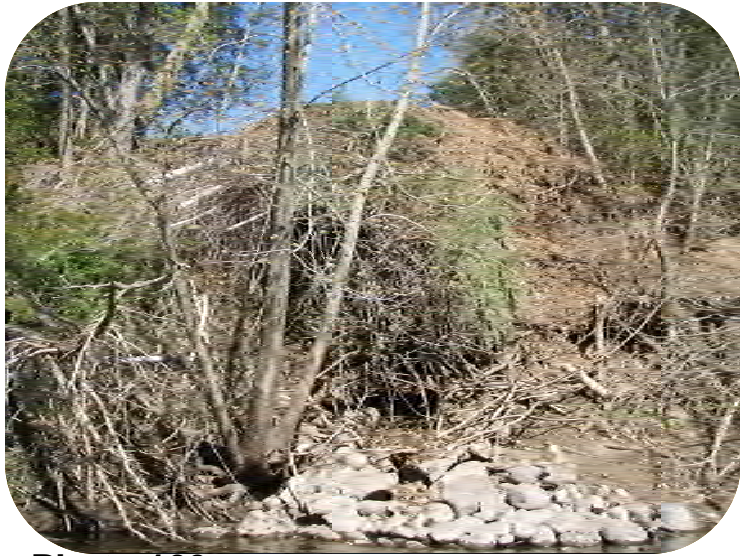
**Photo 109** – Approx. 24" flared end section and yard waste piled above. Also see Photos 110, 111, 112, 113.
