# Rum River Field Assessment throughout the Upper Rum River WMO Area

*Upper Rum River Watershed Management Organization*

## Rum River Field Assessment

15 April 2010

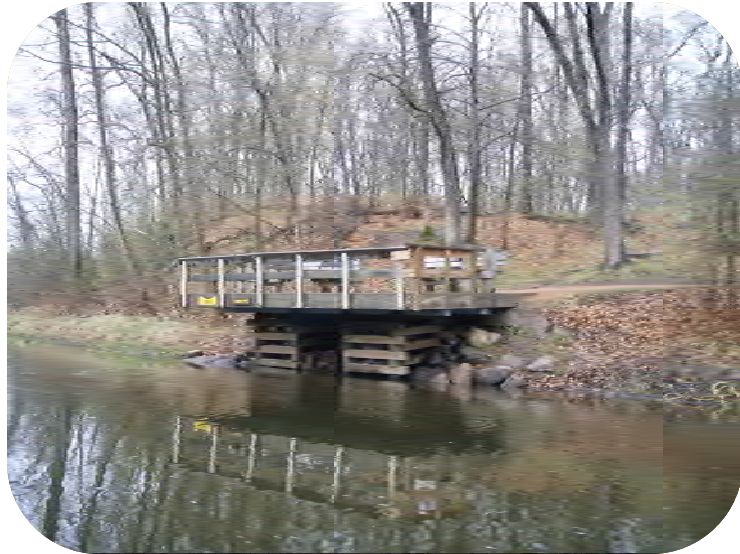
**Photo 1** – Fishing pier at Rum River North County Park.

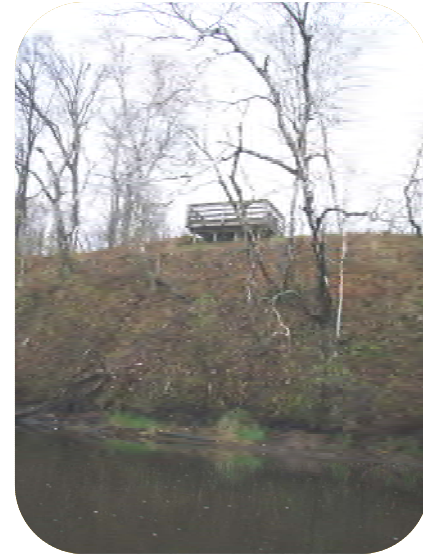
**Photo 2** – Observation deck in Rum R North Co Park

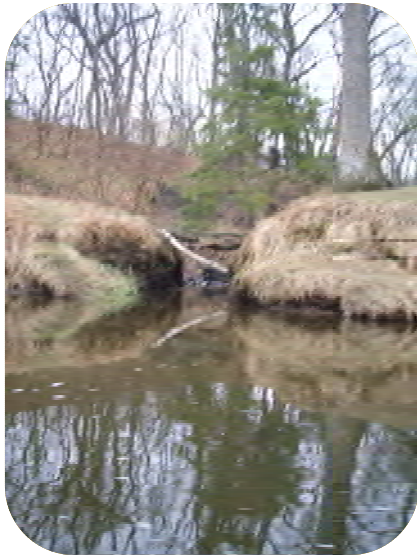
**Photo 3** – Small inlet.

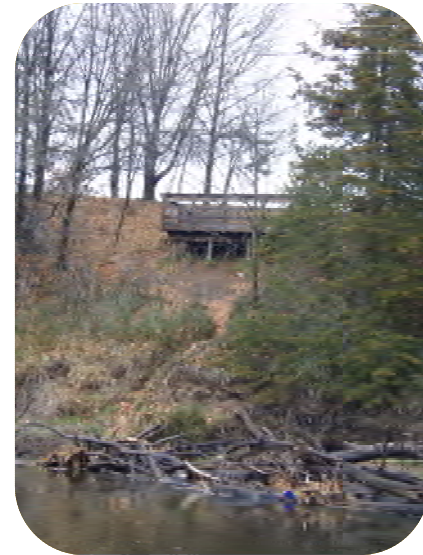
**Photo 4** – Observation deck in Rum R North Co Park

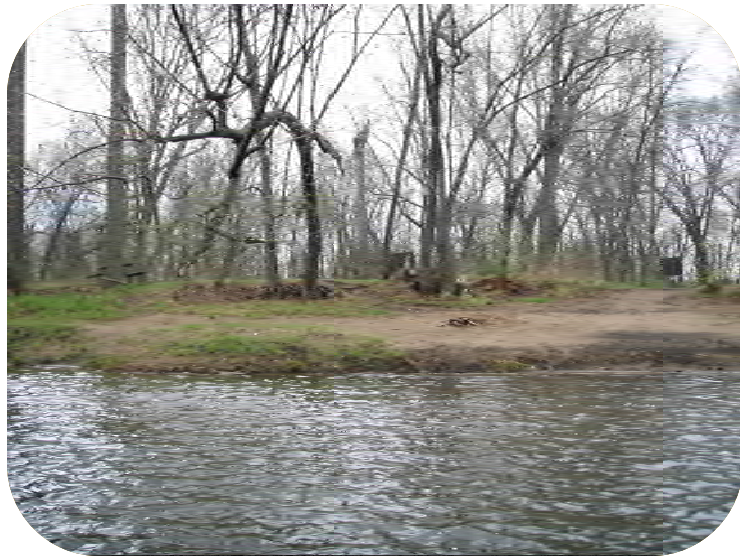
**Photo 5** – Picnic site in Rum R North Co Park.

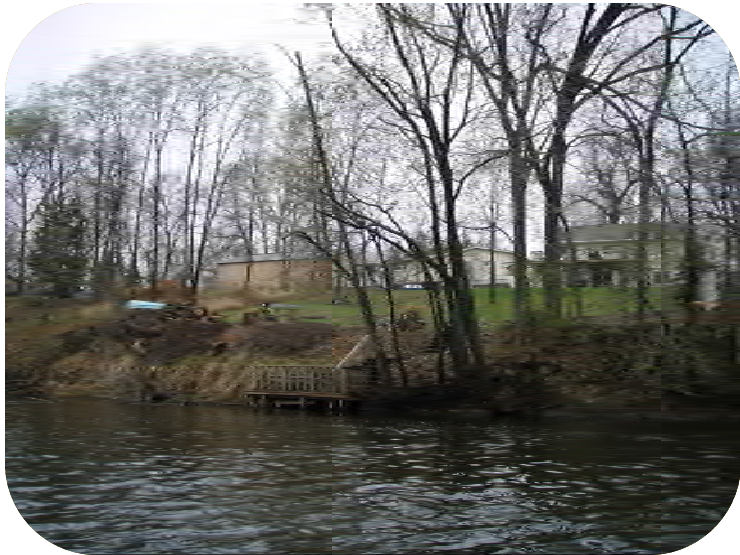
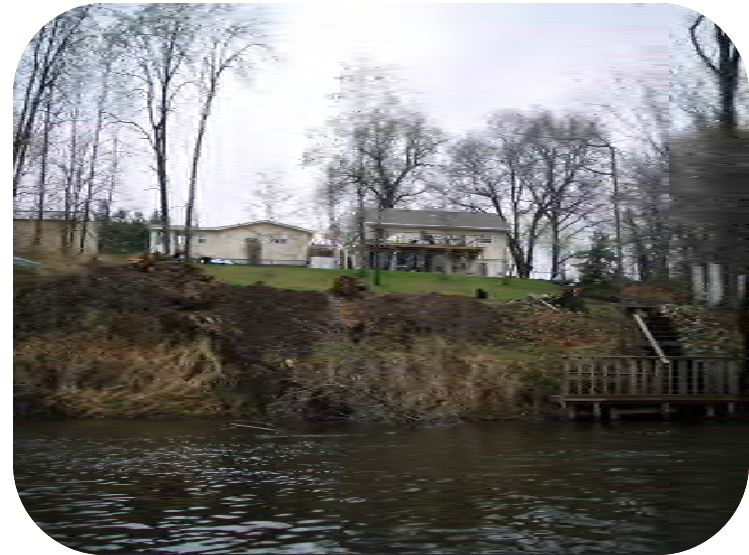
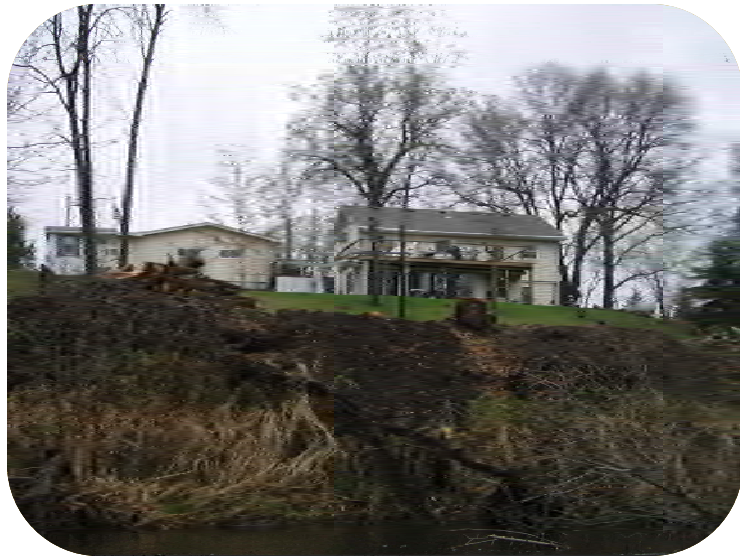
**Photo 10** – Cleared all large near-shore trees. Pushed soil over riverbank. Also see photos 11,12, &13.

**Photo 11** – See Photo 10 description.

**Photo 12** – See Photo 10 description.

**Photo 13** – See Photo 10 description.

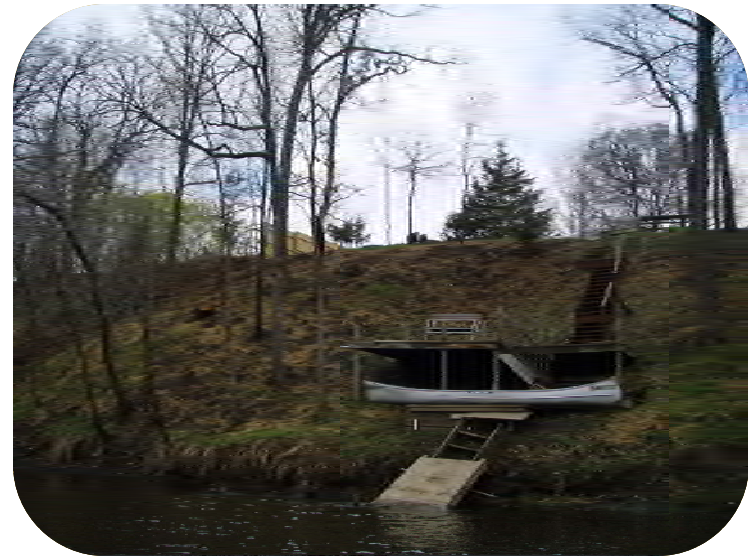
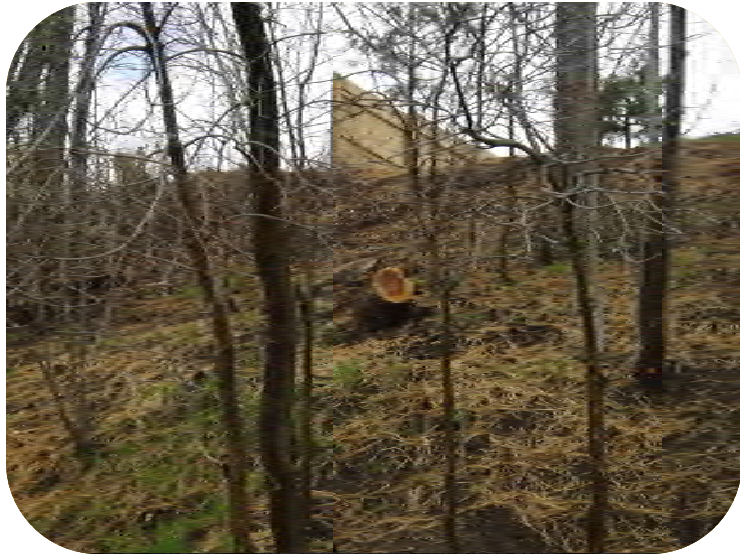
**Photo 15** – Cleared understory veg., left large trees. Bare soil sparsely straw covered. Also see photos 16, 17.

**Photo 16** – See Photo 15 description.

**Photo 17** – See Photo 15 description.

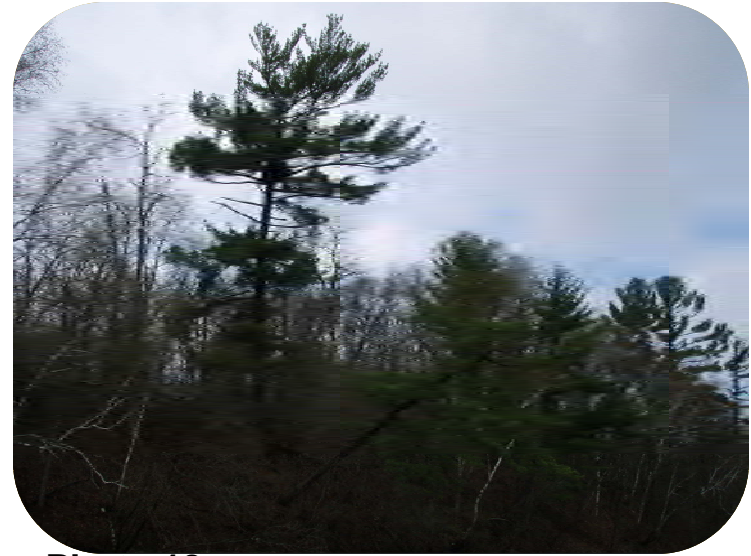
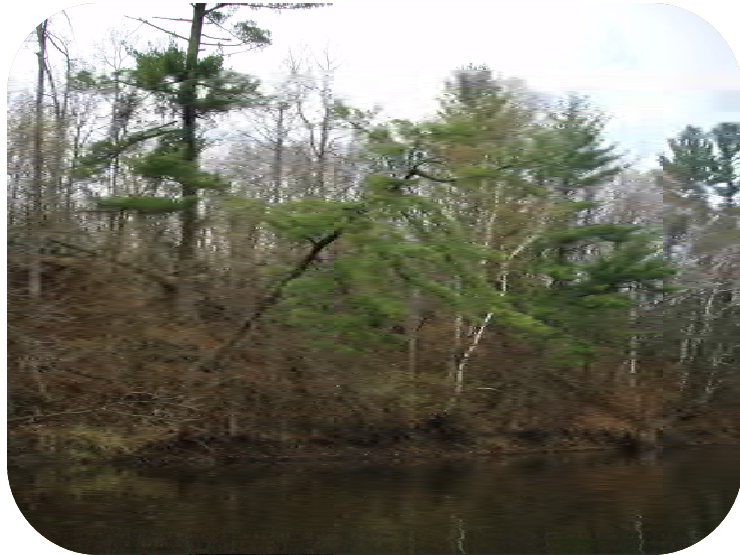
**Photo 18** – Scenic photo of White Pine overhanging river. Also see Photo 19.

**Photo 19** – See Photo 18 description.

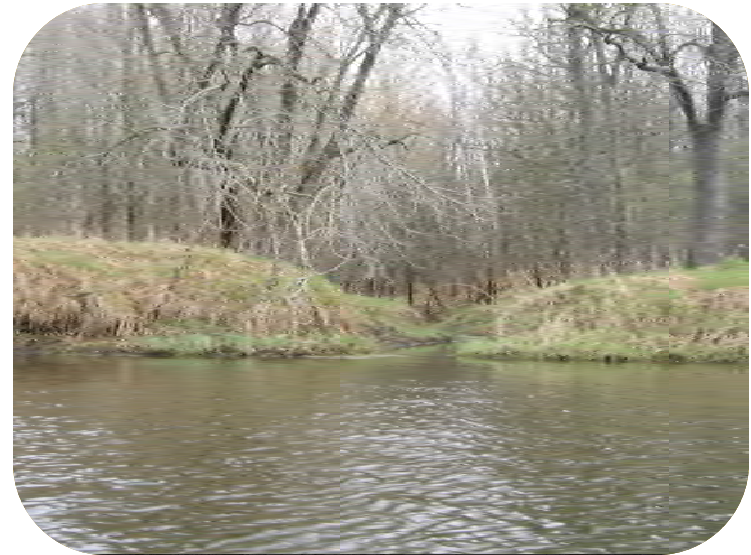
**Photo 20** – Stream inlet approx. 10 ft. wide, low water level.

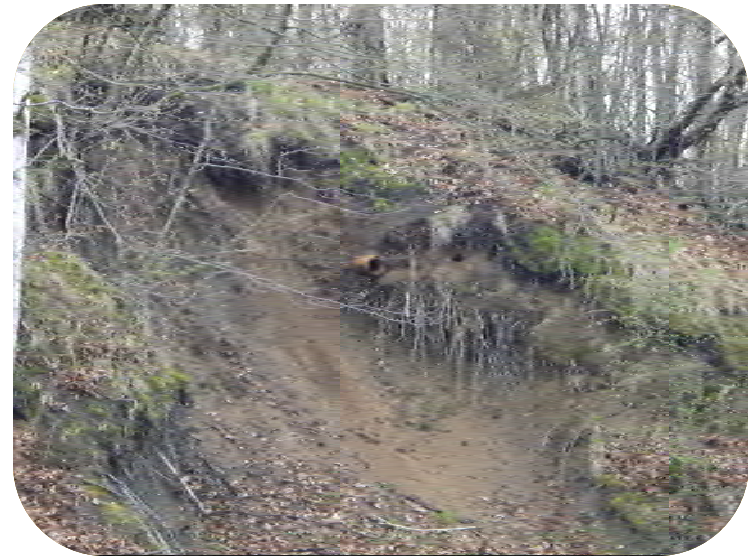
**Photo 7** – Outfall pipe high on slope causing bank failure. 6-8" dia pipe.

**Photo 22** – See Photo 7 description.

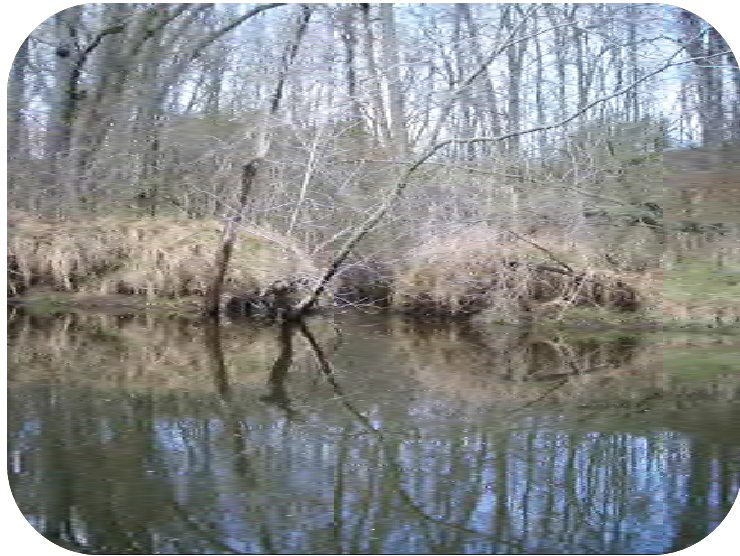
**Photo 23** – Stream inlet approx. 4 ft. wide.

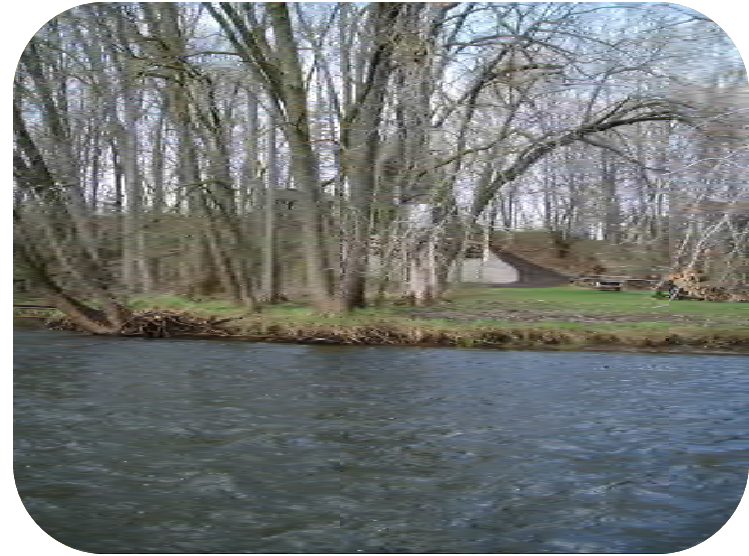
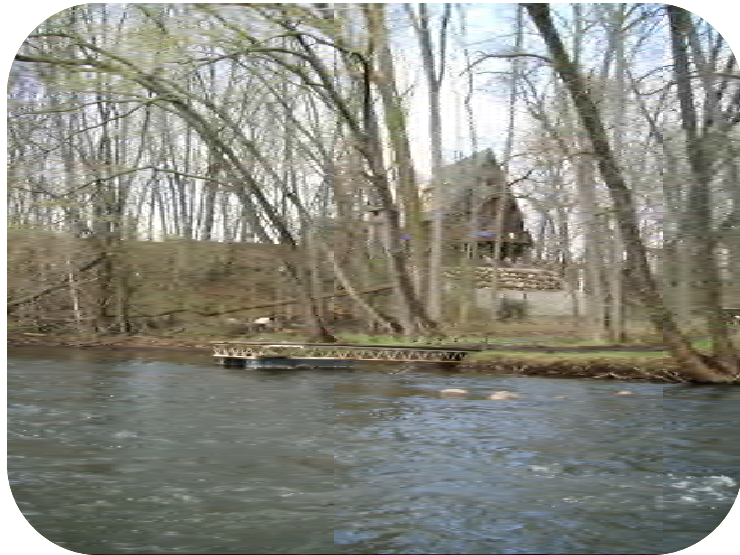
**Photo 25** – A-frame house on bluff. Rock work to stabilize toe of slope. Also see Photos 26, 27.

**Photo 26** – See Photo 25 description.

**Photo 27** – See Photo 25 description.

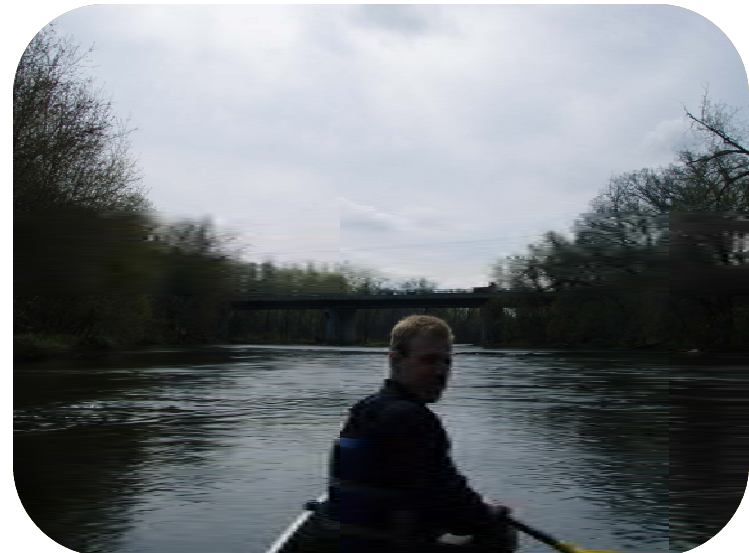
**Photo 30** – County Highway 24 bridge in St. Francis.

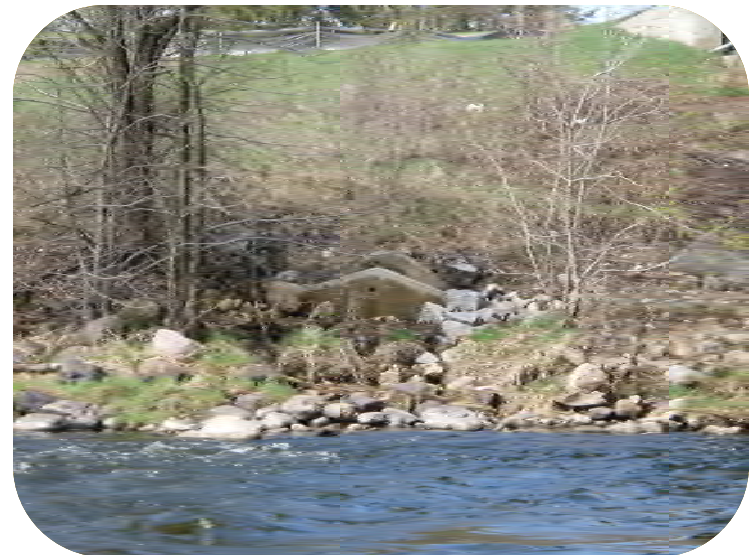
**Photo 31** – Outfall with concrete water break and rock apron. Also see Photo 32.

**Photo 32** – See Photo 31 description.

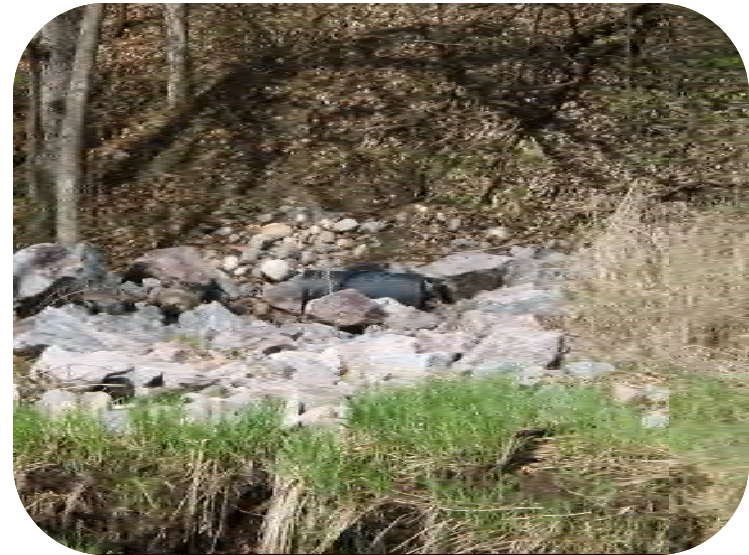
**Photo 35** – Outlet 18-24 in diam. with flow separator. Large rock below, no apparent erosion. Also see Photo 36.

**Photo 36** – See Photo 35 description.

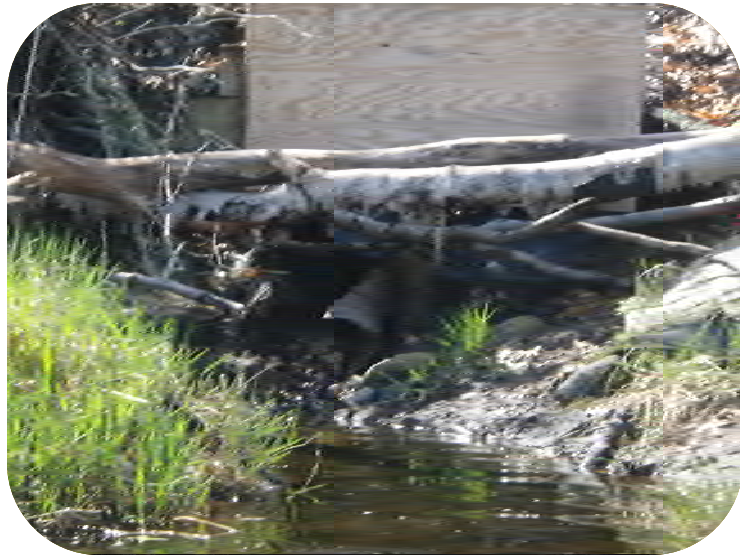
**Photo 38** – 12" pipe at toe of bank. Moderate erosion with homeowner-attempted repair. Also see Photo 39.

**Photo 39** – See Photo 38 description.

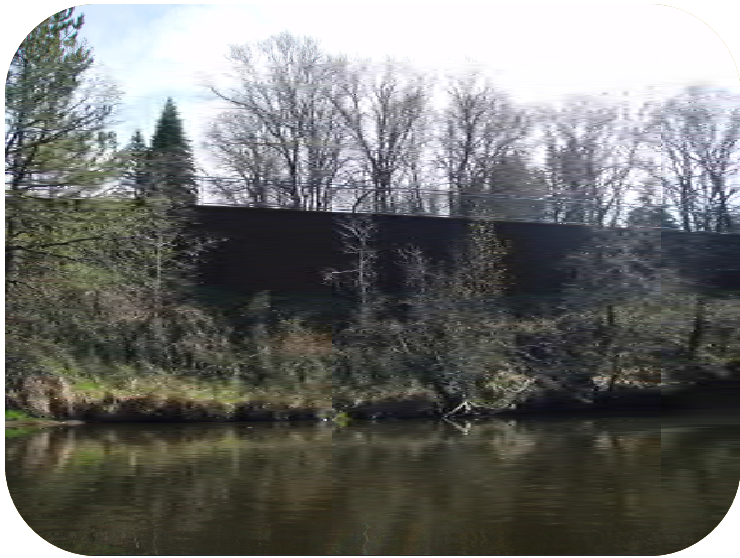
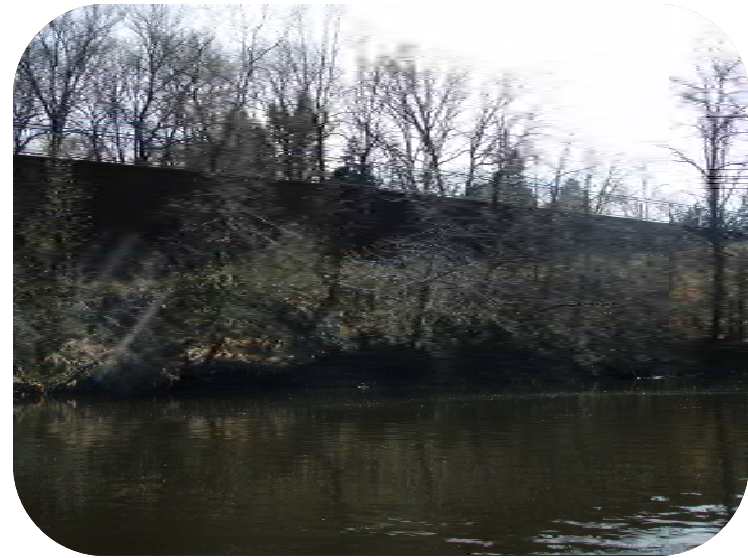
**Photo 40** – Driven piling flood wall to eliminate outer bank erosion. Also see Photos 41 and 42.

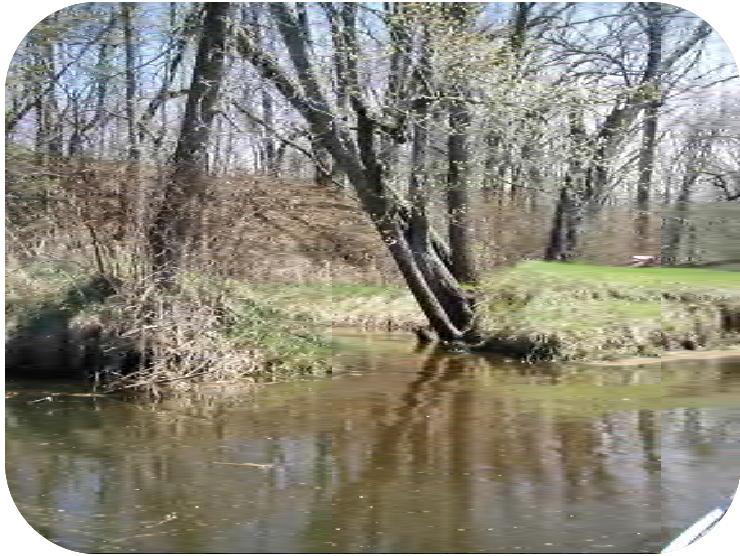
**Photo 44** – Approx. 24 in. flared end section exiting bank at midpoint of slope with concrete apron.

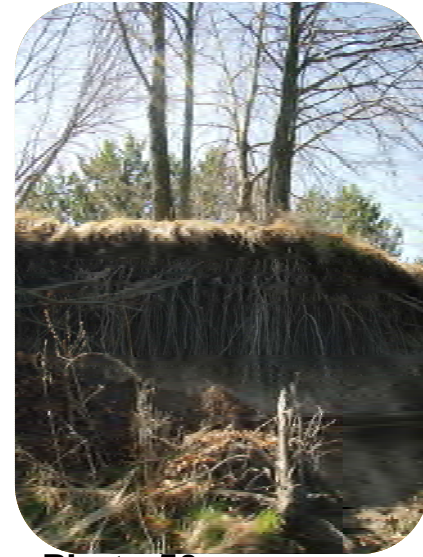
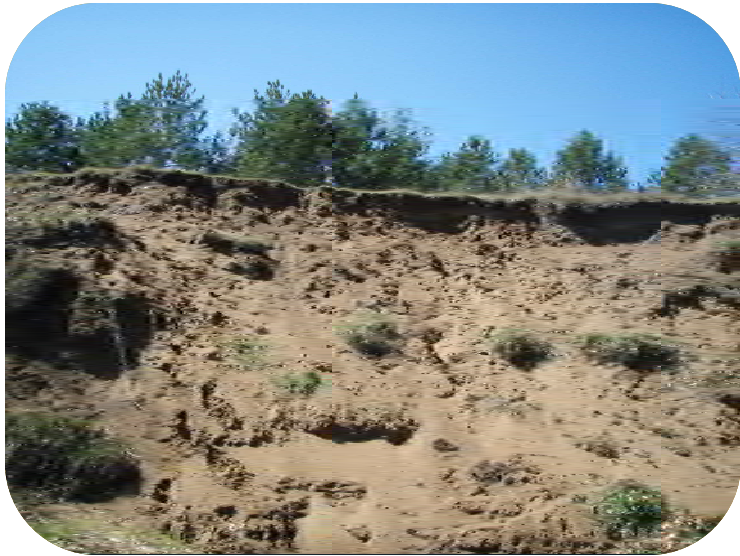
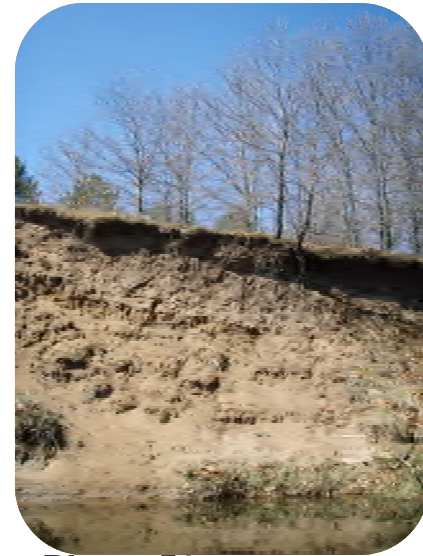
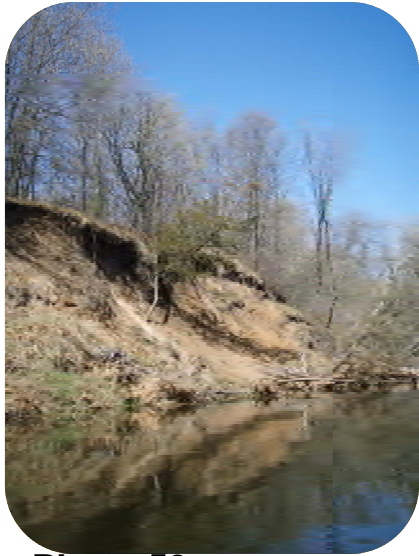
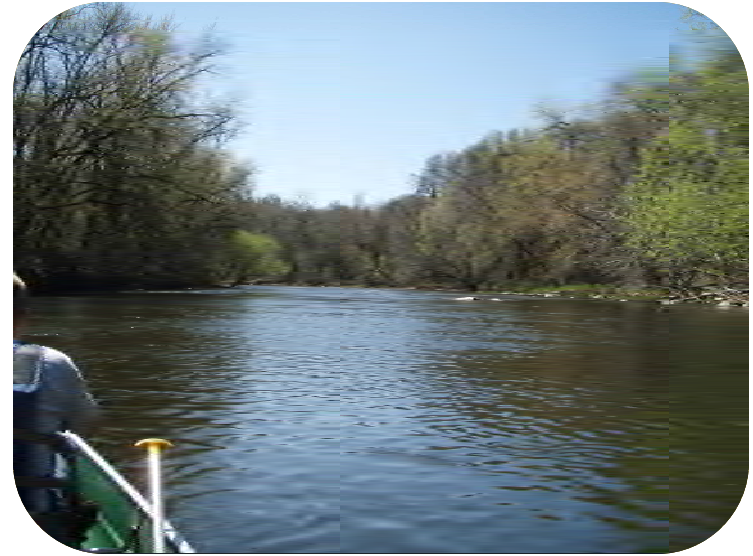
**Photo 46** – Severe erosion. Also see Photos 47, 48, 49, 50, 51, 52, and 53.

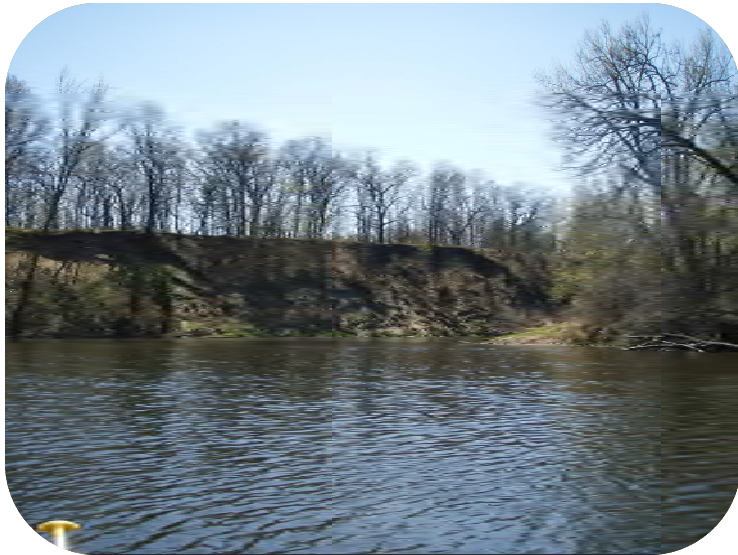
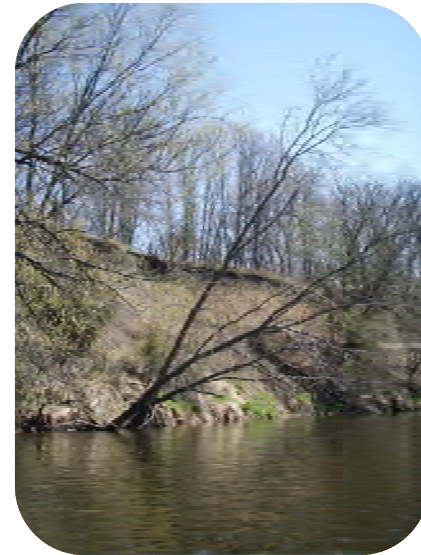
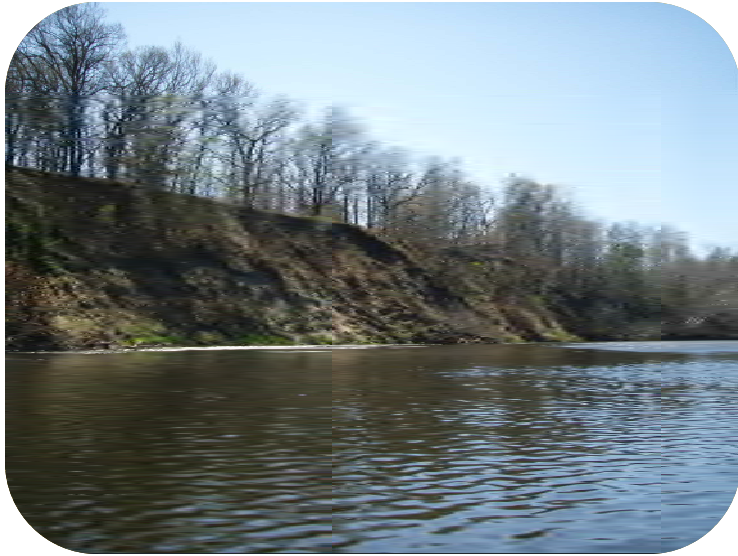
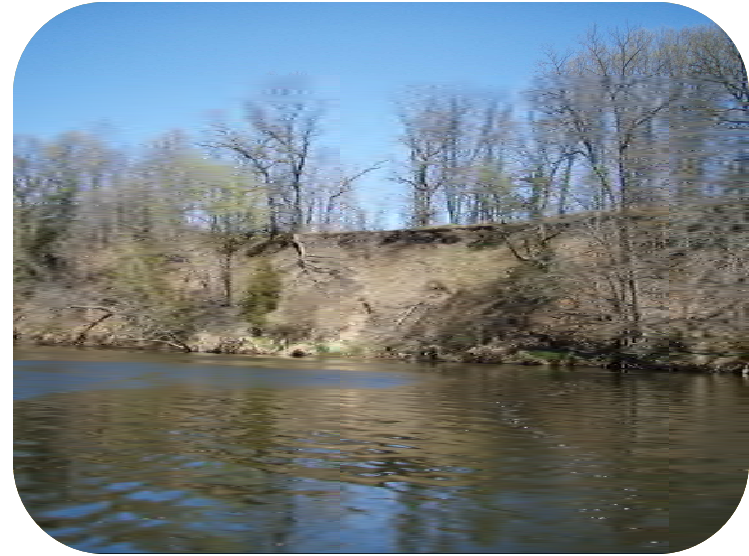
**Photo 70** – High bank with good tree cover. No recommended action. Also see Photos 71, 72, 73, and 74.

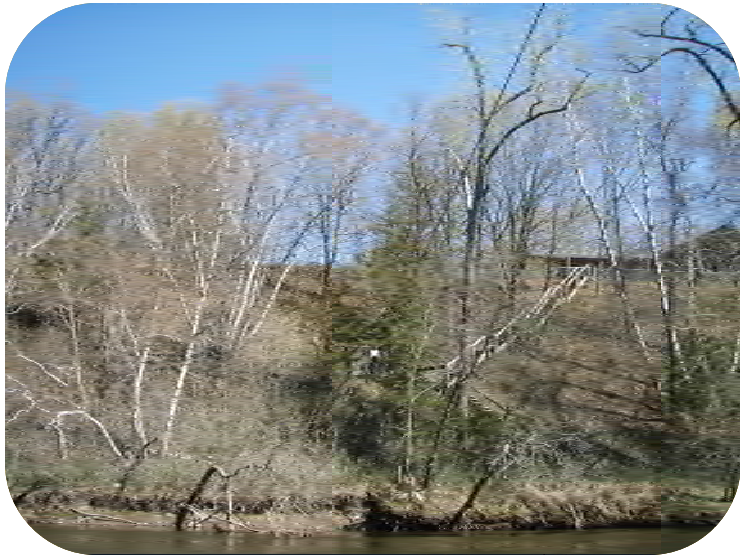
**Photo 78** – Viking Blvd. bridge and approx. 18 in. outlet onto concrete slab approx. 4 ft. above water.

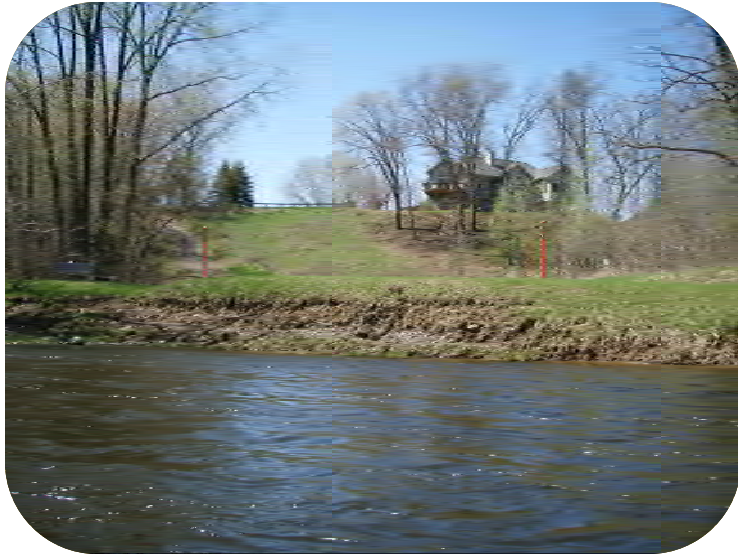
**Photo 84** – Gas pipeline crossing. Also see Photo 85.

**Photo 85** – See Photo 84 description.

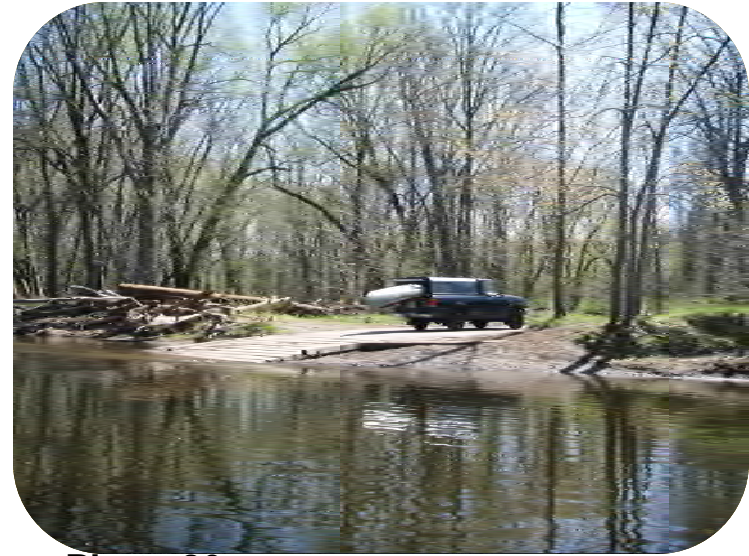
**Photo 86** – Rum River Central County Park boat landing.

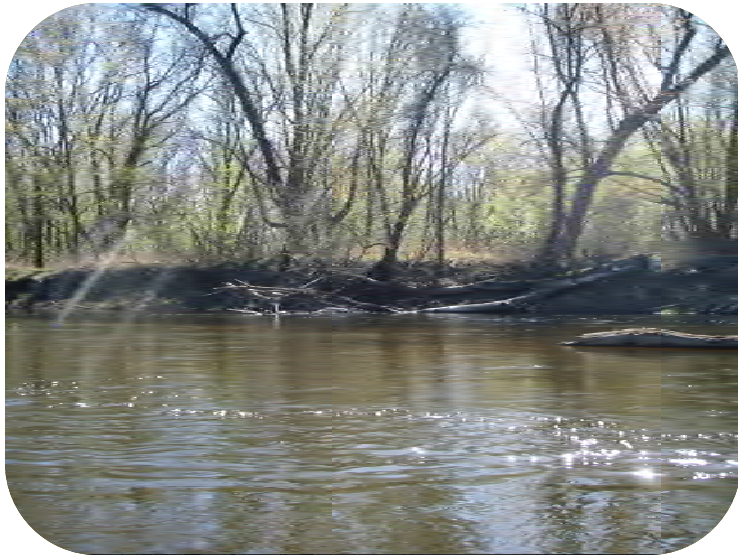
**Photo 87** – Moderate erosion in forested area. Also see Photos 88, 89, and 90.

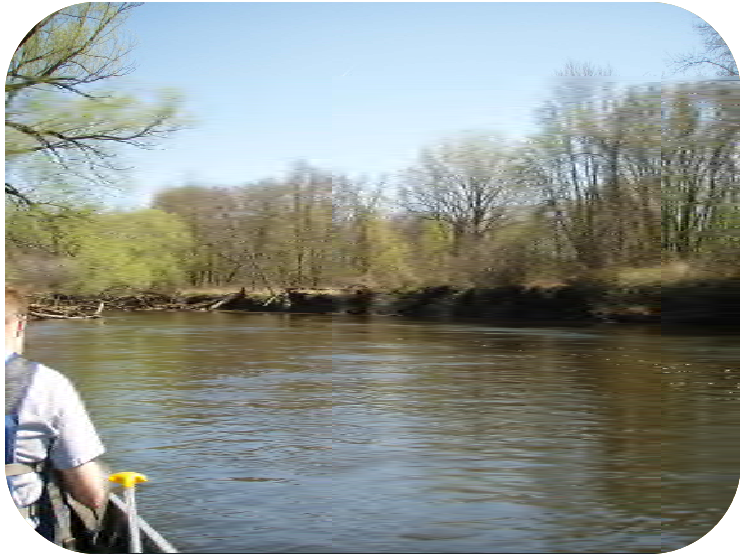
**Photo 89** – See Photo 87 description.

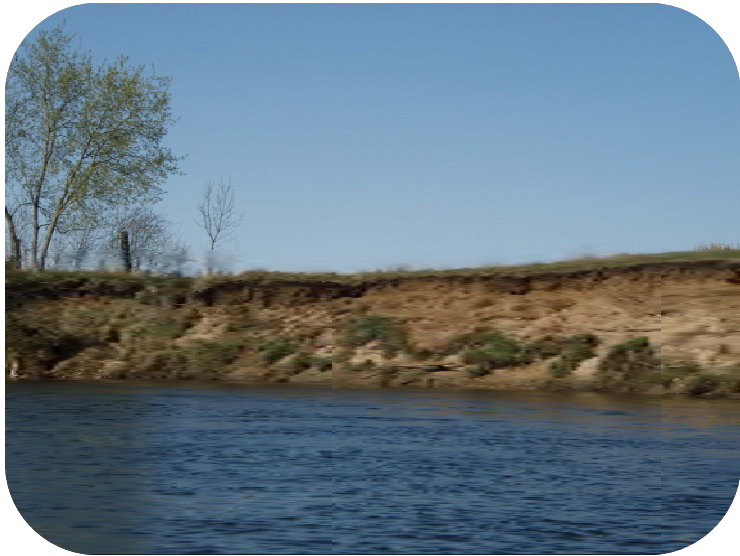
**Photo 91** – Severe erosion, 20 ft. back with fence over water. Also see Photos 92, 93, 94, 95, and 96.

**Photo 95** – See Photo 91 description.

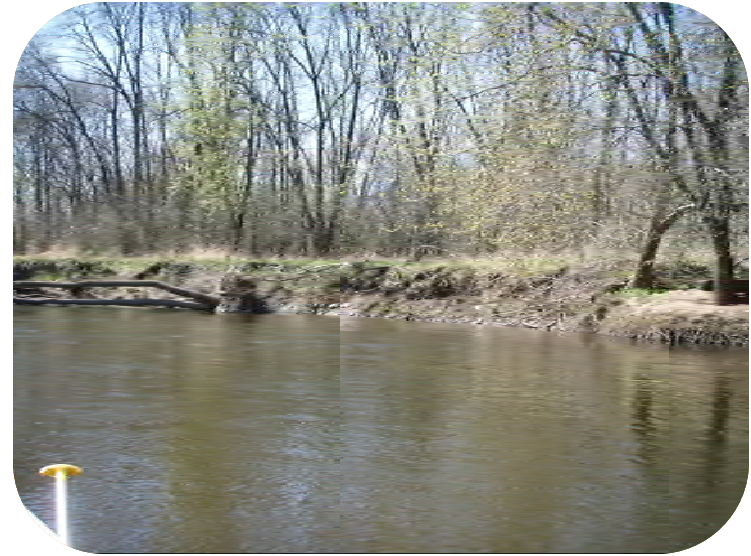
**Photo 97** – Mild erosion. Also see Photo 98.

**Photo 98** – See Photo 97 description.

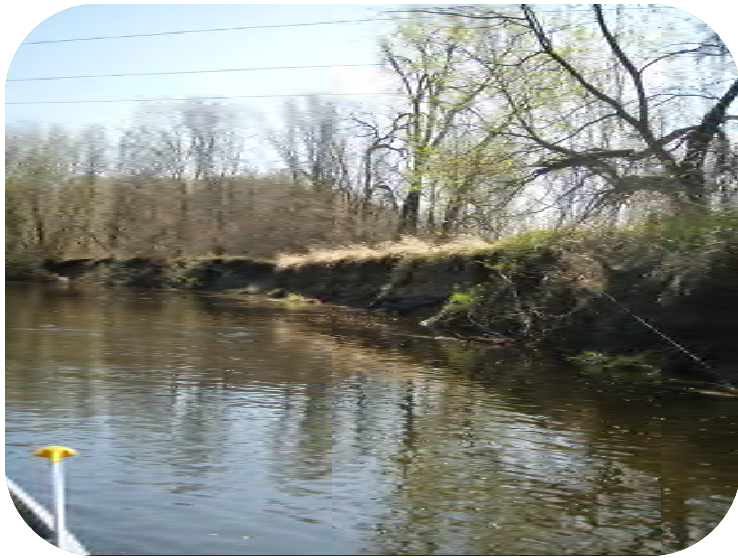
**Photo 99** – Moderate erosion. Also see Photos 100, 101, and 102.

**Photo 101** – See Photo 99 description.

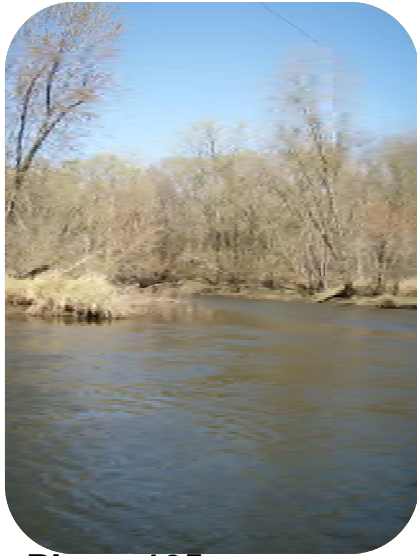
**Photo 105** – Cedar Creek inlet.

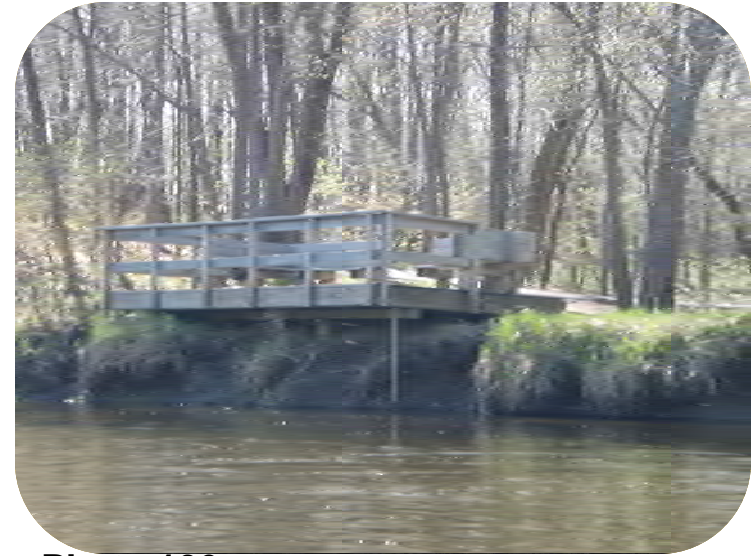
**Photo 106** – Observation platform/deck overhanging the water's edge.

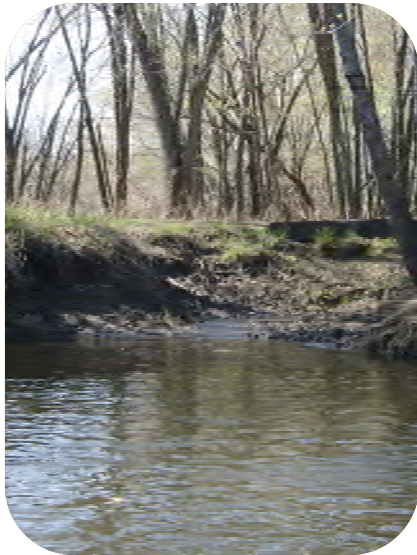
**Photo 107** – Creek inlet.

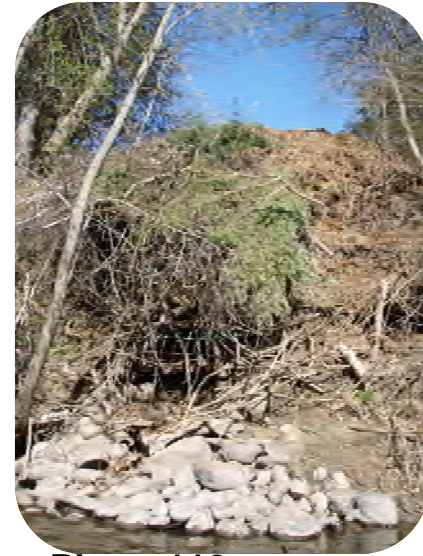
**Photo 109** – Approx. 24" flared end section and yard waste piled above. Also see Photos 110, 111, 112, 113.

**Photo 110** – See Photo 109 description.

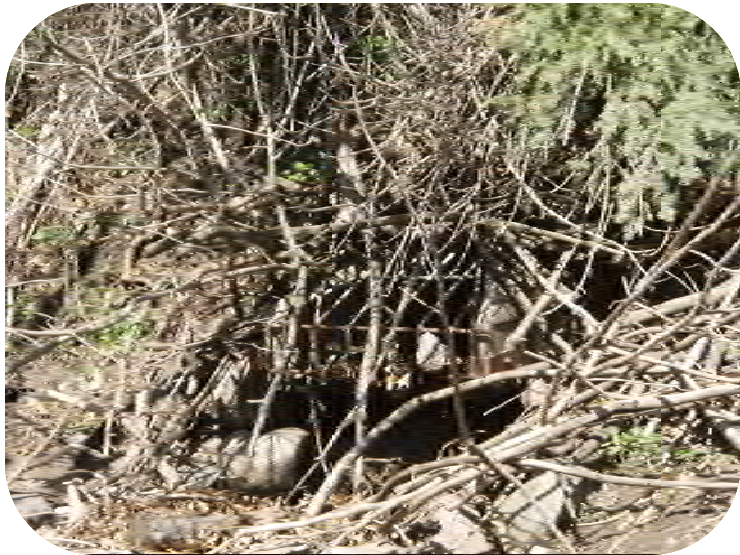
**Photo 111** – See Photo 109 description.

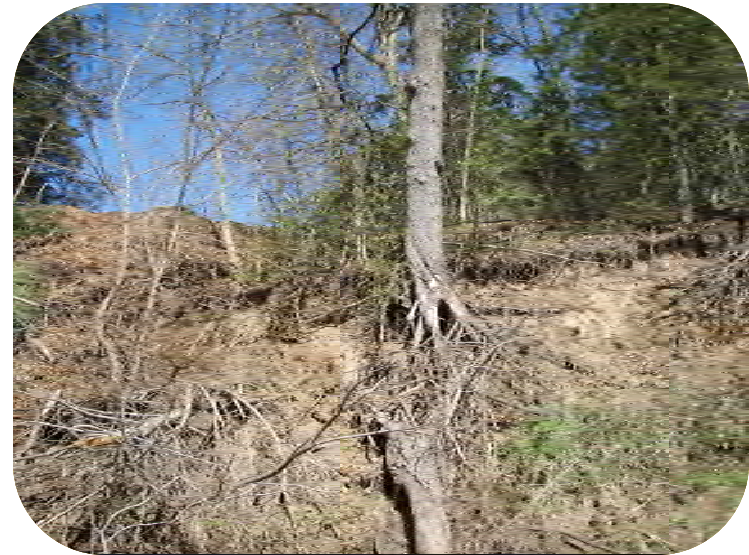
**Photo 112** – See Photo 109 description.

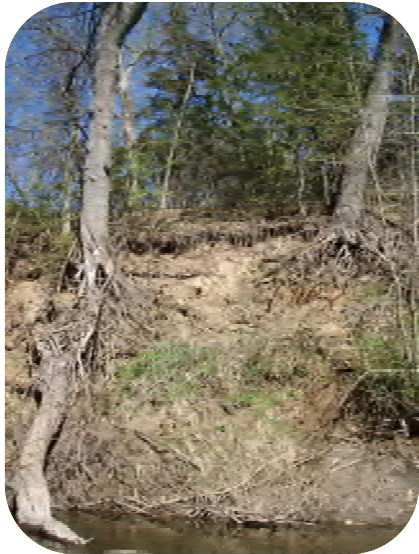
**Photo 113** – See Photo 109 description.

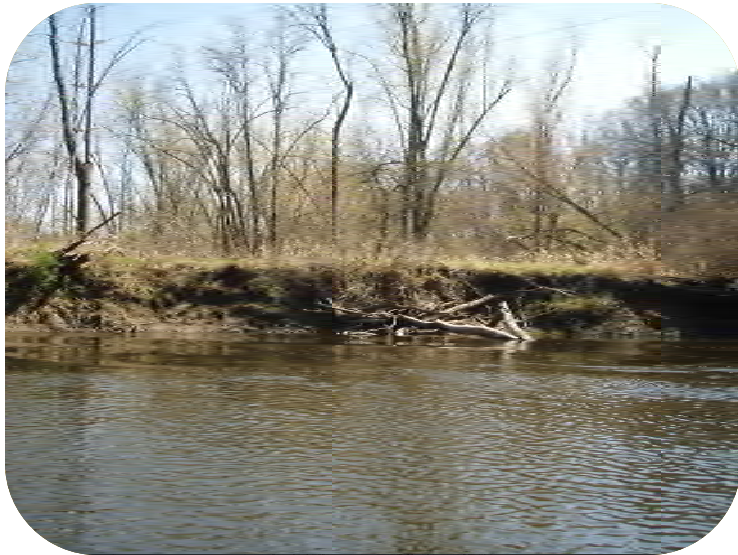
**Photo 114** – Moderate erosion. Also see Photo 115.

**Photo 115** – See Photo 114 description.

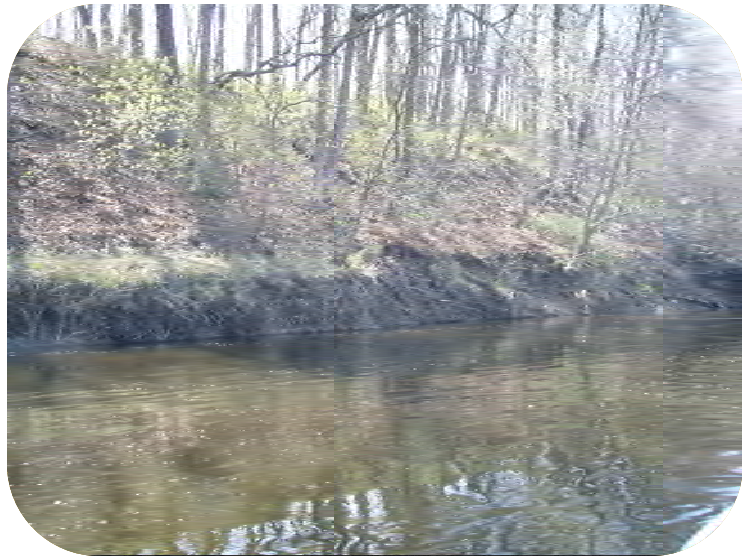
**Photo 117** – Mild erosion.
